# DOUGLAS SHOAL

## PRELIMINARY SITE ASSESSMENT REPORT

Costen, A. Ims, S. and Blount, C. 2017, *Douglas Shoal Preliminary Site Assessment Report*. Document R.1.59918002, Version 1. Report prepared by Cardno Ltd for the Great Barrier Reef Marine Park Authority, Townsville.

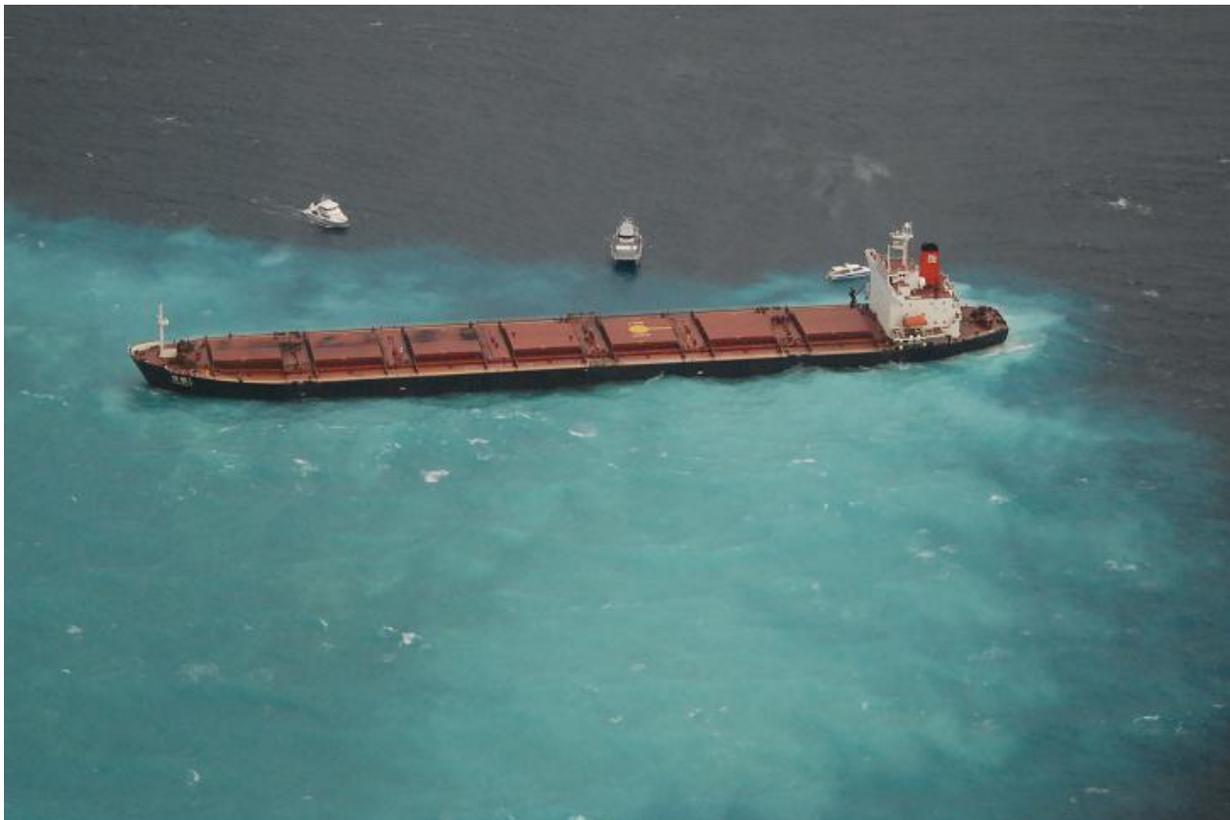
On 3 April 2010, Shen Neng 1 grounded on Douglas Shoal, moving across some 42 hectares during the 10 days before she was re-floated and towed away. The vessel suffered extensive plate damage during the grounding, which comprised plate indentation, push-up, buckling and cracking. The rudder was slightly damaged but the propeller was not.

Figure 1-1 Shen Neng 1 aground on Douglas Shoal – 4 April 2010 (AMSA 2010)

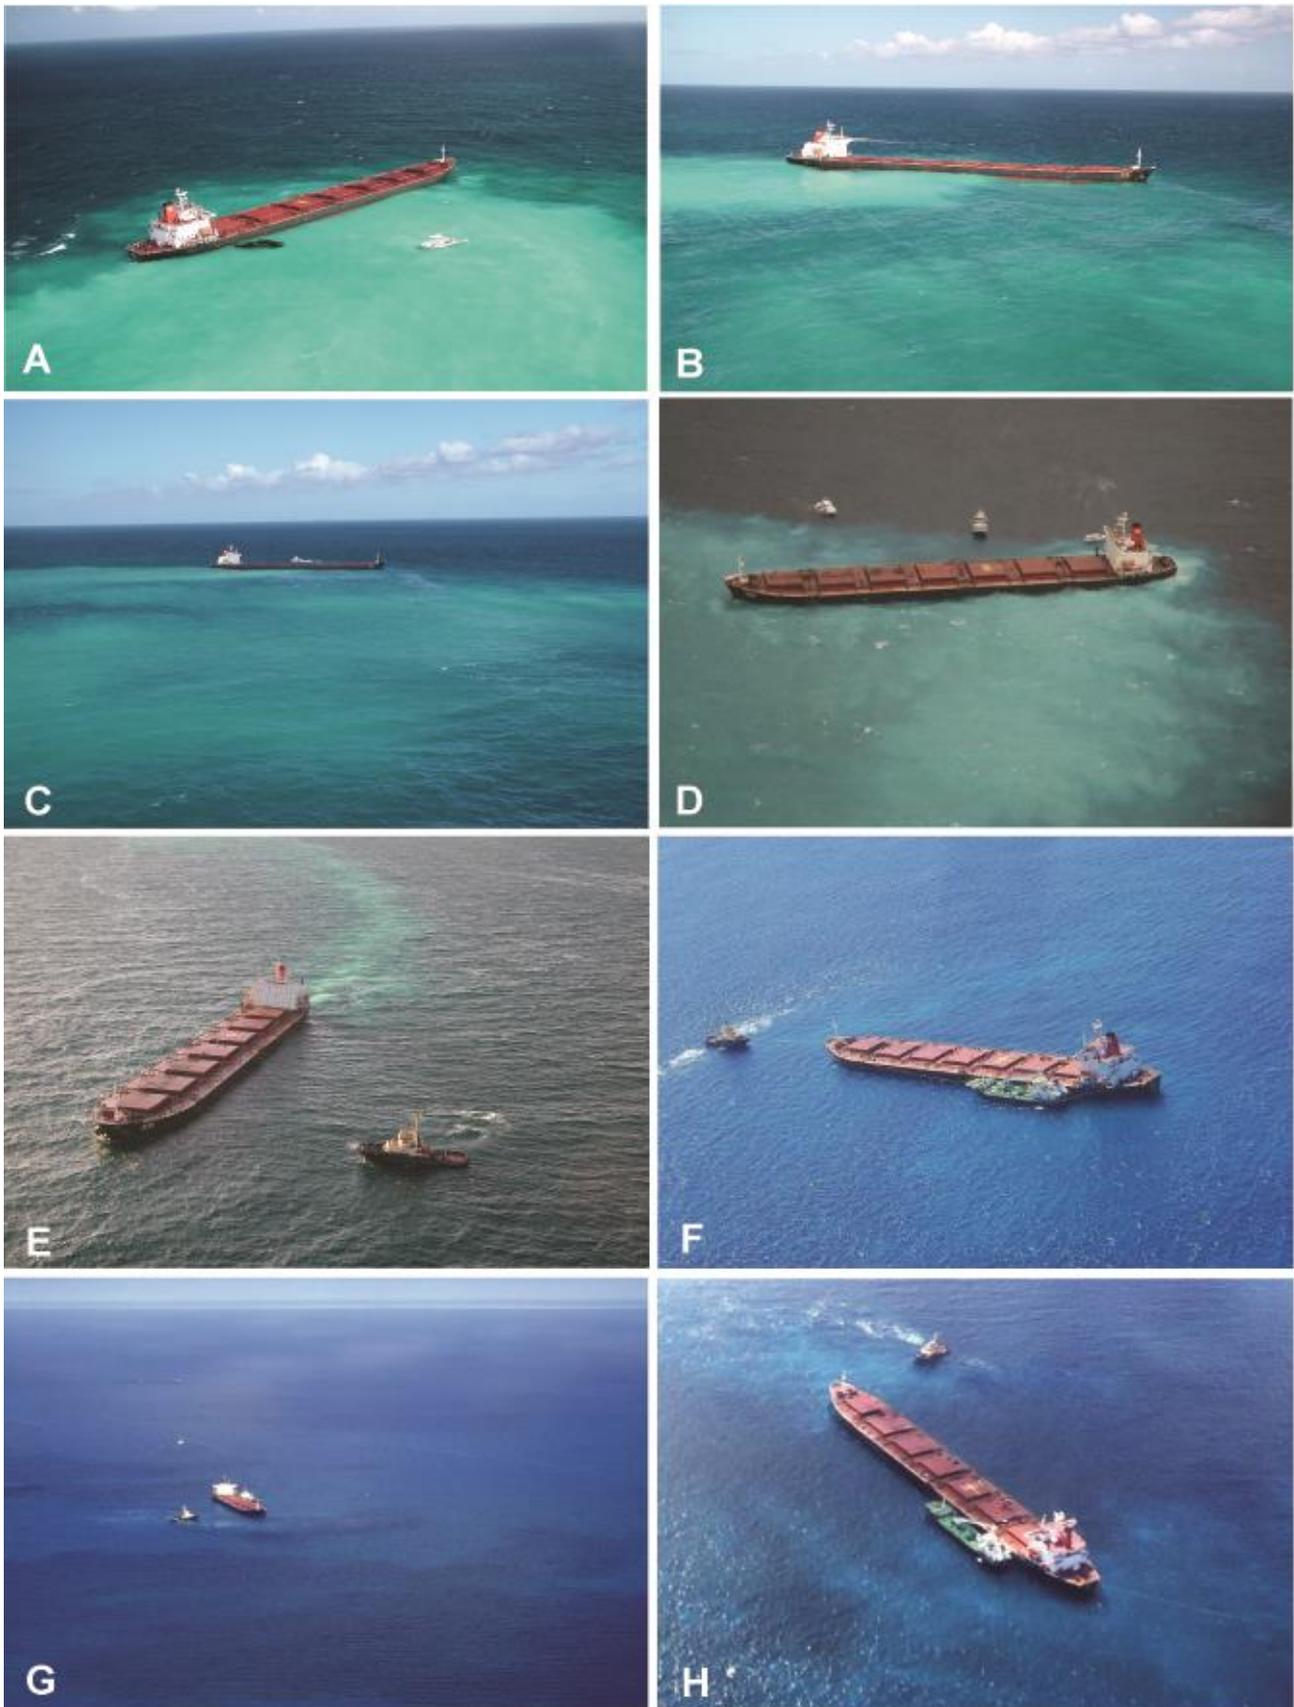
Figure 3-3 Images of Shen Neng 1 aground at Douglas Shoal. Aerial imagery of sediment plumes created during the Shen Neng 1 grounding period. Flood tide (A, B, C; MSQ 2010) and ebb tide (D; AMSA 2010) plume movement on April 4. Aerial images from April 6 (E), (F) (G & H) (MSQ, 2010)

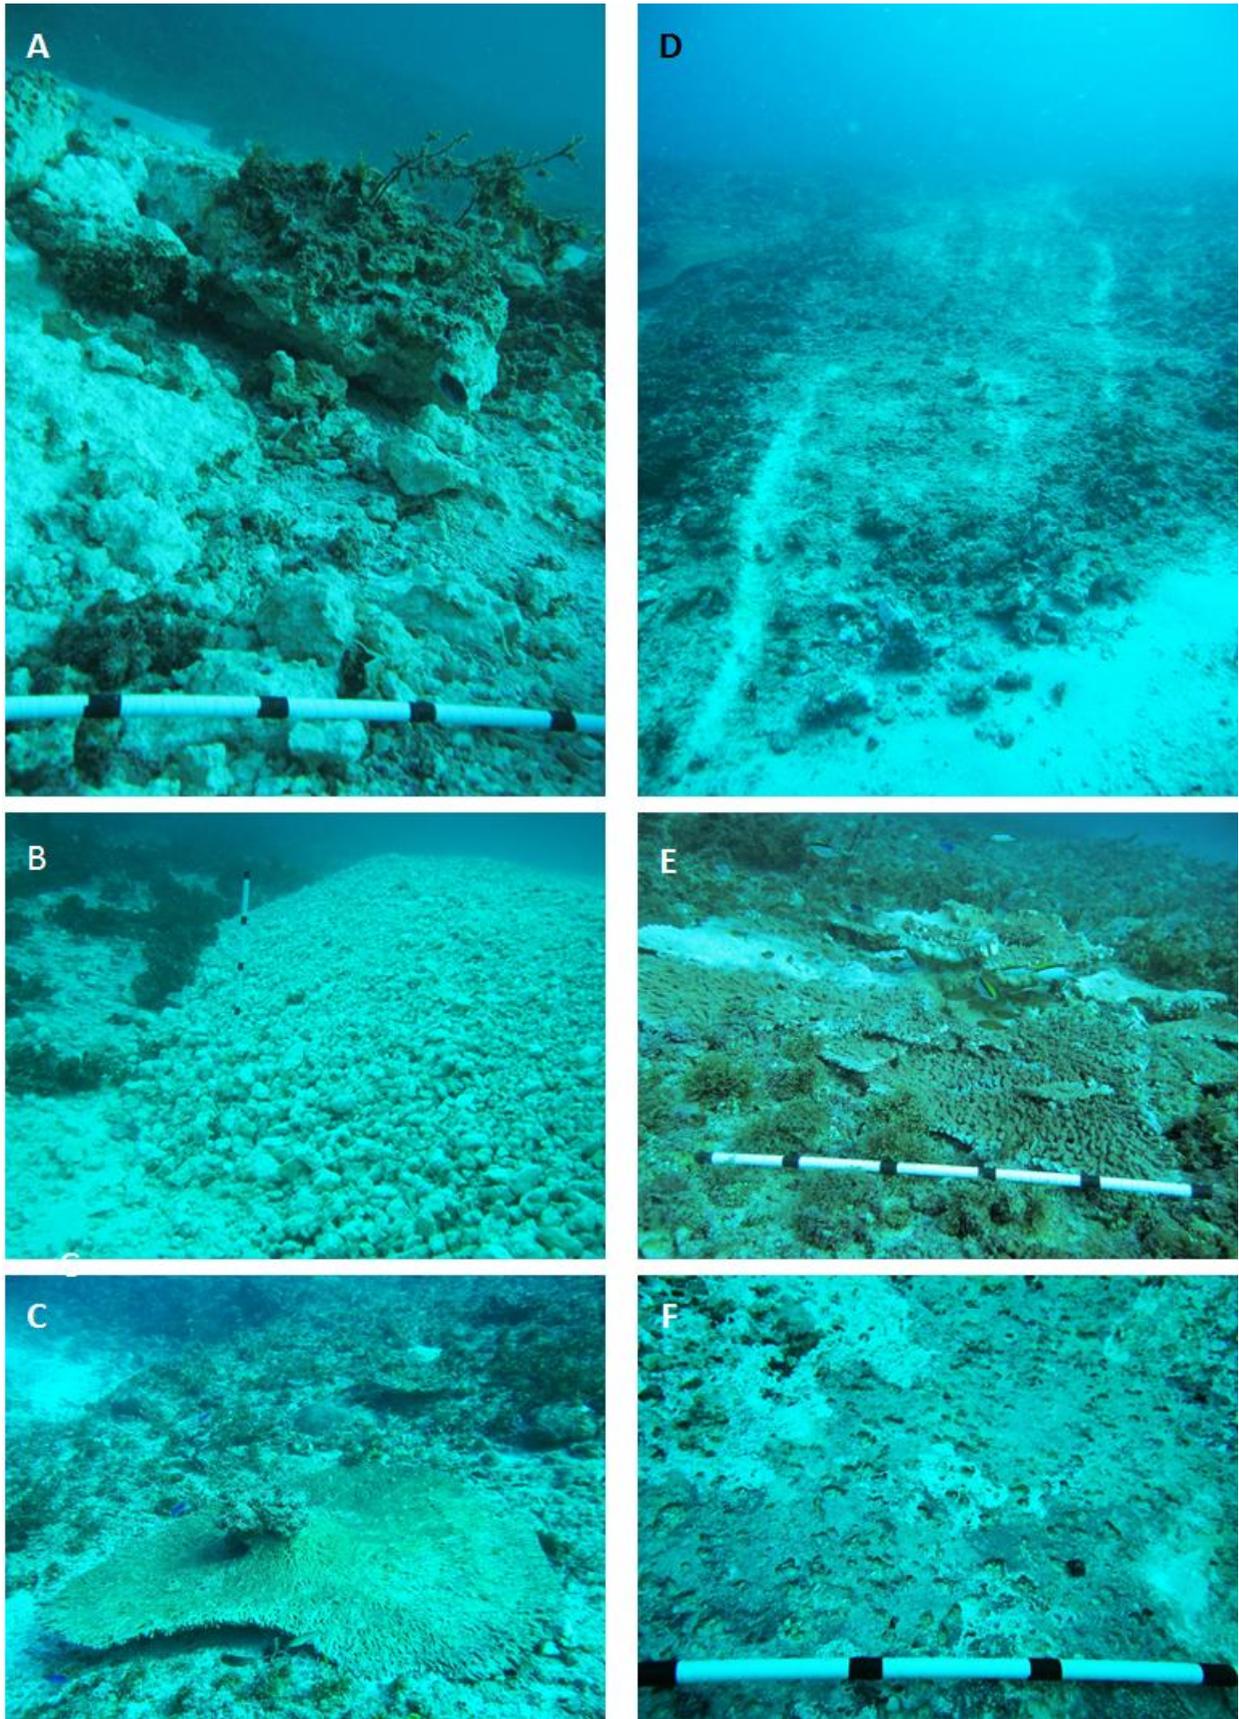
**Figure 4-2 Images of physical damage**

Figure 4-2: **A)** Substrate - fractured & displaced. **B)** Substrate - displaced (berm). **C)** Benthic fauna – displaced (toppled). **D)** Substrate – displaced (scarring). **E)** Benthic fauna – dislodged. **F)** Substrate – displaced (compressed).

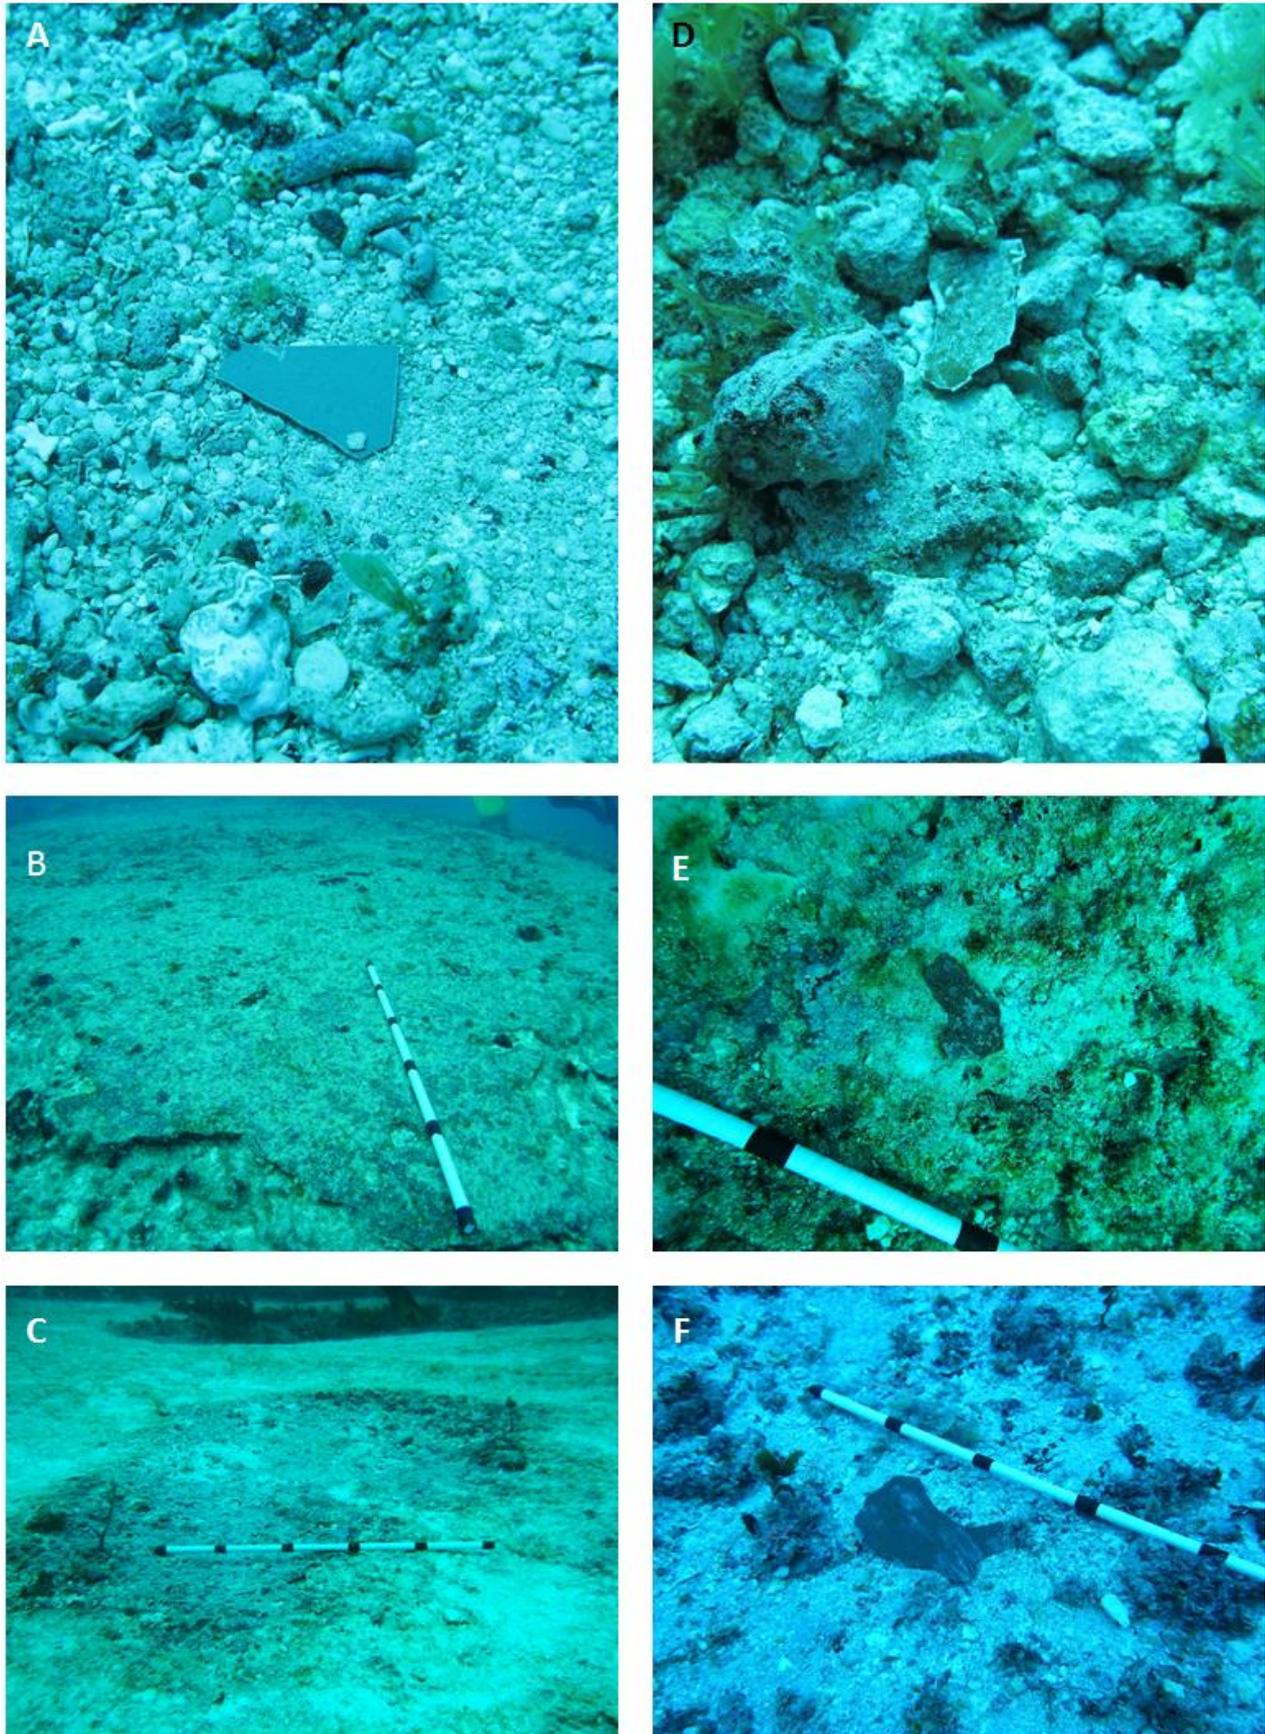
Figure 4-4 Images of in-situ AFP

Underwater inspection and sampling of the hull was undertaken some 6 weeks following the grounding incident indicated that damaged sections of the hull showed evidence of significant paint loss. Chemical analysis of paint samples confirmed the presence of active (biocide) ingredients including tributyltin, zinc oxide and copper oxide, copper pyrithione and zineb at environmentally significant concentrations.

Figure 4-4: A) Flake B) Large smear. C) Large smear (toppled). D) Flake amongst rubble. E) Small smear F) Large flake.

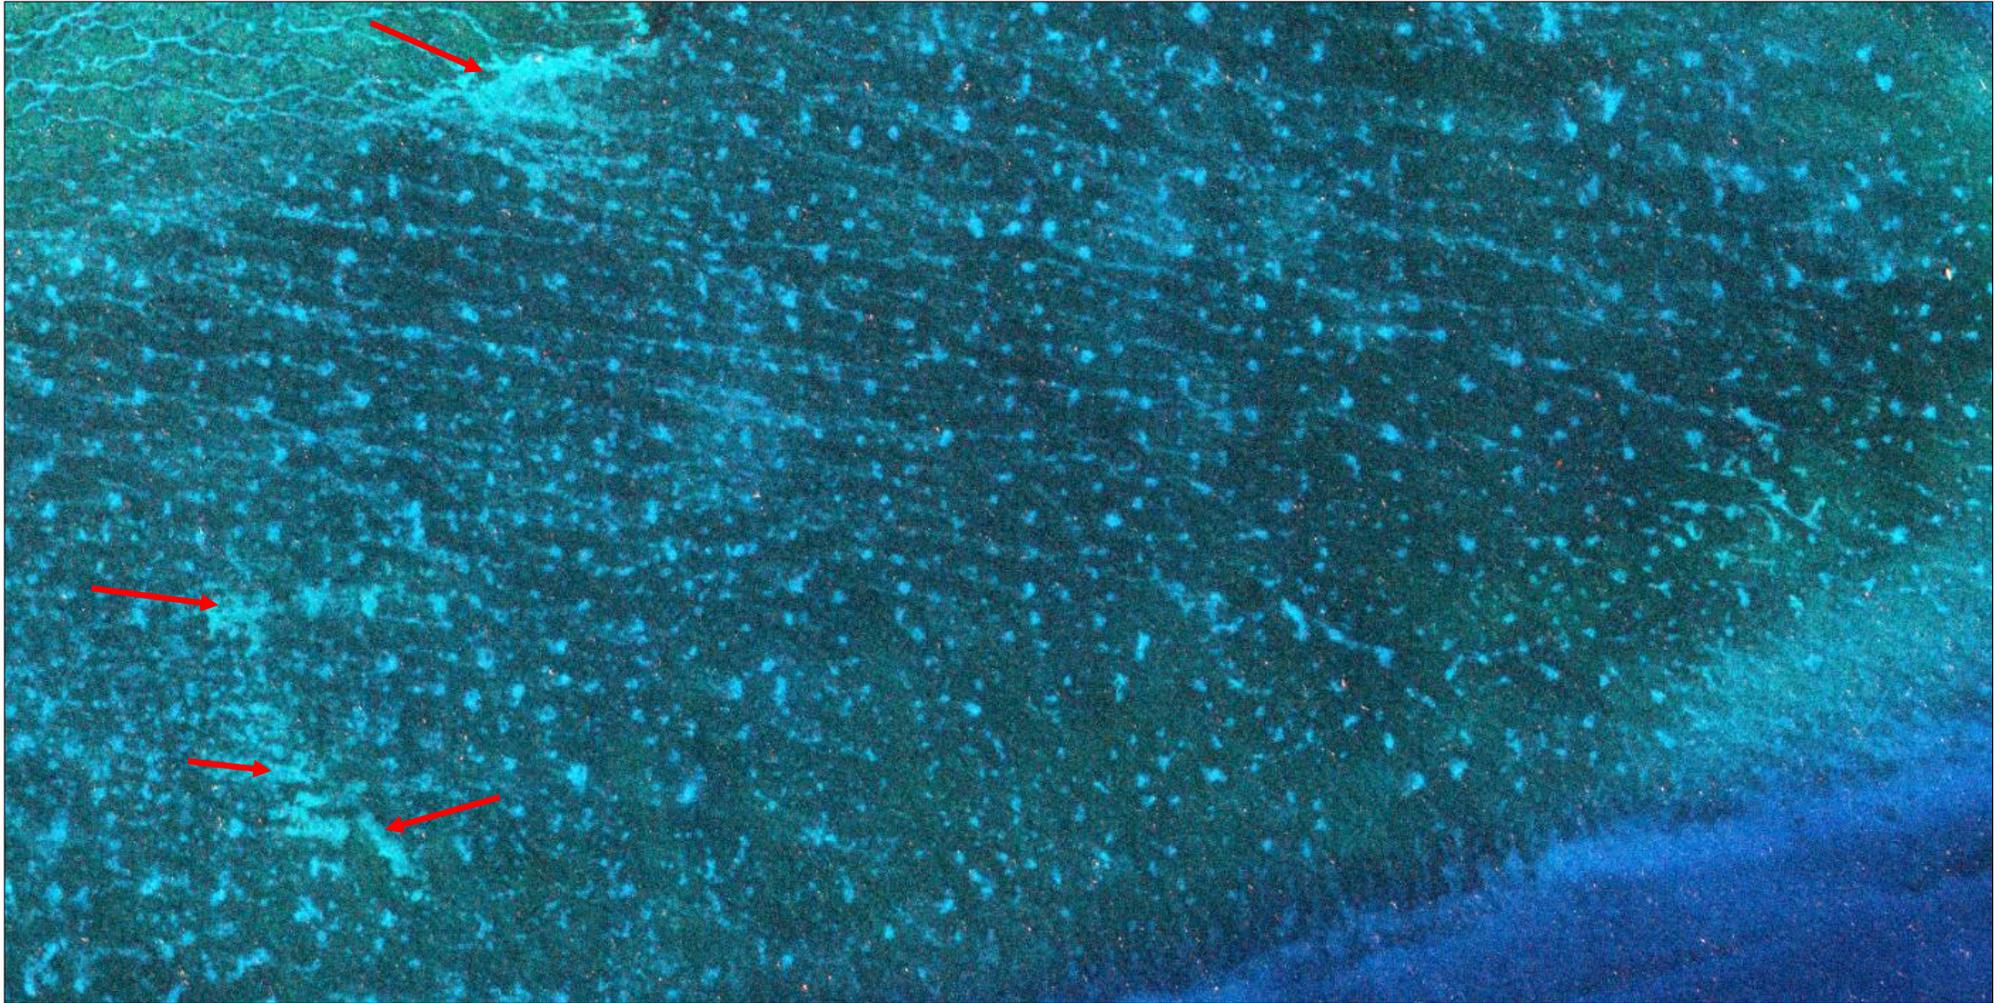
Figure 4-6 2016 World View 2 satellite imagery (red arrows point to visible scars, see Figure 3-2 for corresponding bathymetry)

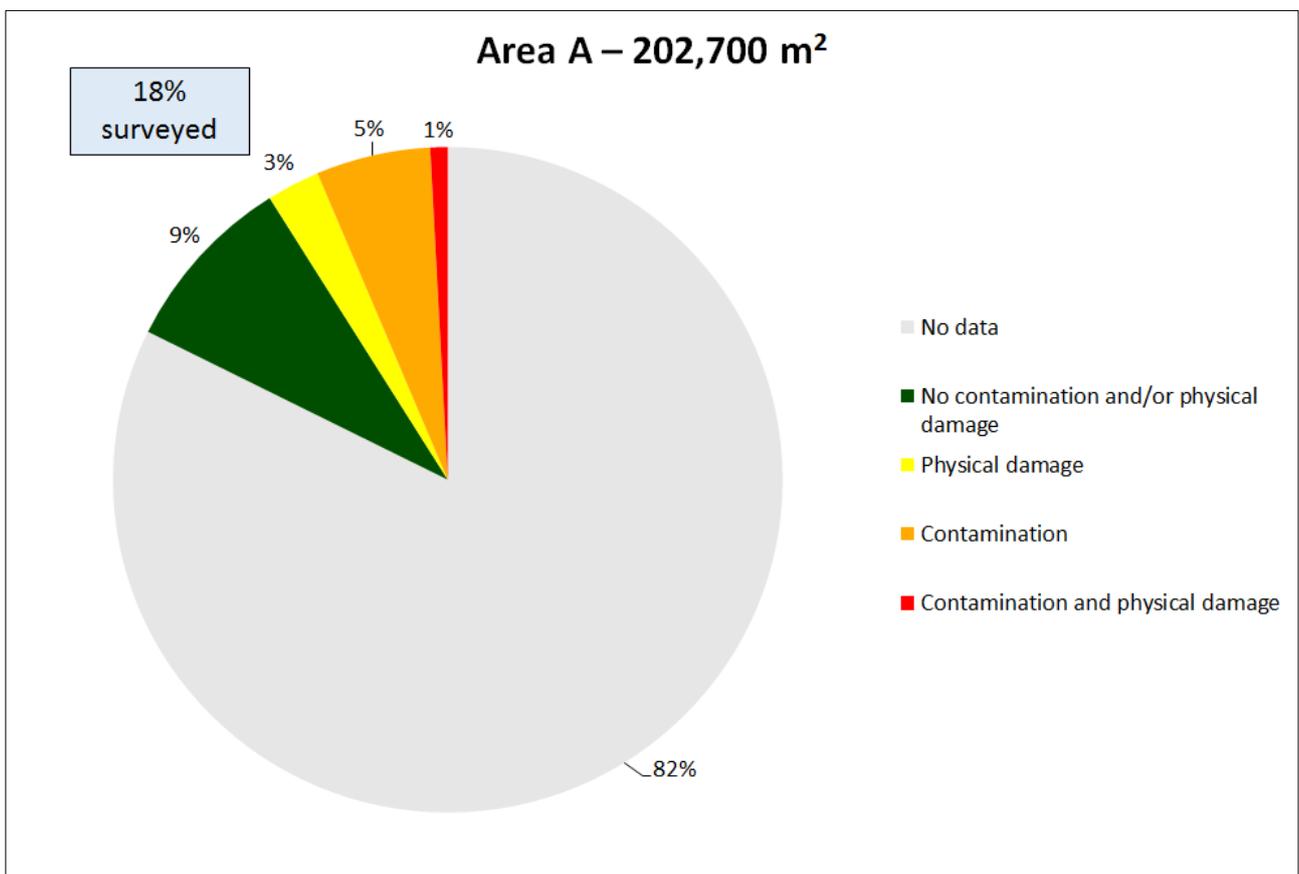
**Figure 5-2 Area A - data summary**

- Covers some 202,700 m<sup>2</sup>
- No data are available for 166,900 m<sup>2</sup>, approximately 82% of the area
- Physical damage and contamination was recorded in 17 cells or 1%
- Cells with only contamination reported, total 112 or 5% of the area
- Cells with only recorded physical damage, total 52 or 3% of the area
- Cells with either no recorded physical damage or contamination represent 9% of the area.

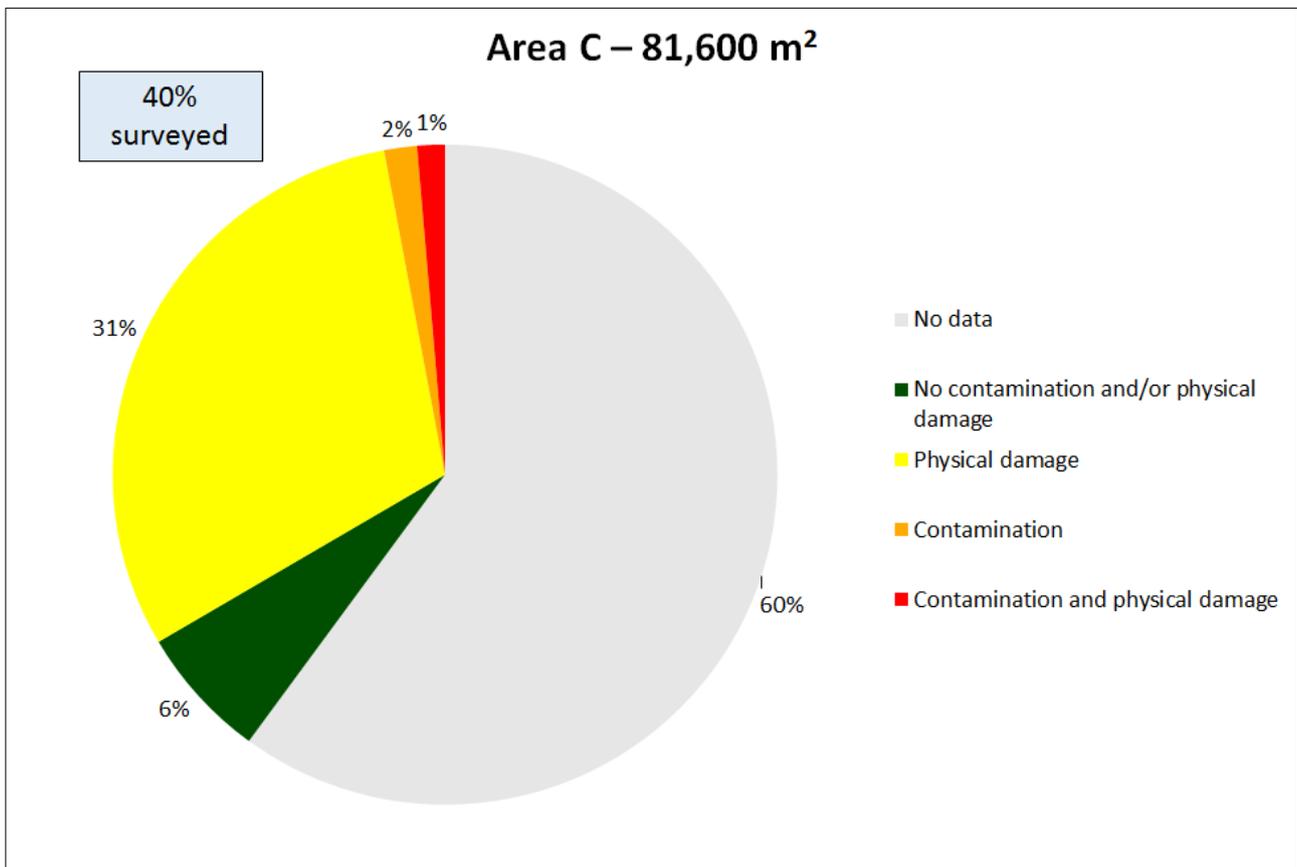
Figure 5-3 Area C – data summary

Note that no sediment samples were collected from **Area C** for analysis of contaminant concentrations. However, Kettle (2014) did collect samples for AFP particle count analysis. Results indicate that 13 of the 24 samples, contained between 1 and 4 AFP particles (per sample).

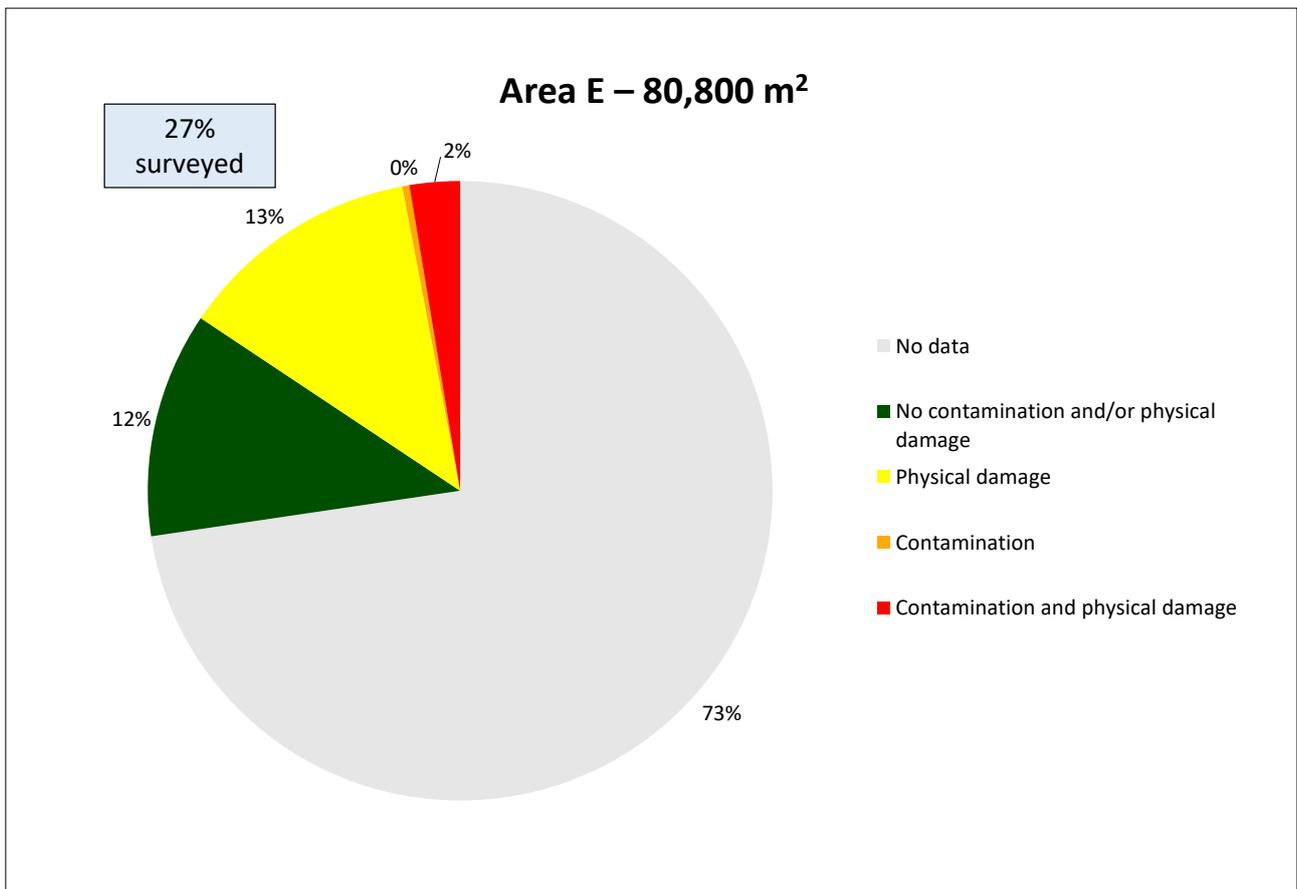
**Figure 5-4 Area E – data summary**

- Covers some 80,800 m<sup>2</sup>
- No data are available for 58,700 m<sup>2</sup>, approximately 73% of the area
- Physical damage and contamination was recorded in 21 cells or 2% of the area
- Cells with only contamination recorded, total 3 (less than 1%)
- Cells with only reported physical damage, total 102 or 13% of the area
- Cells with either no recorded physical damage or contamination represent 12% of the area.

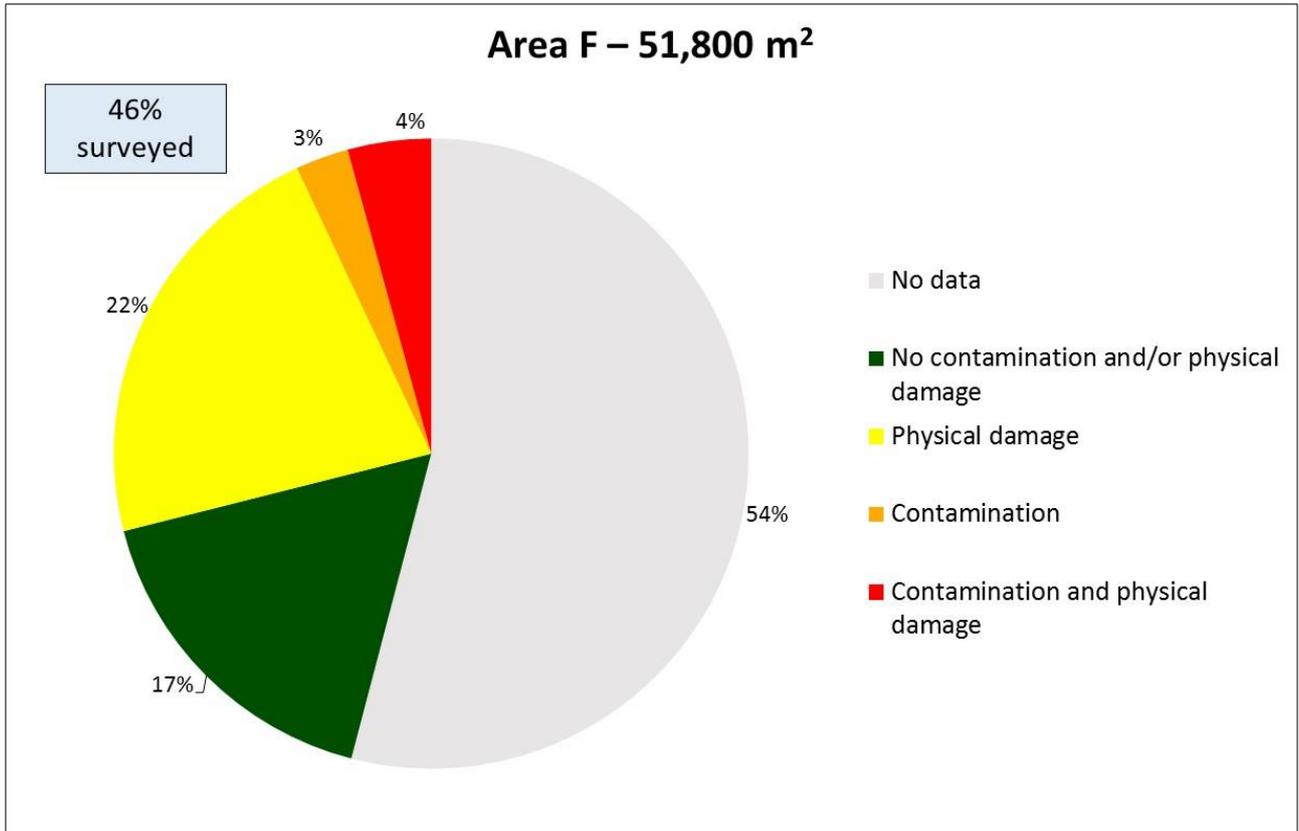
**Figure 5-5 Area F – data summary**

- Covers some 51,800 m<sup>2</sup>
- No data are available for 28,000 m<sup>2</sup>, approximately 54% of the area
- Physical damage and contamination was recorded in 22 cells or 4% of the area
- Cells with only contamination recorded, total 14 or 3% of the area
- Cells with only reported physical damage, total 114 or 22% of the area
- Cells with either no recorded physical damage or contamination represent 17% of the area.
