Site Assessment Report

**Douglas Shoal Remediation Project
Great Barrier Reef Marine Park Authority**

8 November 2019

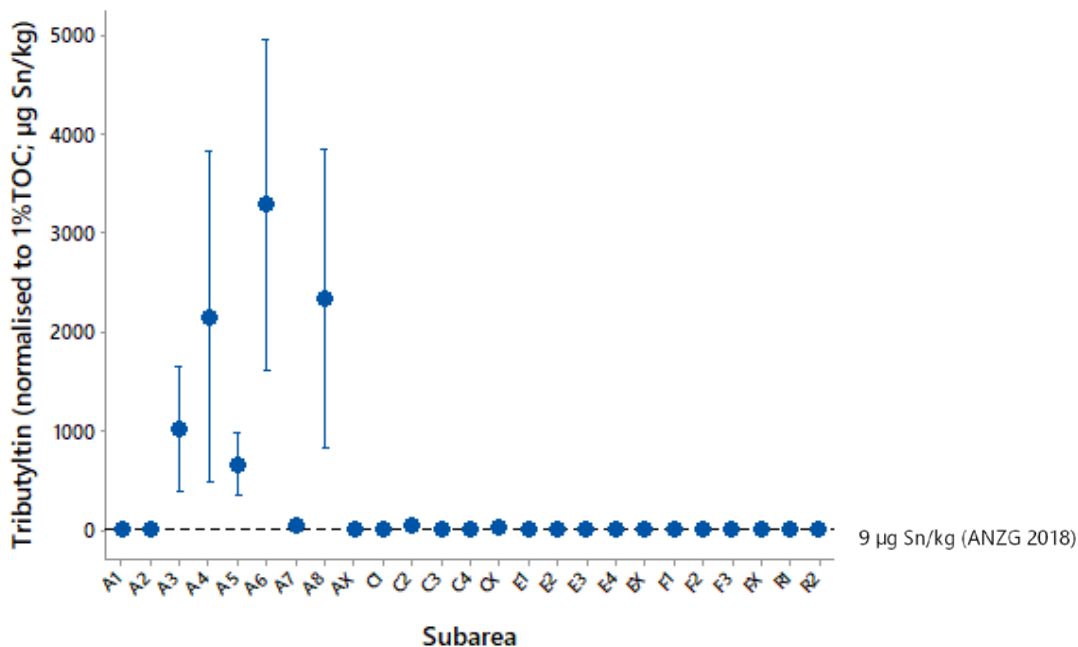
Figure 1-4 Mean concentrations of tributyltin (\pm standard error) by sub-area (ANZG (2018) default guideline value of $9\mu\text{g Sn/kg}$ is displayed as a dashed line)

Analysis supported delineation of high and moderate priority areas for remediation with respect to contamination. Contamination of sediments exists primarily within part of the previously identified Priority Area A and is principally associated with TBT (Figure 1-4).

No visible evidence of AFP smears, flakes or chips was identified during the survey. It is likely that the extent and level of contamination has reduced at the grounding site over time, with contributing factors to reduction including exposure to erosive forces (e.g. ocean currents and waves) through normal conditions and extreme events. Notwithstanding this, investigation of TBT persistence show it may be another decade before TBT ceases to be a contaminant of concern in Priority Area A. As such, it is considered that addressing AFP-related contamination should remain a priority for remediation.

Remediation planning and monitoring should recognise that sediments are not well mixed, with contamination typically associated with remnants of AFP flakes in fine sediment. Contamination of sediments may occur outside of the priority remediation areas; however, such areas are likely to be small, isolated and with lower levels of contamination.

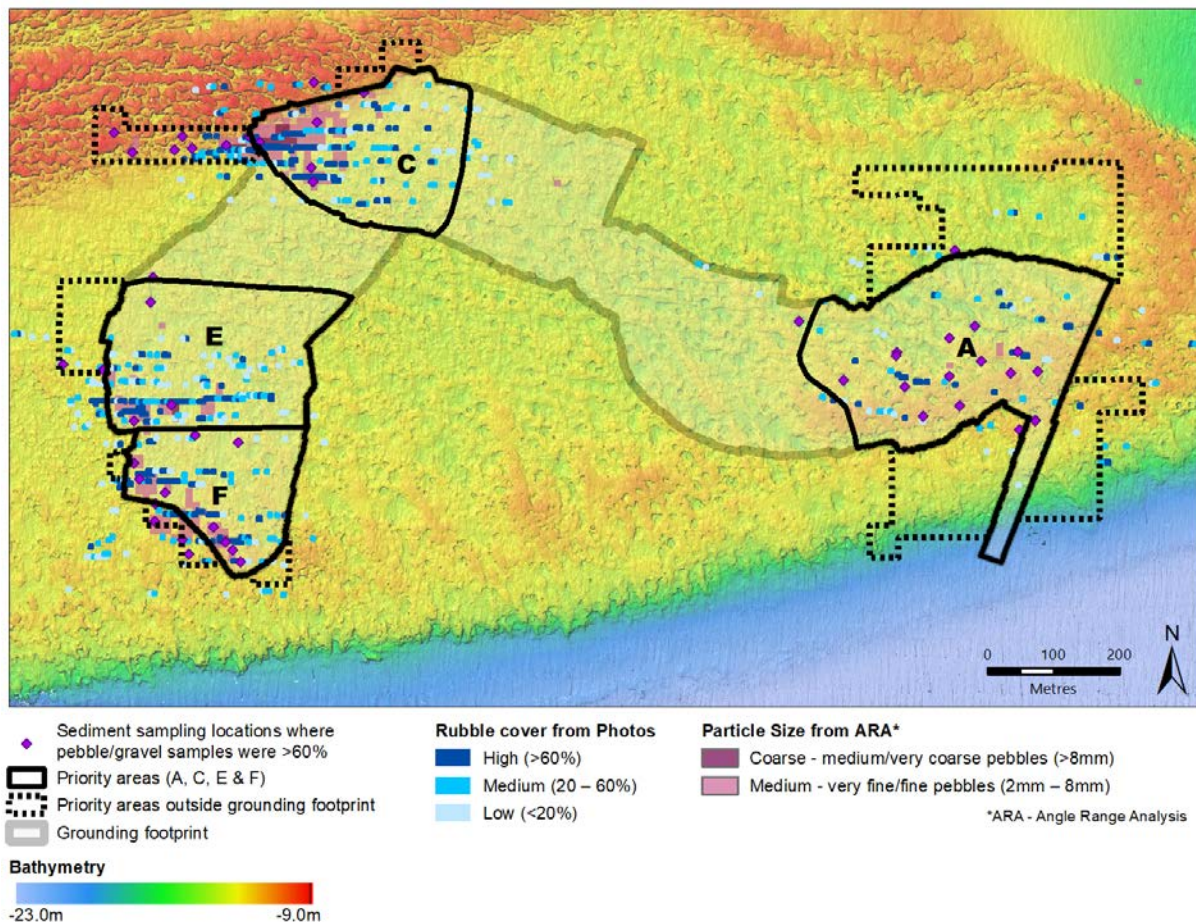
Figure 1-5 Rubble distribution across the priority areas

Physical contact between the vessel and the shoal created rubble. The rubble is different from naturally occurring sediments (including dead coral fragments) as it is coarser, more angular, and typically without encrusting organisms (coralline algae or turf algae, encrusting sponges or coral). The rubble is commonly unconsolidated and its movement over time appears to impede natural recovery.

Fieldwork and analysis focussed on identification and delineation of areas of rubble. Data derived from sonar survey (including Angle-Range Analysis (ARA)) was correlated with sediment particle size distribution data and habitat characterisation data from underwater video survey to delineate areas of rubble (Figure 1-5). This analysis also shows that unconsolidated rubble has moved over time, generally in a westerly direction, and affected habitat on the shoal beyond the grounding footprint. Further analysis indicates in some locations the rubble has filled (partially or completely) natural depressions and therefore altered habitat complexity on the shoal.

Physical damage associated with rubble is more obvious than areas affected by abrasive flattening and compaction as these areas are commonly obscured by the rubble. Analysis of changes over time (between 2010 and 2019 survey) in flattened extent suggests that grounding-related flattened areas are at least in part associated with rubble filling in depressions and 'flattening' the profile of the shoal.

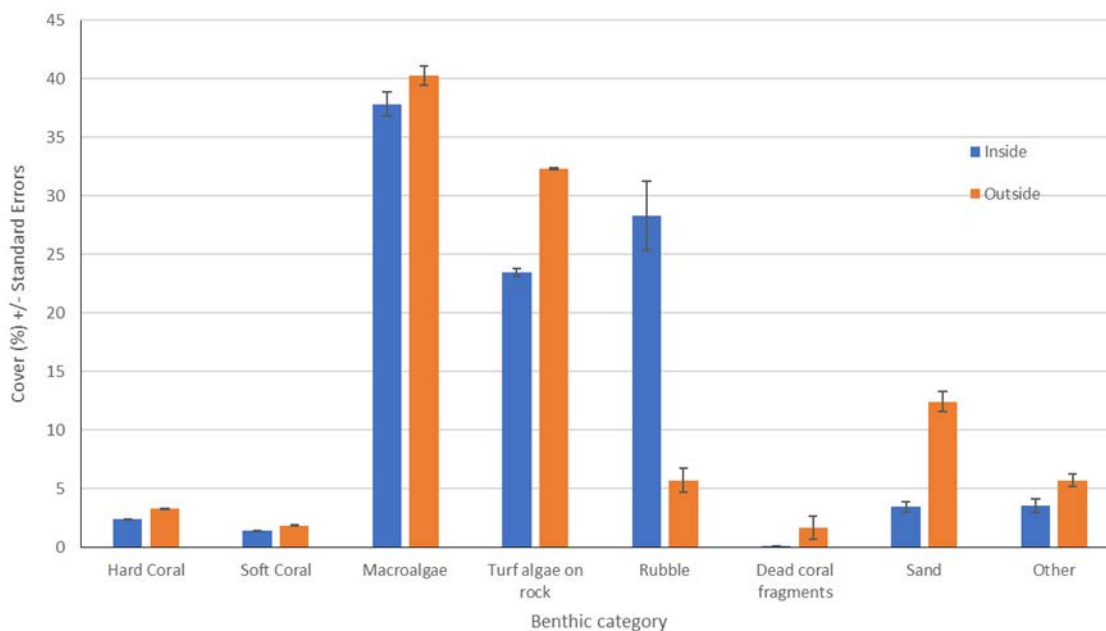
Figure 1-6 Percentage covers (+/- standard error) of benthic groups inside and outside the assumed impacted areas

Comparison of 2019 survey benthic habitat and benthos data from inside and outside the area assumed to be impacted by the grounding is shown in Figure 1-6. Outside the impacted areas, hard and soft coral, macroalgae, turf algae on rock, sand and other benthos were more abundant. The impacted areas were characterised by having very high cover of rubble. Closer examination of the benthic groups shows the cover of rubble is highest inside the impacted area in Priority Area F (47.9%), followed by Priority Area C (23.5%), Area E (31.4%) then Area A (10.4%). It is considered likely that the grounding caused habitat changes on the shoal including the replacement of areas of 'turf algae on rock' and areas of 'sand' with 'rubble'.

The appearance of the rubble does not appear to have changed significantly since the grounding and remains obviously different to the natural sediments found in the reference or unaffected areas; however, some areas of rubble do support benthic organisms and have consolidated over time. It appears that some areas of substrate smothered by rubble following the grounding have been exposed with westward movement of rubble over time. Undulating substrate was found in these areas to be devoid of algal growth; however, now exposed these areas may support the settlement and growth of coral recruits and other benthos.

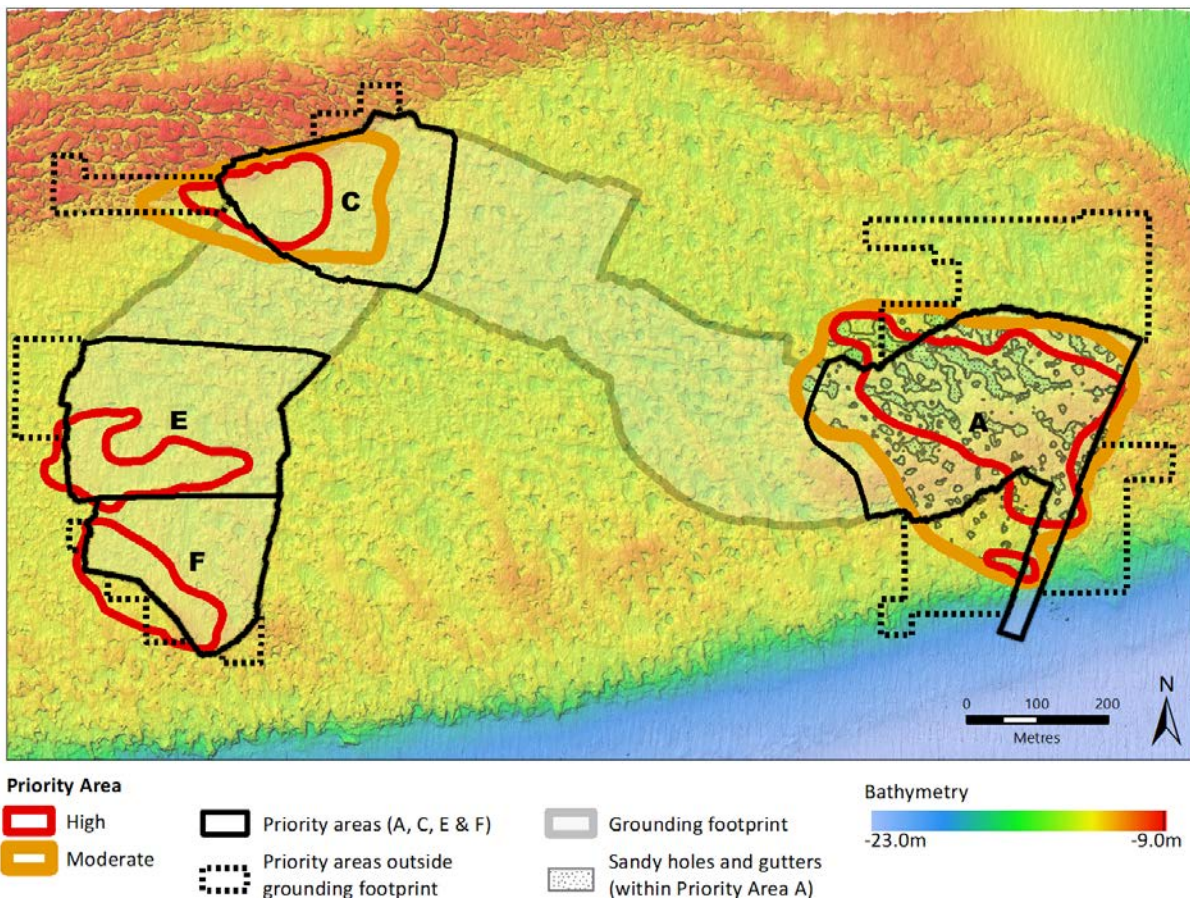
Figure 1-7 Delineation of high and moderate priority areas

The site assessment investigations show that almost ten years after the grounding incident contamination and physical damage remain as potential impediments to natural recovery, albeit their significance within the survey area may have diminished over time. The investigations support delineation of priority areas for remediation as follows (Figure 1-7):

- Remediation priority for contamination in part of Priority Area A:
 - Moderate priority assigned where analysis shows concentrations of TBT, copper or zinc in sediment are predominantly above default guideline values for ecosystem protection, with contaminant levels in sediment likely to remain above the guideline values for about ten years
 - High priority assigned where, in addition to the above, analysis shows that disturbance of the sediment is likely to release water with concentrations of TBT, copper or zinc above default guideline values for the protection of a high ecological or conservation value system.
- Remediation priority for persistence of rubble in part of priority areas C, E and F:
 - High priority assigned where analysis shows most substrate is rubble
 - Moderate priority assigned where analysis shows rubble is a significant part of the substrate.

The persistence of rubble obscures the extent of abrasive flattening and compaction damage on the shoal; however, these areas of abrasive flattening and compaction are considered to be of lower importance with respect to remediation, given that the areas are small, within identified areas of rubble and that 'natural' areas adjacent to the grounding footprint are likely to offer habitat of similar value to these abraded flattened areas. Areas of abrasive flattening and compaction damage are not mapped and are not considered to be a priority for remediation. It is considered that other areas within the grounding footprint, including the remainder of areas A, C, E and F (Figure 1-7) do not represent a priority for remediation as there is insufficient evidence to show that natural recovery of the shoal is impeded by any ongoing influence of the grounding in these areas.

The total area of high and moderate remediation priority (contamination and physical damage) is 9.8 hectares (Table 1-1). This includes 2.3 hectares considered to be of high and moderate remediation priority for contamination and 7.5 hectares considered to be of high and moderate remediation priority for physical damage. Using the average measured sediment depth for each area the volume of sediment within the high and moderate remediation priority areas (contamination and physical damage) is estimated to be 7,065m³ (Table 1-1). This includes 1,386m³ of sediment considered to be of high and moderate remediation priority for contamination within part of Priority Area A, and 5,679m³ of rubble considered to be of high and moderate remediation priority for physical damage across part of priority areas C, E and F.
