Site assessment of Douglas Shoal ship grounding in the Great Barrier Reef

Neale, S.J.¹, Boylson, B.D.¹ Graham, T.G.¹, Cameron; D.S.², Gray, L.A.², Reese, R. E.²

¹ Advisian Pty Ltd, Brisbane, Australia; bill.boylson@advisian.com

² Great Barrier Reef Marine Park Authority, Townsville, Australia; darren.cameron@gbrmpa.gov.au

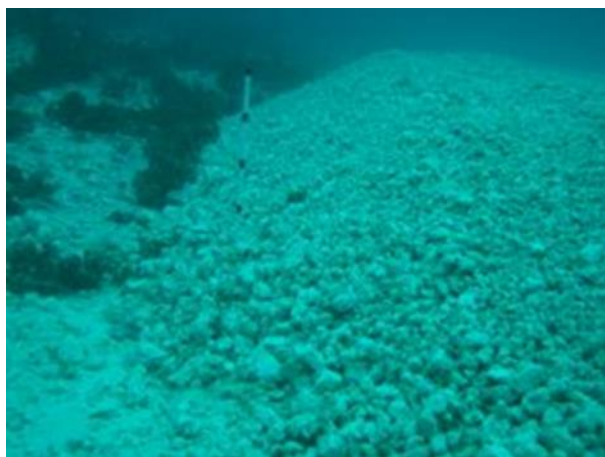
Immediately following the grounding incident in 2010, rubble accumulation was identified by diver survey (Figure 3). As such, sonar survey techniques were included as part of the 2019 field survey to provide efficient and effective bottom profiling coverage across the entire grounding area. Sonar survey was undertaken to refine remediation priority areas by investigating:

Figure 3 Rubble banks observed during investigations undertaken immediately after the grounding in 2010 [6].

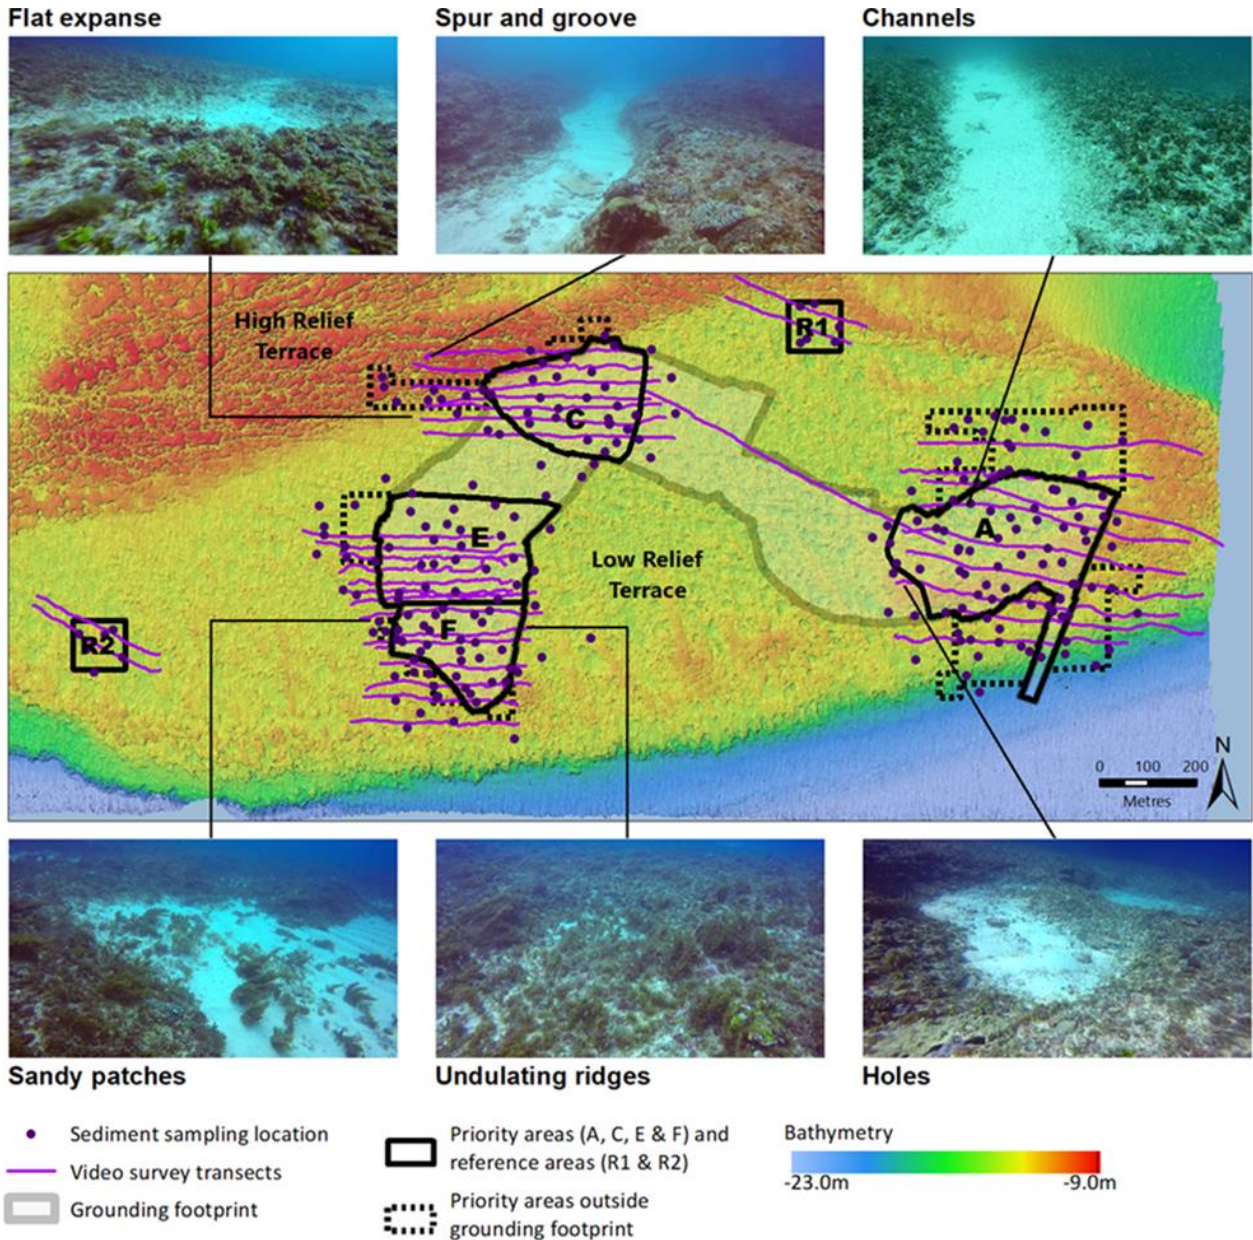
Figure 4 Field survey and habitat types at Douglas Shoal.

Comparison of 2019 survey benthic habitat data from inside and outside the grounding footprint showed that outside the impacted areas, hard and soft coral, macroalgae, turf algae on rock, sand and other benthos were more abundant. The impacted areas were characterised by having very high cover of rubble. Closer examination of the benthic groups shows the cover of rubble is highest inside the impacted area in Priority Area F (47.9%), followed

by Priority Area C (23.5%), Area E (31.4%) then Area A (10.4%) (refer Figure 4). It is considered likely that the grounding caused habitat changes on the shoal including the replacement of areas of 'turf algae on rock' and areas of 'sand' with 'rubble'.

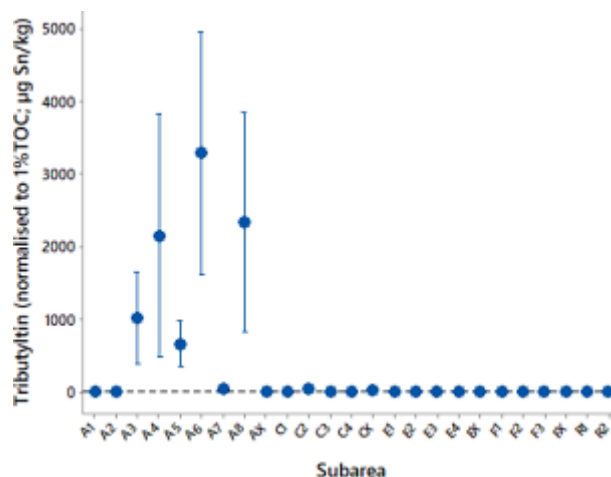
Contamination of sediments exists primarily within part of the previously identified Priority Area A and is principally associated with TBT (Figure 5).

The assessment identified that sediments are not well mixed, with contamination typically associated with remnants of AFP flakes in fine sediment.

Figure 5 Results of contamination survey in 2019. Mean concentrations of tributyltin (\pm standard error) by sub-area (ANZG (2018) [1] default guideline value of 9 $\mu\text{g Sn/kg}$ is displayed as a dashed line).

Due to the limited nature of previous investigations direct comparison of contamination analysis was not able to be made; however, it is likely that the extent and level of contamination has reduced at the grounding site over time, with contributing factors to reduction including exposure to erosive forces (e.g. ocean currents and waves) through normal conditions and extreme weather events. Notwithstanding this, investigation of TBT persistence show it is likely to be a considerable time before TBT ceases to be a contaminant of concern in Priority Area A.

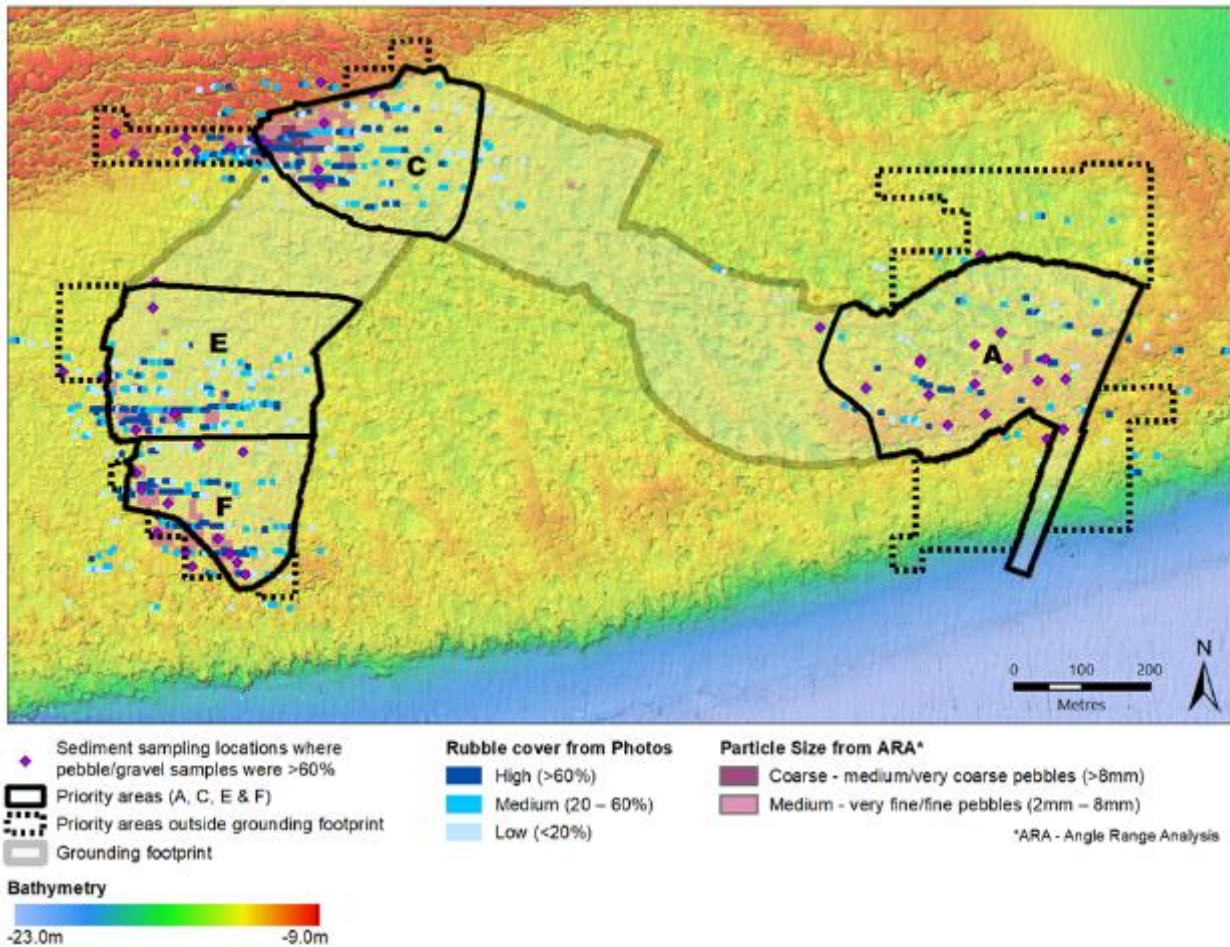
In identification of areas of rubble, good correspondence existed between the independently acquired data sets i.e. data derived from sonar survey, sediment particle size distribution data and habitat characterisation data (Figure 6).

The analysis also shows that unconsolidated rubble has moved over time, generally in a westerly direction, and affected habitat on the shoal beyond the grounding footprint. Further analysis indicates some locations where the rubble has filled (partially or completely) natural depressions which has altered habitat complexity on the shoal.

Figure 6 Rubble distribution across the priority areas.

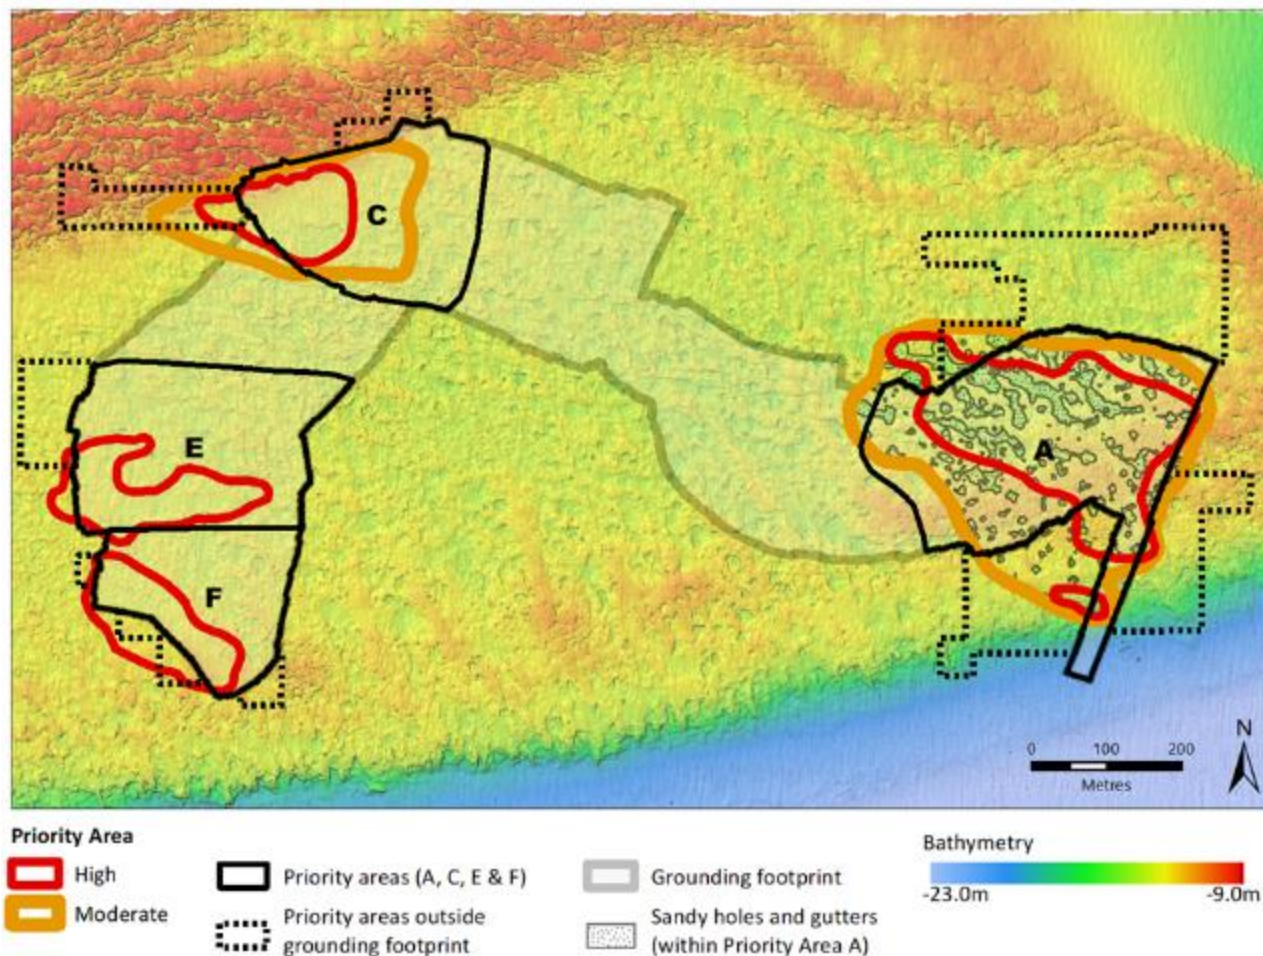
The site assessment investigations show that almost ten years after the grounding incident contamination and physical damage remain as potential impediments to natural recovery, albeit their significance within the survey area may have diminished over time. The investigations supported delineation of priority areas for remediation as follows (Figure 7):

Other areas within the grounding footprint, including the remainder of areas A, C, E and F (Figure 7) were not considered to represent a priority for remediation as there is insufficient evidence to show that natural recovery of the shoal is significantly impeded by any ongoing influence of the grounding in these areas.

Figure 7 Delineation of high and moderate priority areas.

- Remediation priority for contamination in part of Priority Area A:
 - Moderate priority assigned where analysis shows concentrations of contaminants in sediment above default guideline values for ecosystem protection
 - High priority assigned where, in addition to the above, disturbance of the sediment is likely to release water with concentrations of contaminants above default guideline values for the protection of a high ecological or conservation value system.
- Remediation priority for persistence of rubble in part of priority areas C, E and F:
 - High priority assigned where analysis shows most substrate is rubble

- Moderate priority assigned where analysis shows rubble is a significant part of the substrate.
