Great Barrier Reef  
Marine Park Authority

# Grounding of the *Shen Neng 1* on Douglas Shoal, April 2010: Impact assessment report

June 2011

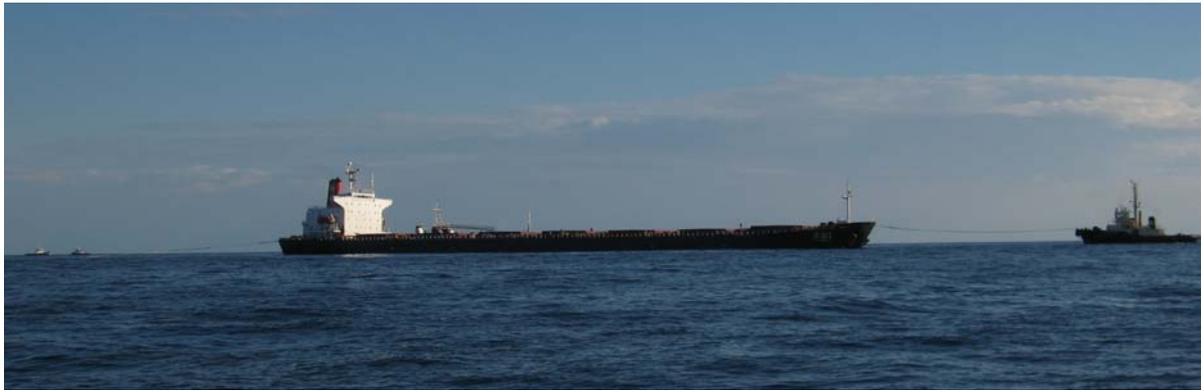
Fig. 1: Photograph of the *Shen Neng I* aground on Douglas Shoal in the southern Great Barrier Reef.

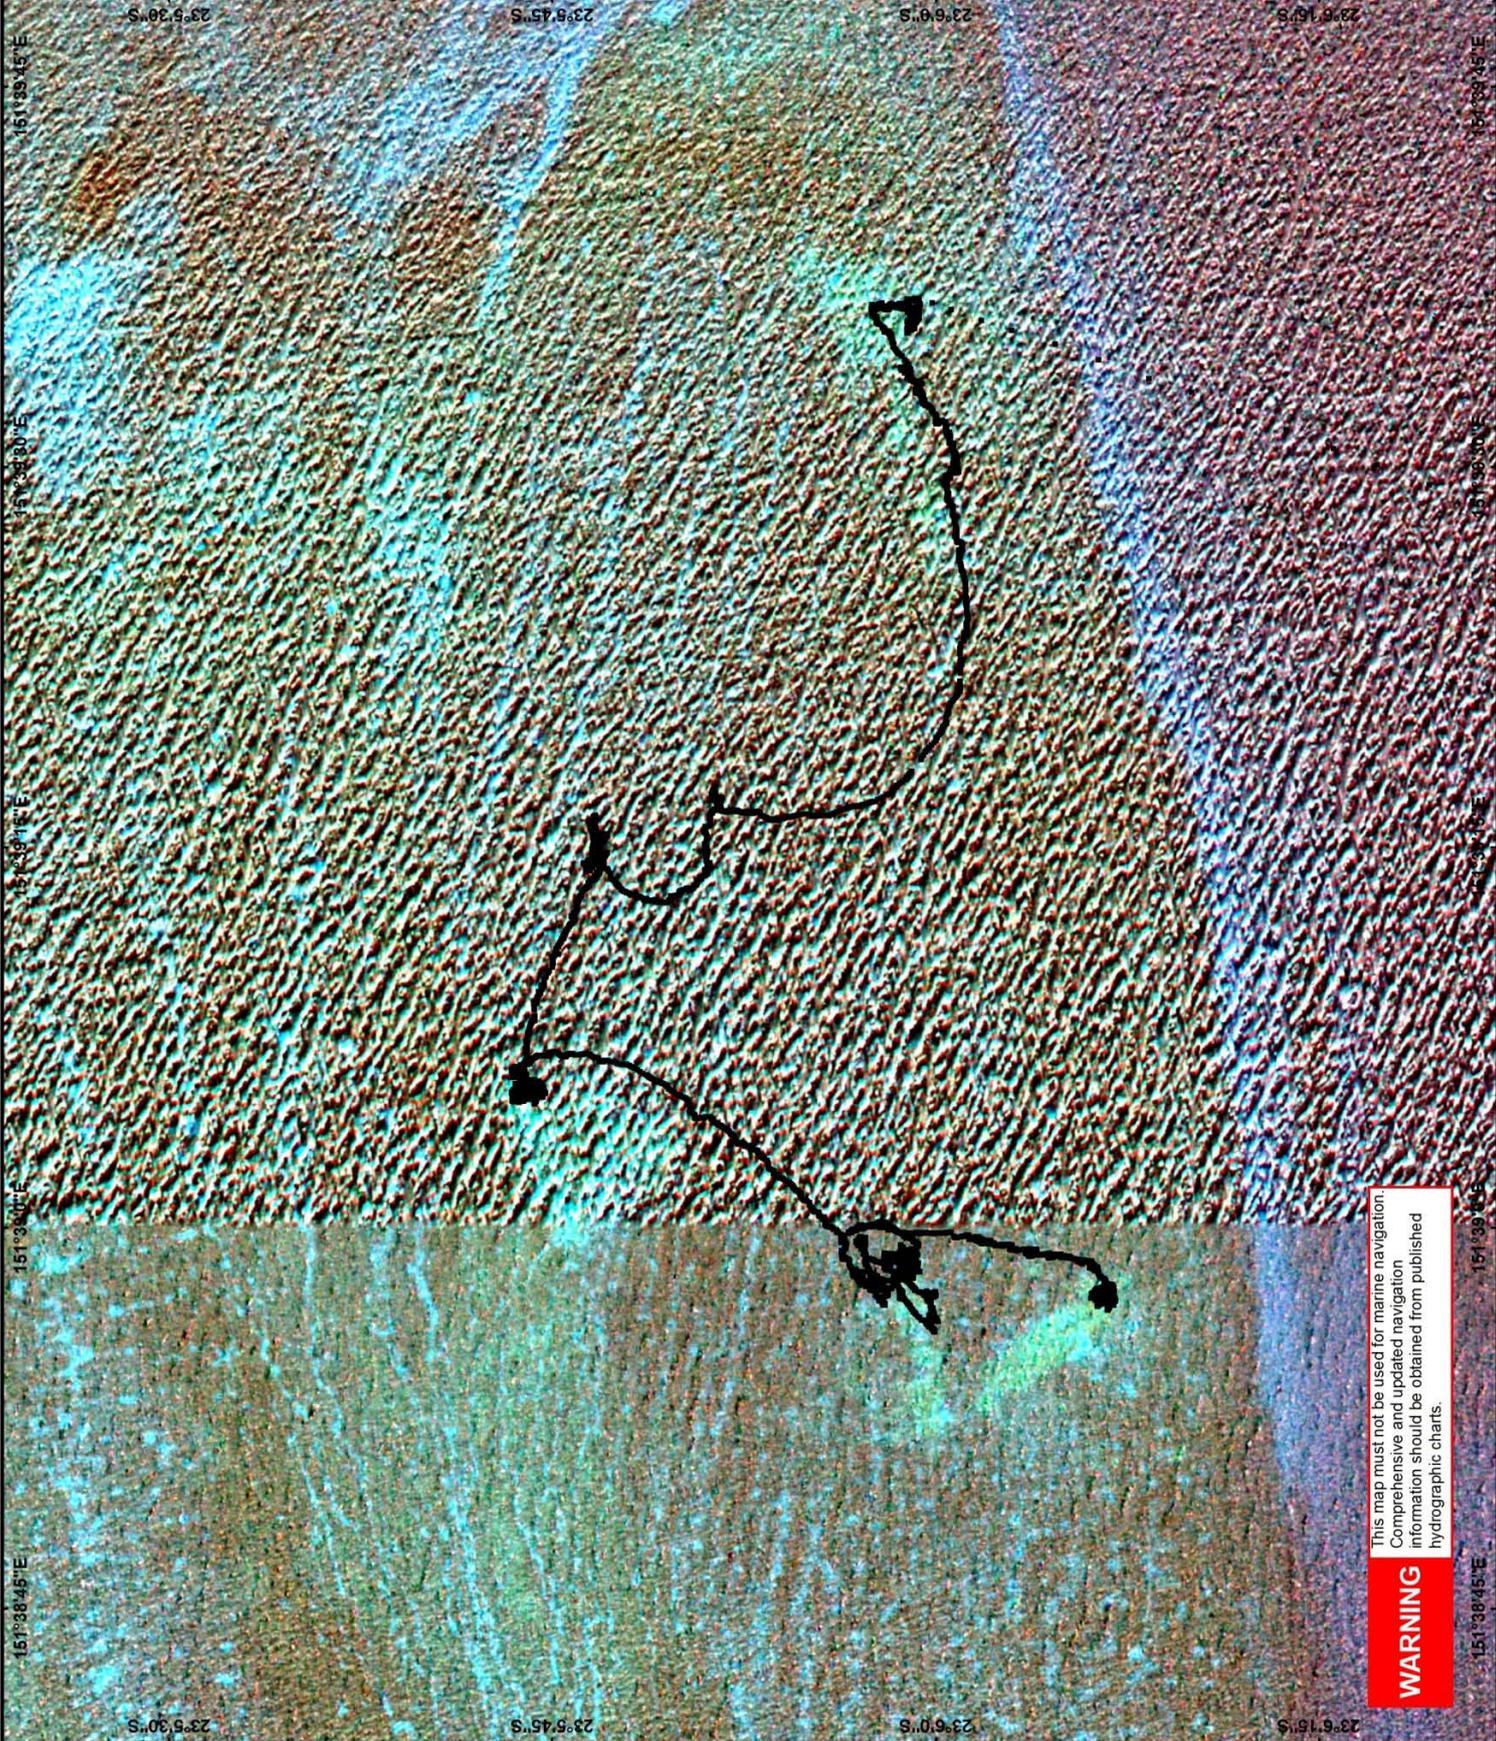
Examination of the WorldView 2 image of Douglas Shoal taken on 19 May 2010 (Fig. 5<sup>5</sup>), clearly indicates patterns of light coloured seafloor. (Light colour on a tropical shoal or coral reef indicates exposed calcium carbonate (limestone), either as sand or exposed reef substrate, often as a result of damage to the darker, pigmented reef organisms such as corals and algae. Calcium carbonate is white in colour). Comparisons of this image with Fig. 3 and Fig. 4 in particular show that there is a strong overlap between these light areas and the areas where the vessel remained stationary during the grounding.

<sup>5</sup> Fig. 5 (over): WorldView2 satellite image showing patterns of light colour in the shoal seafloor. Comparison with Figs. 3 and 4 indicates that these areas are consistent with damage caused by the ship grounding, especially during periods where the ship was stationary. Markings indicate the path of the stern of the vessel.

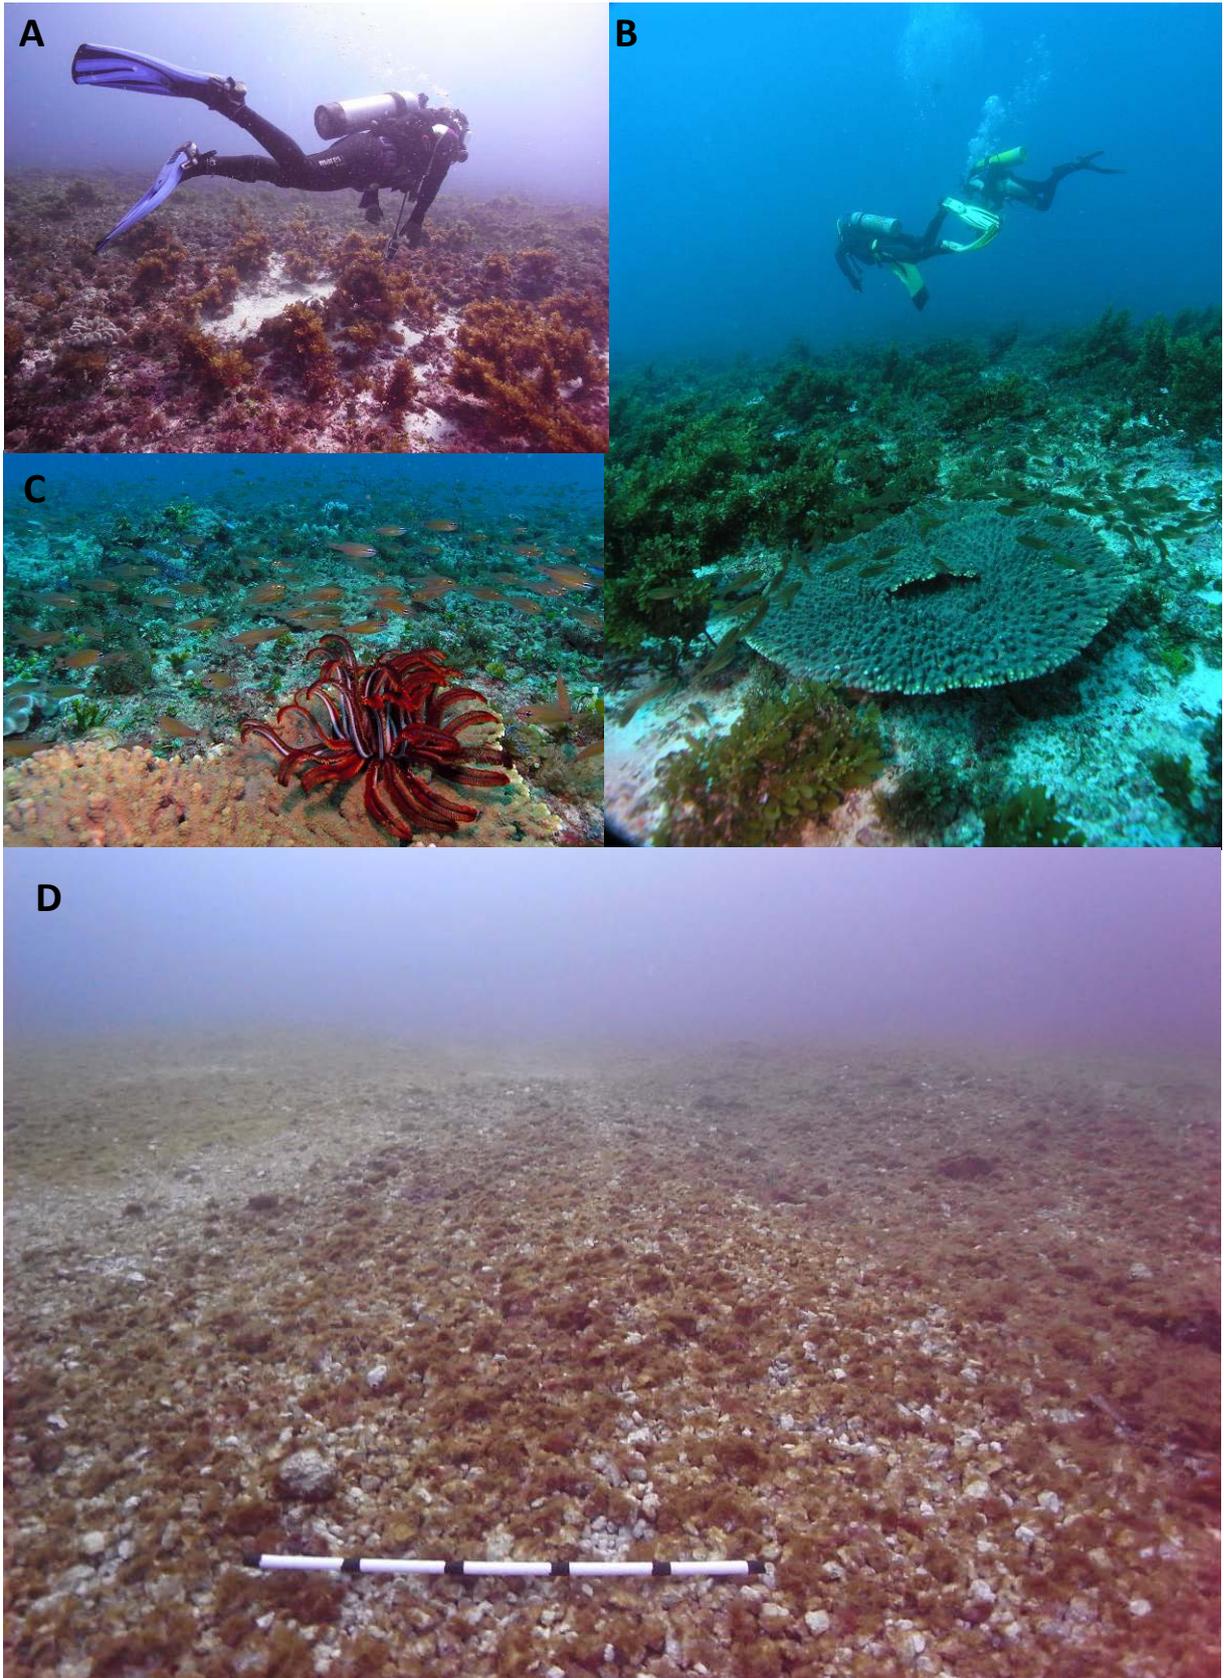
Fig. 11. A-C. Photographs showing undisturbed shoal habitats in areas remote from the vessel grounding. The shoal habitats included abundant seaweeds, such as *Sargassum* (A, B), corals (B) and diverse invertebrates such as the crinoid (feather star) in C. Shoal topography includes many features up to 30 cm high. D. Contrasting view of shoal in area affected by the vessel grounding. Substrate has been reduced to broken rubble with a developing growth of ephemeral (short-lived, slimy) algae typical of disturbed sites. Virtually all of the organisms previously present have been removed or broken, and the 3-dimensional topography reduced to a few cms. Scale bar intervals are 10 cm.

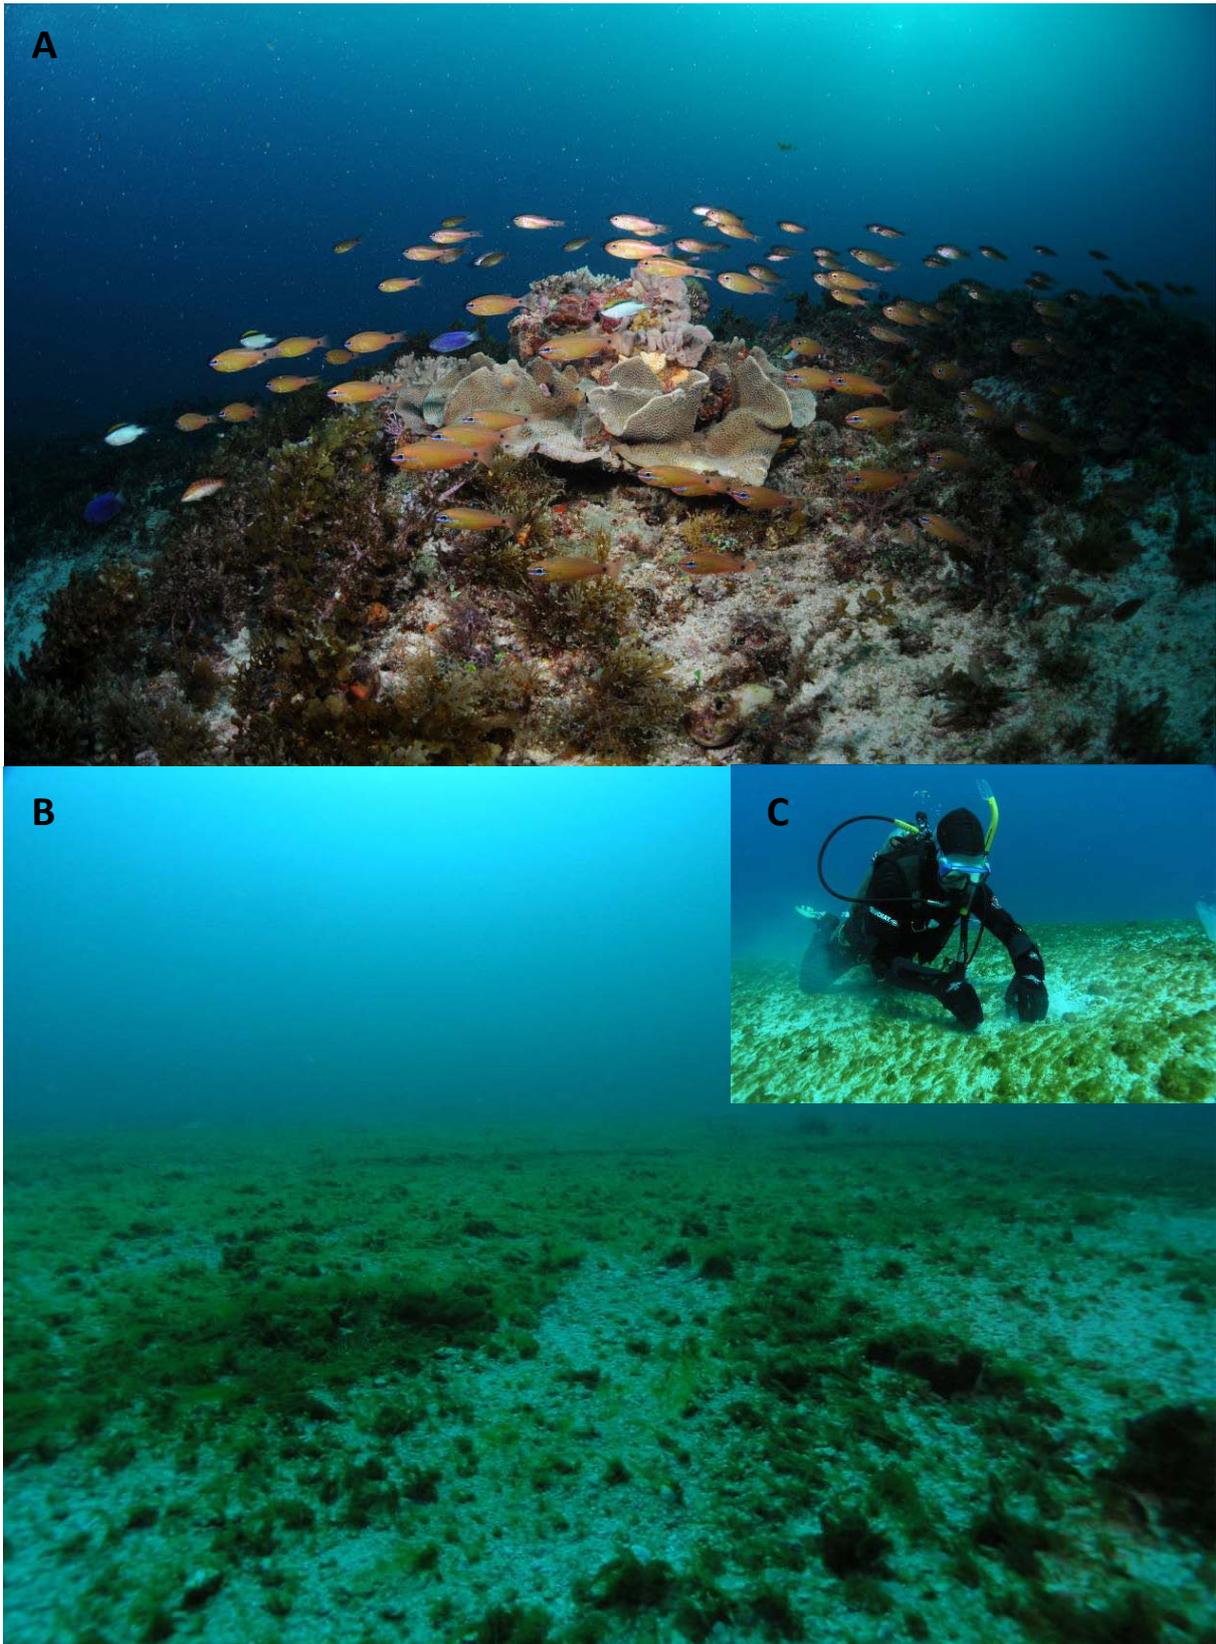
Fig. 12. A. Photographs showing diversity of seaweeds, corals and other invertebrates, and fishes in an undisturbed shoal habitat (remote from the vessel grounding). Note also the 3-dimensional topography. B. Shoal seafloor in the area of the vessel grounding, showing flattened topography, rubble and sand substratum, and thick growth of ephemeral (short-lived) algae typical of disturbed sites. C. Inset shows diver collecting sediment sample amidst ephemeral algal.

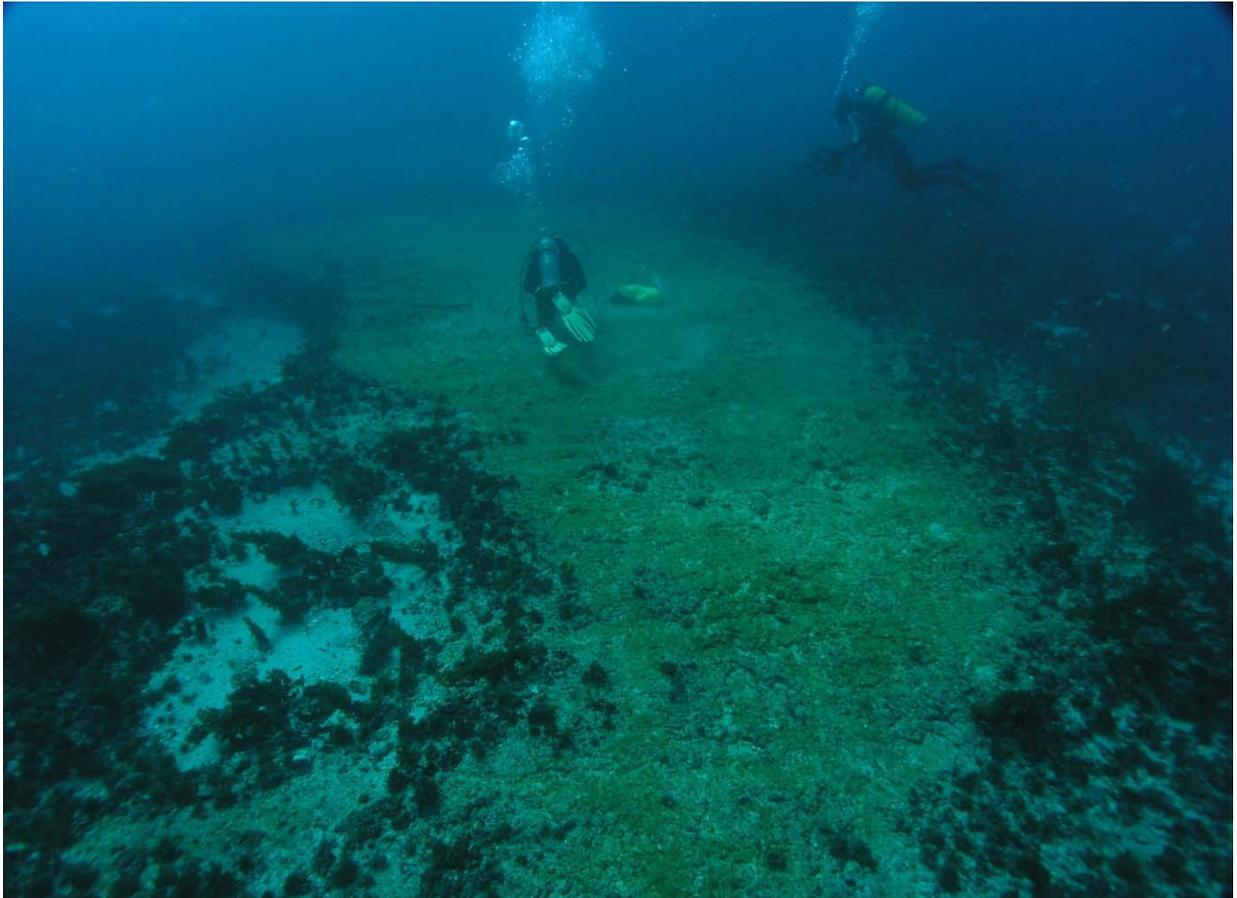
Fig. 13. Divers sampling sediments within a swathe of disturbed benthos on the shoal. Note the contrast between the larger, long-lived (perennial) seaweeds (predominantly *Sargassum*) and the new growth of ephemeral algae growing on the disturbed substratum. (A sea snake is just visible to the left of the lower diver).<sup>14</sup>

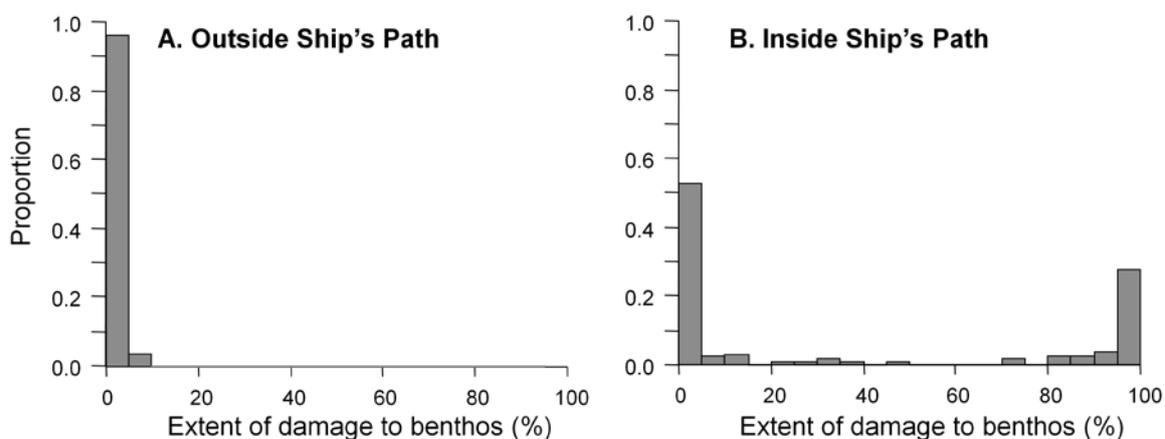
However, it is important to note that not all areas within the ship's path were damaged: some areas had little damage observed (Fig. 16B). It is concluded that the vessel was floating higher than the benthos at that location and time of the tidal cycle and so did not damage the shoal benthos.

Fig. 16: Comparisons of estimated damage to the shoal benthos (A) outside the area of the ship's path and (B) inside that area\*. Frequency histograms of estimated damage to reef benthos: Graphs show the proportion of sites (vertical axis) with different degrees of damage (horizontal axis). The data show that (A) outside the ships path, almost all sites had no damage, whereas (B) inside the ships path many sites were assessed as having 80-100% damage. Note also that relatively few sites had intermediate damage (20-80%), showing that damage tended to be severe where it occurred. (\*Figure B area includes a 30m buffer zone around the plotted path, to allow for the precision of the georeferencing procedures: i.e. sites within 30m of the grounding path were included).

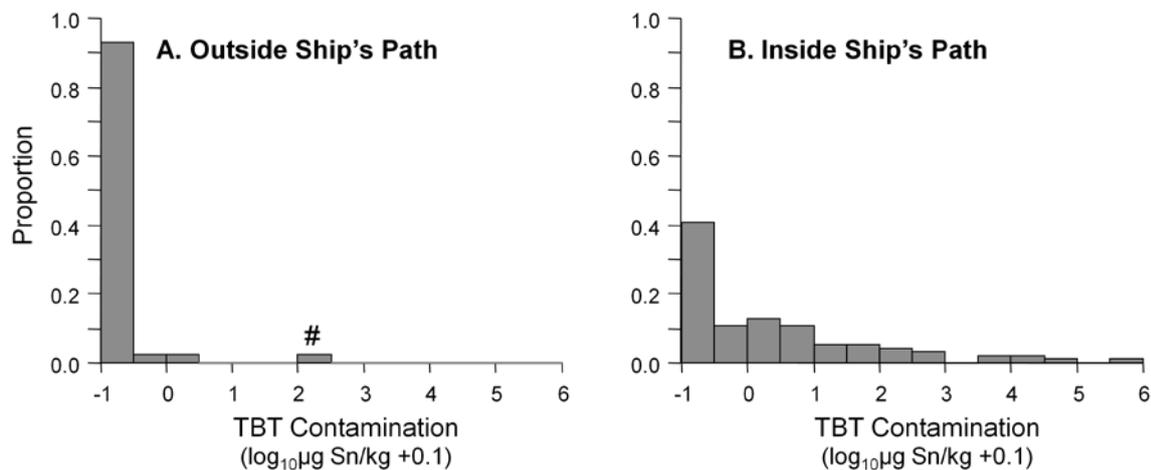
Fig. 21: Comparisons of TBT concentrations in samples collected (A) outside the area of the ship's path and (B) inside that area\*. Frequency histograms of concentrations on a log scale: Graphs show the proportion of samples (vertical axis) with different concentrations of TBT (horizontal axis). The data show that (A) outside the ships path, almost all samples had very low concentrations, whereas (B) inside the ships path many samples had much higher concentrations. The only sample with a high TBT concentration outside the ship's path, indicated with #, was <50m from the path, in the area of the initial grounding. (\*Figure B includes a 30m buffer zone around the plotted path, to allow for the precision of the georeferencing procedures: i.e. sites within 30m of the grounding path were included).

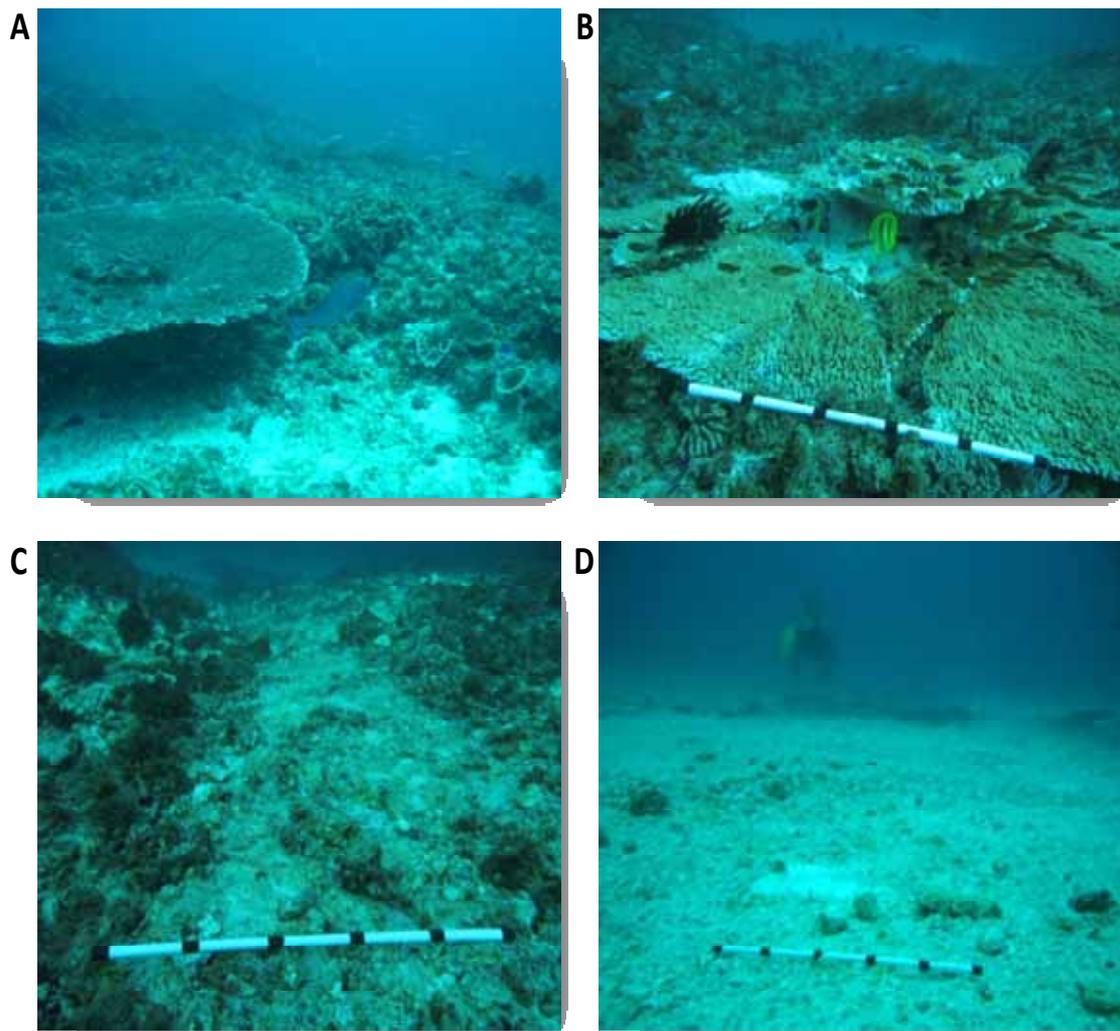
**Figure 3.** Images from Douglas Shoal after *Sheng Neng 1* grounding showing the different categories of damage. (A) Undamaged reef; (B) Minor damage (most benthos intact; some damaged); (C) Moderate damage (most benthos killed; patchy damage to substrate); (D) Severe damage (all benthos displaced, crushed or smothered and substrate scraped or covered in rubble). Scale bar = 50 cm.

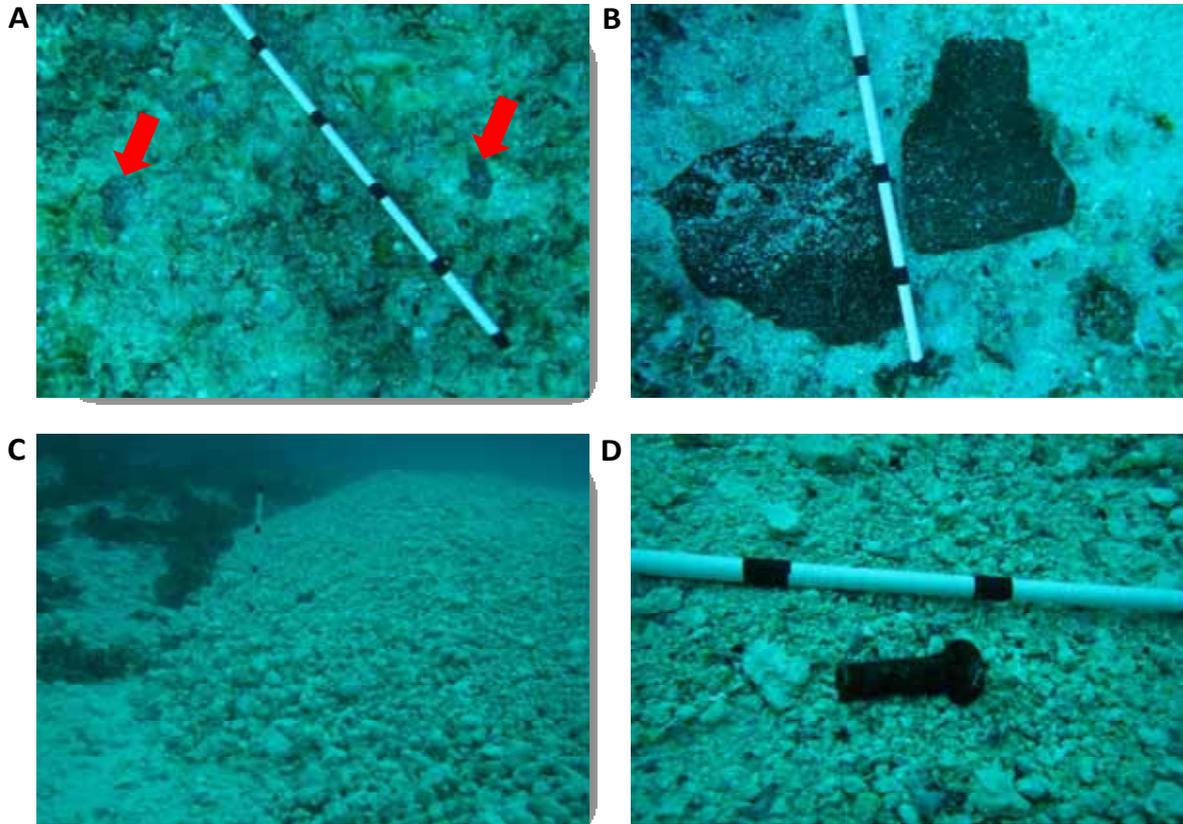
**Figure 4.** Photographs from damaged areas of Douglas Shoal. (A) Antifoulant paint smears (red arrows) on moderately damaged site (Site A); (B) Large metal flakes on moderately damaged reef site (Site B); (C) Recently created rubble bank on edge of severely damaged site (Site D); (D) Metal bolt on severely damaged seabed (Site D). White sections on scale bar = 8 cm.

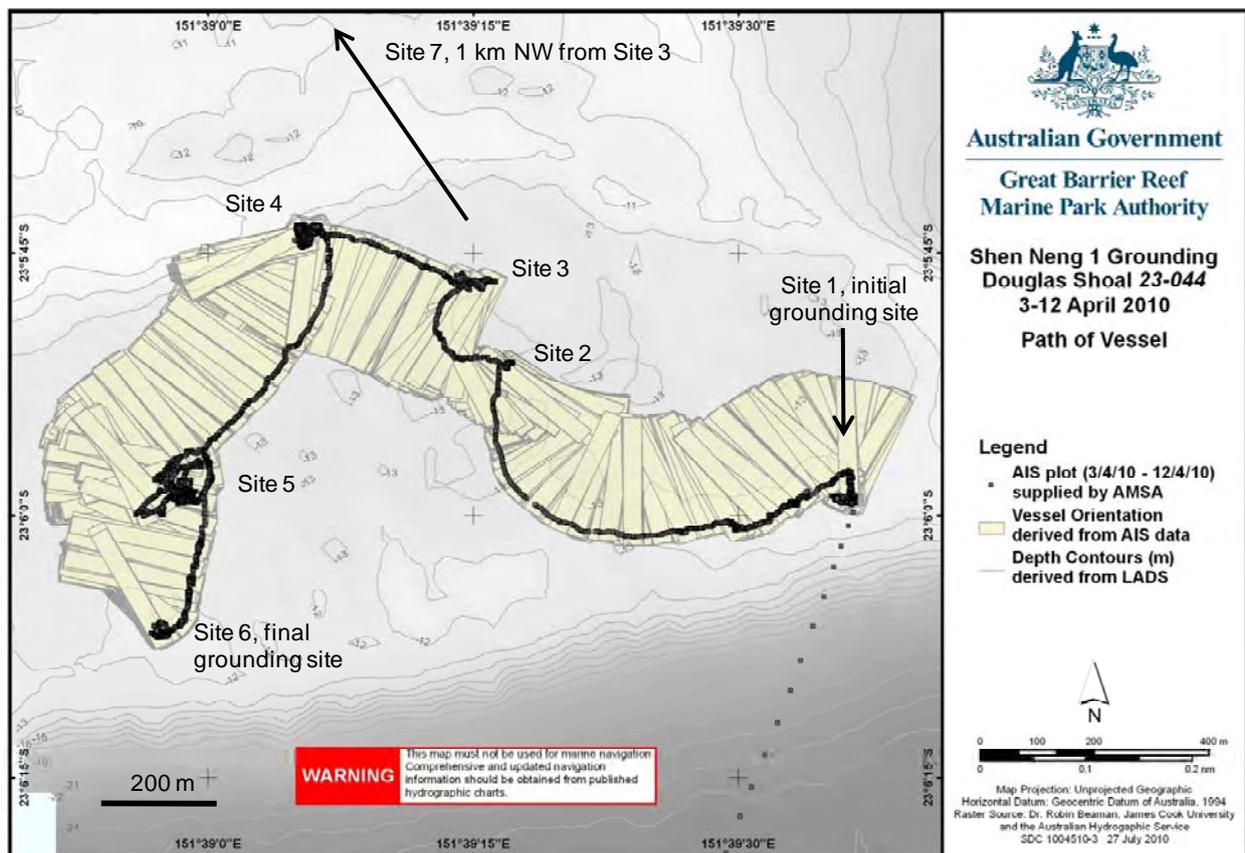
Figure 1. The path of the *Shen Neng 1* over the course of its grounding (sites overlaid on map provided by the Spatial Data Centre, Great Barrier Reef Marine Park Authority 2010).

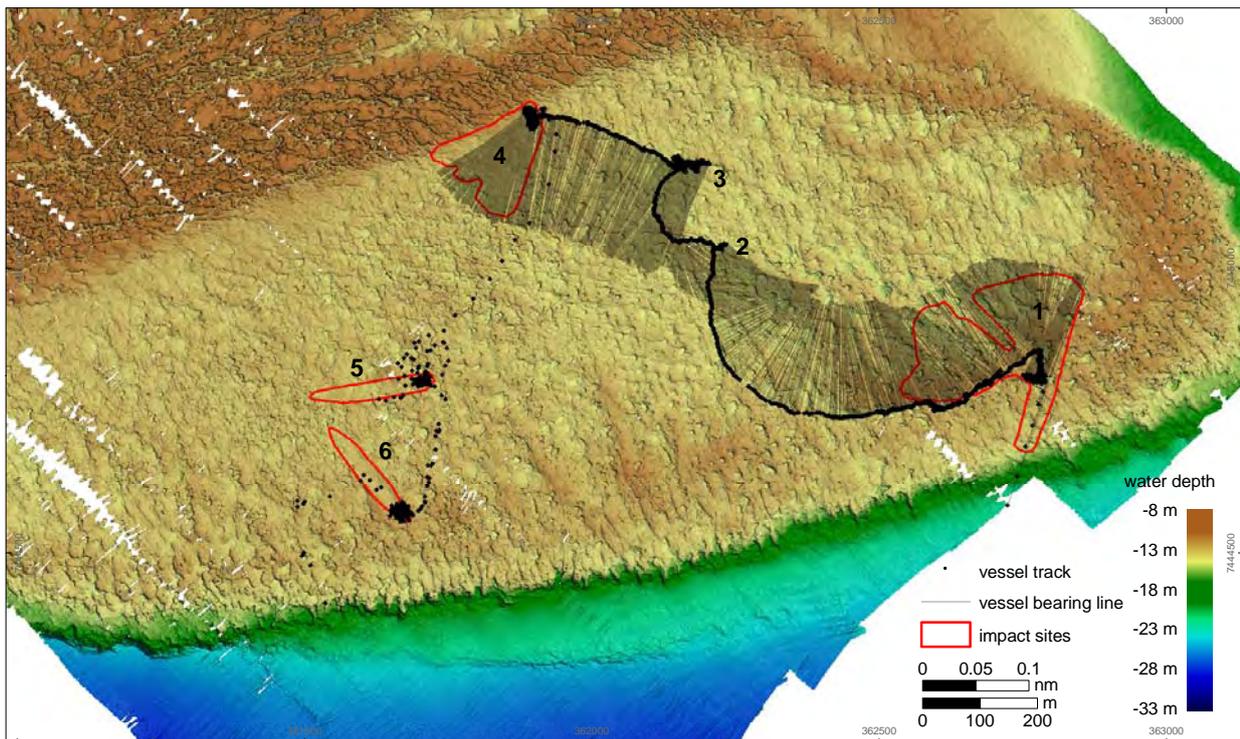
Figure 5. Colour-coded, sunshaded multibeam bathymetry of the impact sites of Douglas Shoal with track of *Shen Neng I* and impact sites as determined from sonar data analysis.

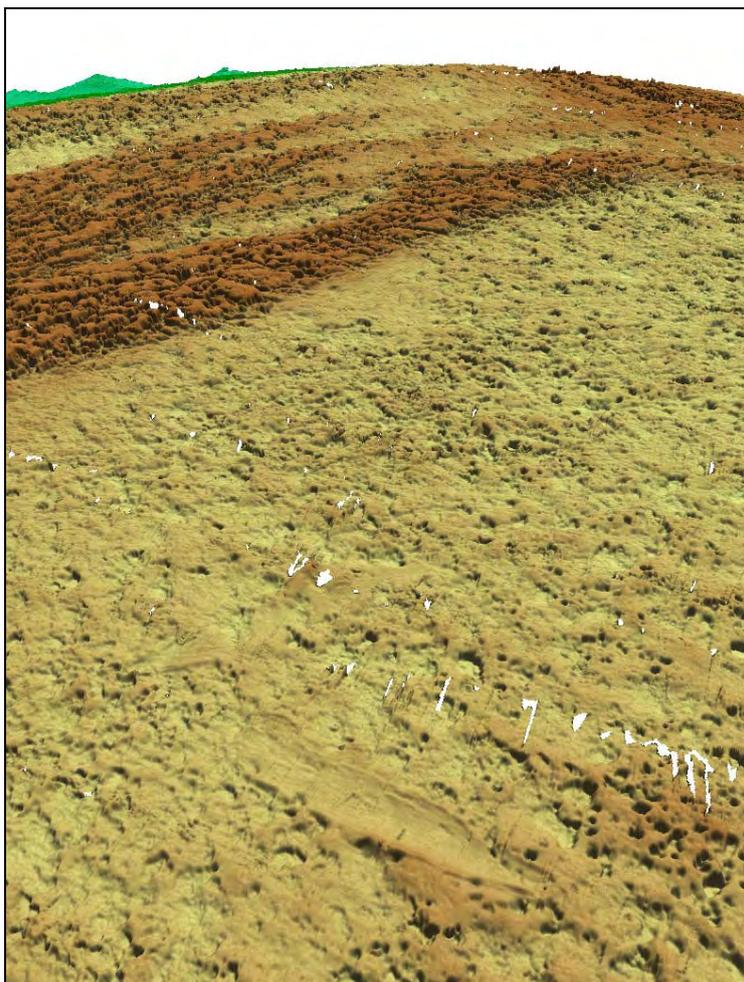
Figure 6. Aerial view of multibeam bathymetry of Site 6 at Douglas Shoal. The imprint of *Shen Neng 1*'s hull on the reef matrix is clearly visible in the foreground.

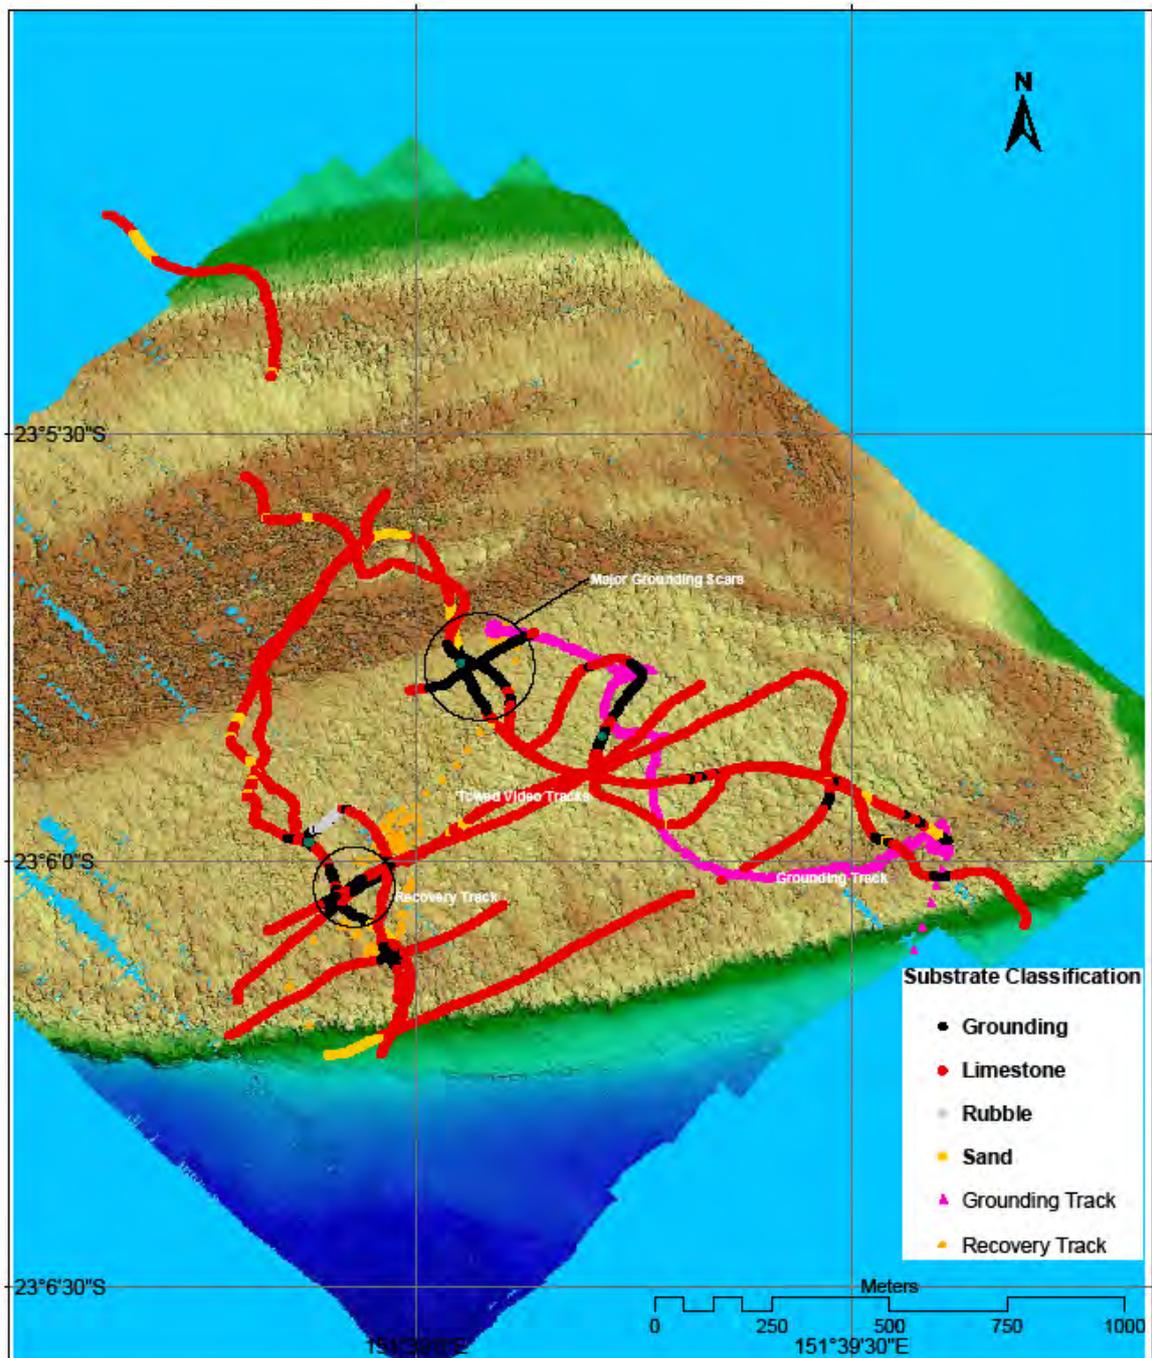
Figure 7. Towed underwater video tracks and the movement of the *Shen Neng I* (pink – grounding, orange – recovery of ship by tug boat) across Douglas Shoal. Black markers denote areas where damage was evident.

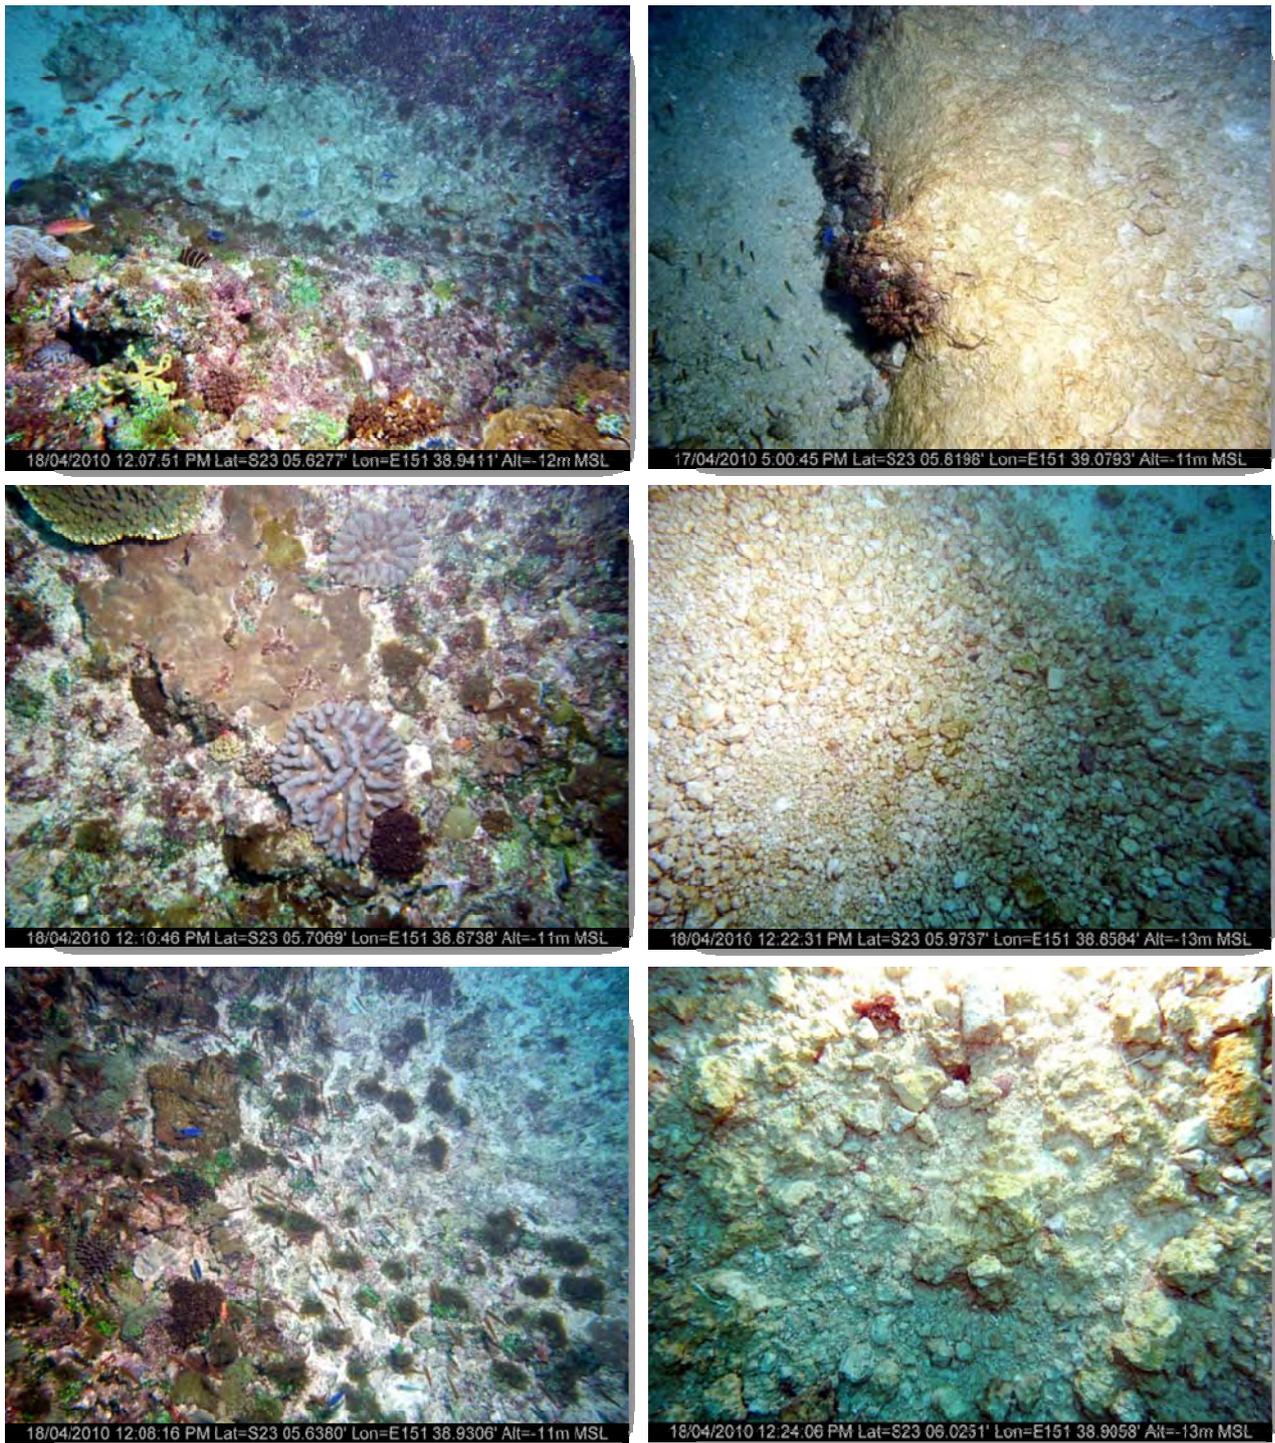
Figure 10. Representative images of the undisturbed benthos on Douglas Shoal (left) and areas affected by the grounding of the *Shen Neng 1* (right). The top right image gives a clear indication of how the reef was ground down leaving only benthos on the sides. Further images representative of each of the specific damaged sites can be found in Fig. 13.

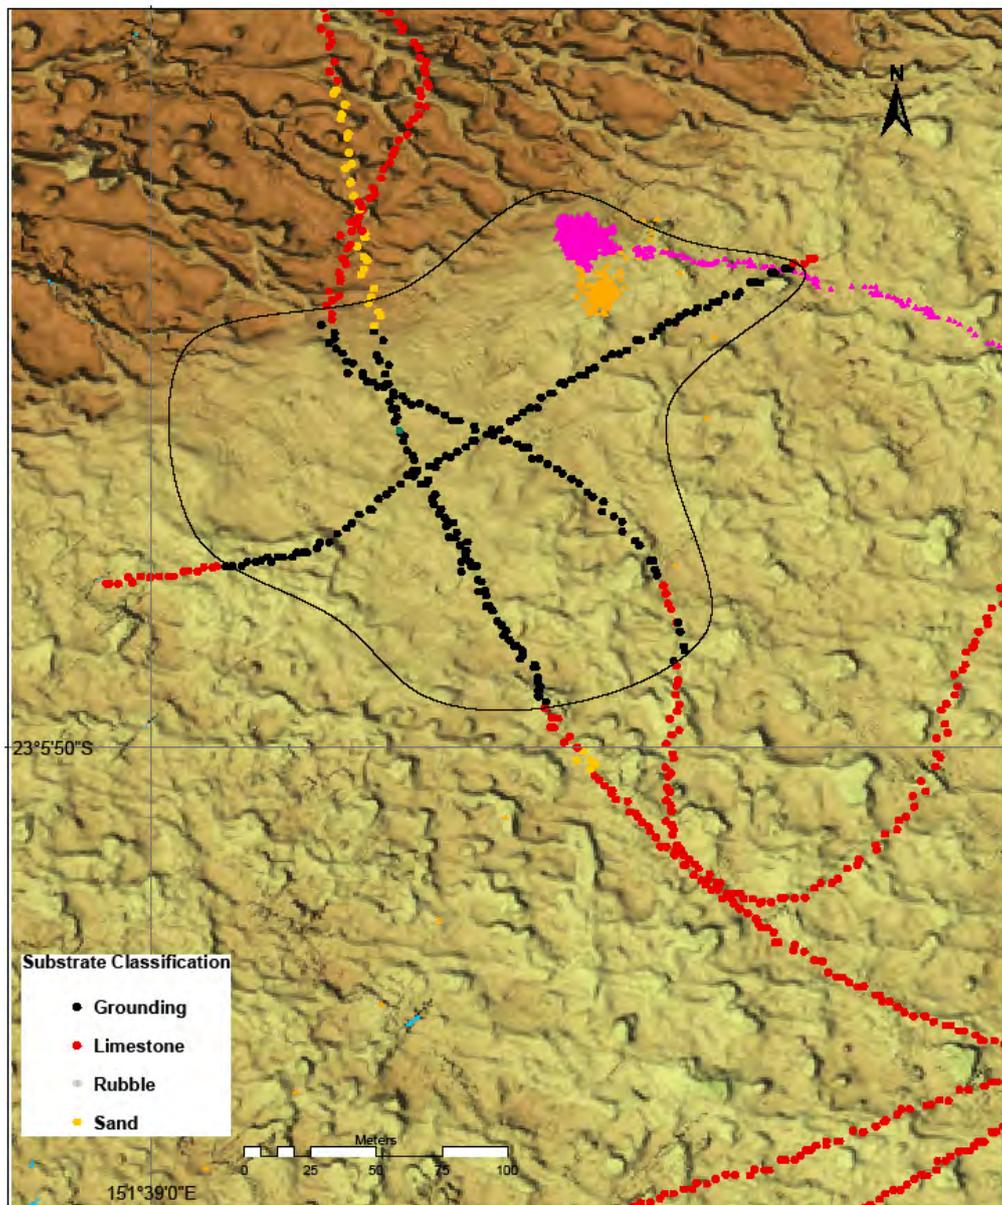
Figure 11. Acoustic image of Douglas Shoal where the *Shen Neng 1* encountered further shoaling which arrested its westerly drift (Site 4). Alterations to the topography are clearly evident as an area of disturbance (encompassed by black line) and visual assessment by towed camera validated and characterized these marks. Pink dots represent the grounding track and the orange dots the recovery track of the *Shen Neng 1* (see Figs. 1 and 7).

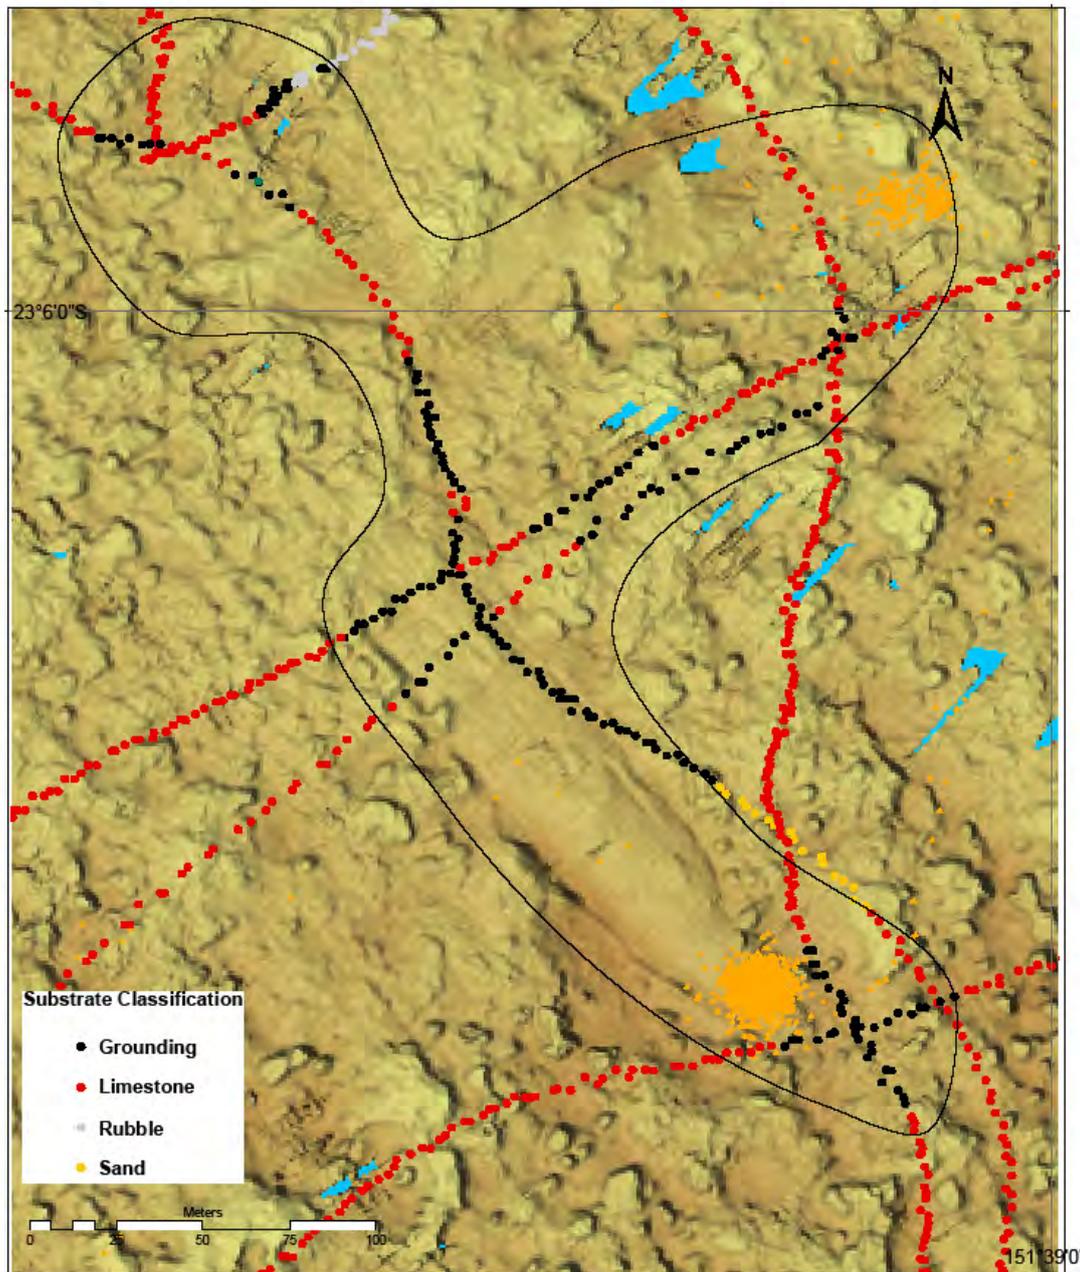
**Figure 12.** Acoustic image of Douglas Shoal where the *Shen Neng 1* rested for 1 week prior to being refloated (Site 6). The impression of the hull is clearly evident and visual assessment by towed camera validated and characterized these marks and adjacent marks to the north and northwest. In this image, the ship lay east – west and then the stern was brought directly south with the ship rotating on its bow section. Orange dots represent the recovery track of the *Shen Neng 1* (see Figs. 1 and 7).
