Great Barrier Reef  
Marine Park Authority

# Grounding of the *Shen Neng 1* on Douglas Shoal, April 2010: Impact assessment report

June 2011

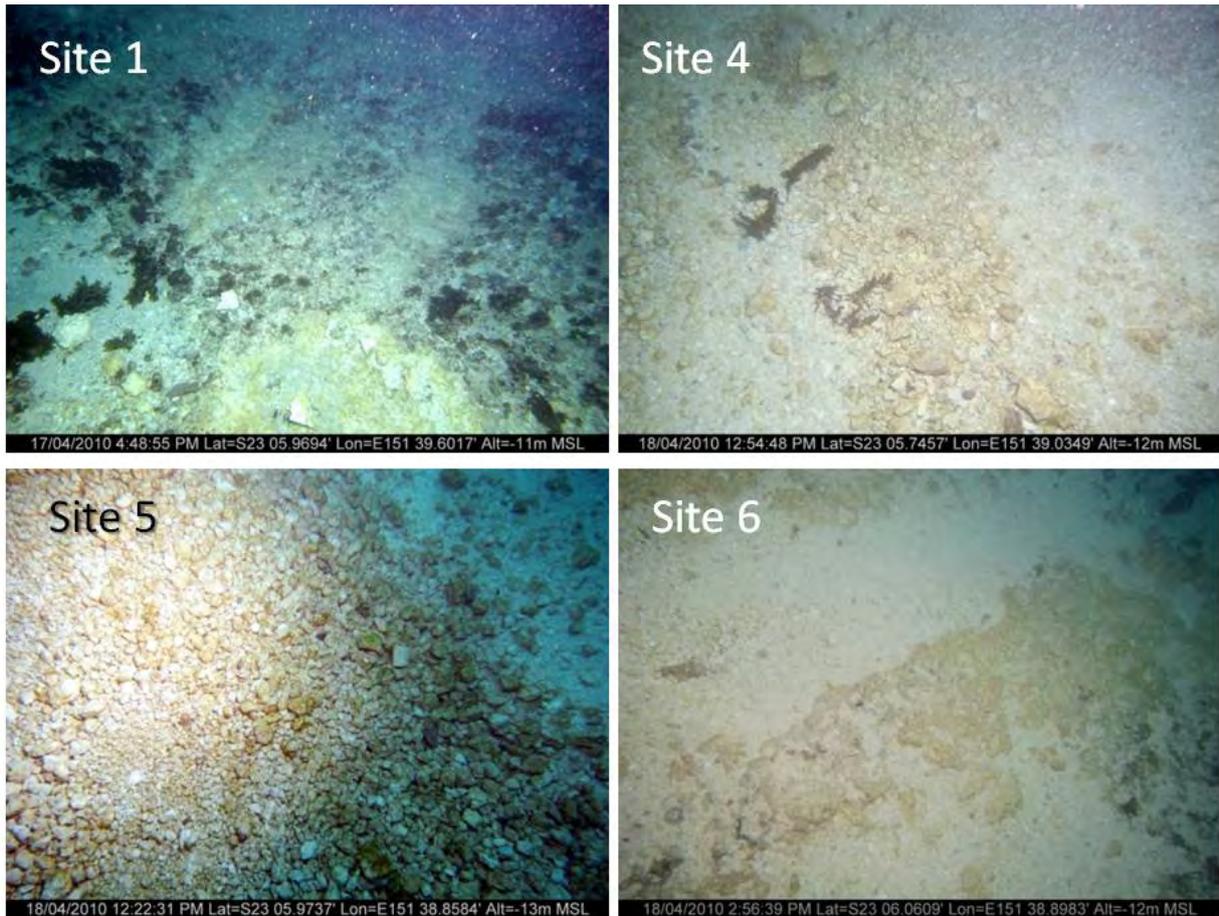
Figure 13. Photographs representative of damage Sites 1, 4, 5 and 6.

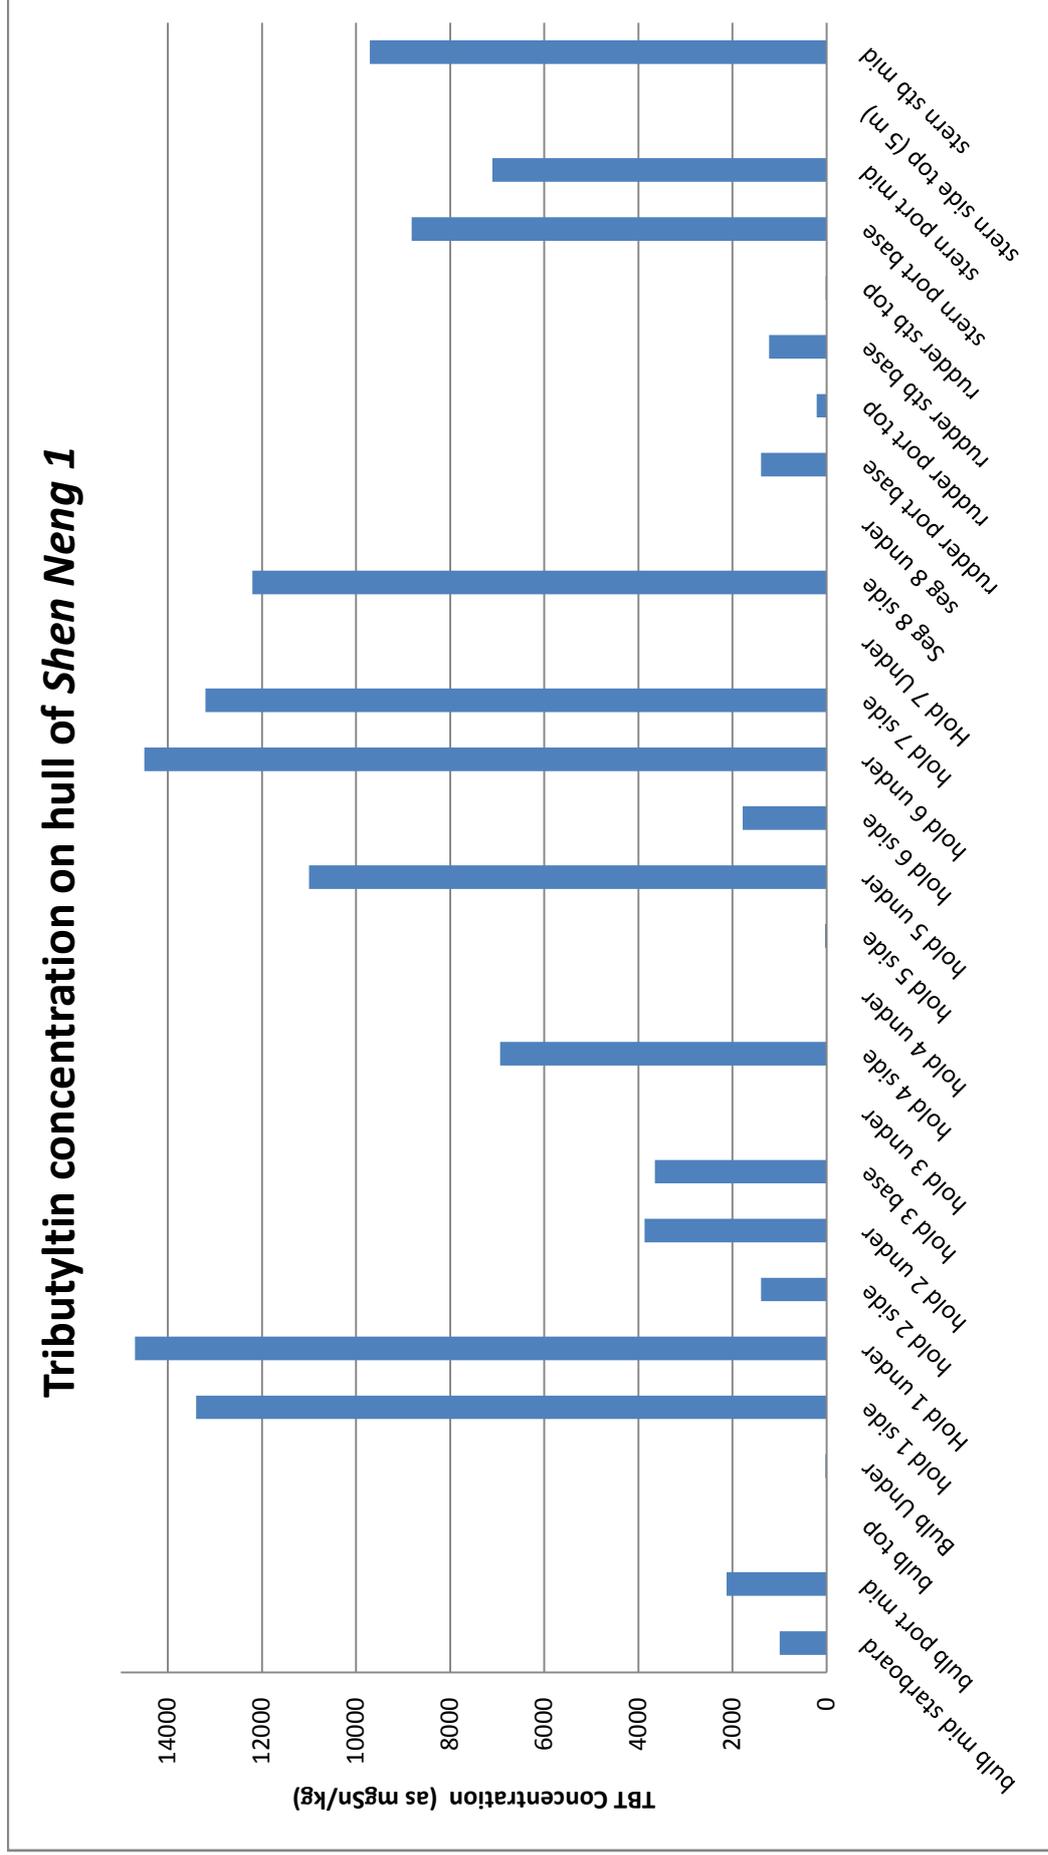
Graph 1: Tributyltin concentrations on hull of Shen Neng 1. Note TBT was detected in all samples (refer Annexure A), resolution of display in this graph limits visibility of results in some locations.

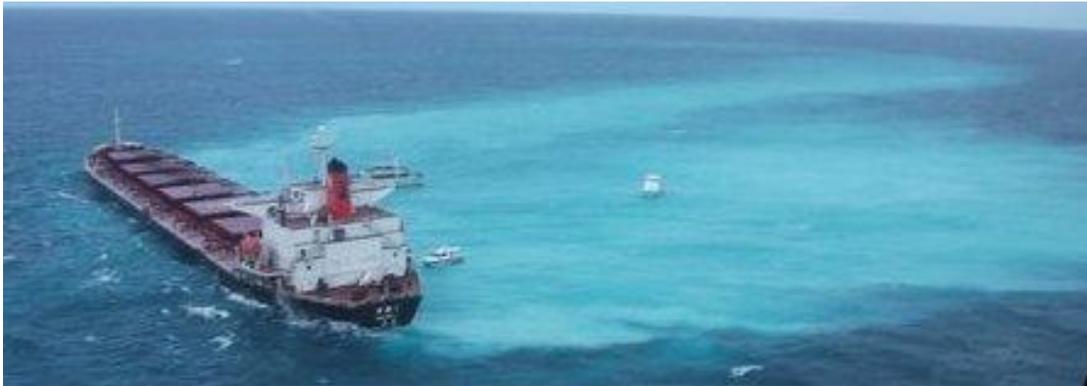
Figure 8. Turbid plume associated with grounded Shen Neng 1 on 4 April 2010.
