RESEARCH PUBLICATION No. 113

Historic Shipwreck Foam (1893)

Survey Report 2015

Peter Illidge

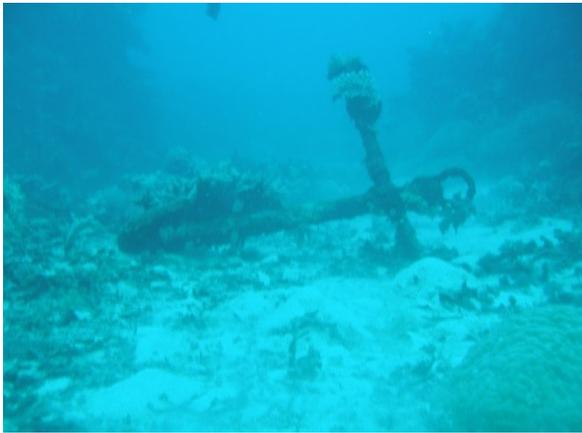
Comparison of the present position and condition of the anchor with archival data presents evidence that may be consistent with two attempts to steal this artefact. The author first dived the *Foam* anchor in 1982 when it was on top of the large coral bommie near its present position. It is now lying off this bommie. Also, on comparison of the archival photograph of the anchor taken 2009 (Figure 2) to recent pictures in its present situation (Figure 3) it looks to have been moved for a second time. It is unlikely that these movements would have been caused by cyclonic wave action because, on closer inspection of the anchor, it was noted that a piece of rope about 12 millimetres in diameter was attached to the shackle, further supporting the theory that it has been deliberately interfered with. The anchor's size and design may make it attractive to theft and this risk should be taken into account in the future management of the site.

Figure 1: Picture of *Foam* anchor. © Commonwealth of Australia (Australian Institute of Marine Science), photographer: Joe Gioffre, 2009.

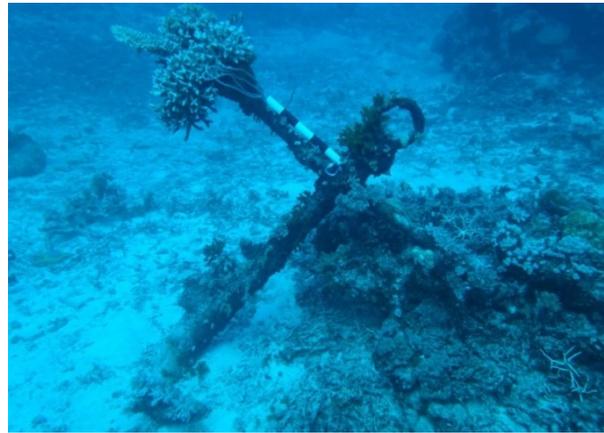
Figure 2: *Foam* anchor in 2015. Note the change in position from the 2009 picture.

The anchor is over 340 metres from the main wreck site and, though considered an artefact associated with *Foam*, it is outside the 200 metre Historic Shipwrecks protected zone and therefore does not carry the restriction to access as does the main site. This positioning and the potential attractiveness of the anchor to thieves suggest that moving the anchor to within the 200 metre protective zone or extending the protective zone could be considered. The anchor has already been moved at least twice. Moving it closer to the main site and within the protected zone will not subtract from its provenance but may save it from theft.

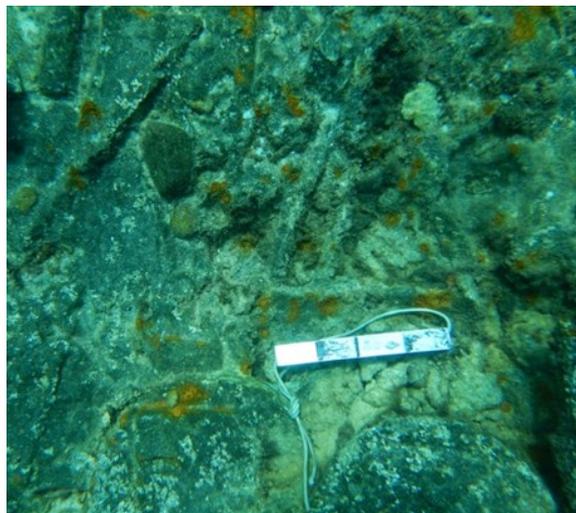
The ballast pile is a concretion of the ballast material, stone and iron and the cargo which includes iron objects. Consequently, it is a conglomerate of iron, terracotta bricks and rounded rock (Figure 5) in the form of the timber hull which has since degraded and disappeared. Its area is approximately 11 metres by four metres and extends from underneath a significant area of coral near the reef top, towards the north through a valley of the same coral to an open area where the coral is sparse. There does not seem to be any significant damage to the ballast from cyclone Yasi. There are, however, significant areas of rust spots across the whole of the ballast pile (Figure 5) which seem to be fresh, perhaps caused by grazing herbivores (which are common in the area) removing the protective algae and exposing ferrous objects to the elements.

Several herbivores were noted feeding on the black algae growing on some iron artefacts around the site. Similar black algae are common on iron wrecks and associated reefs in the Line Islands in the Central Pacific Ocean, there it has smothered the living coral and devastated coral communities for over one kilometre from the wreck (personal observation P. Illidge). The low algae cover on the *Foam* is possibly due to high numbers of herbivores grazing it within the vicinity of the wreck, though this is not supported by Kelly *et al* (2012).

Figure 4: Ballast pile, showing concreted iron artefacts, stone and rust spots. (Scale is 20 centimetres in 5 centimetres sections).

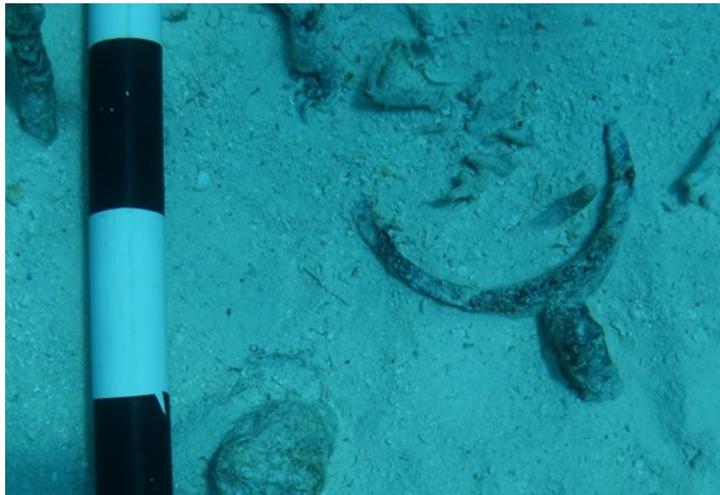
Figure 5: Possible bow sprit or sprit end brace. The white section of the scale shown is a 10 centimetre section of a 50 centimetre scale.

The transit on the starboard side of the wreck (eastern sector) found significant anomalies up to eight metres from the baseline. In this area, what looks to be the iron brace possibly from the bow sprit or sprit end and a larger iron concretion were located.

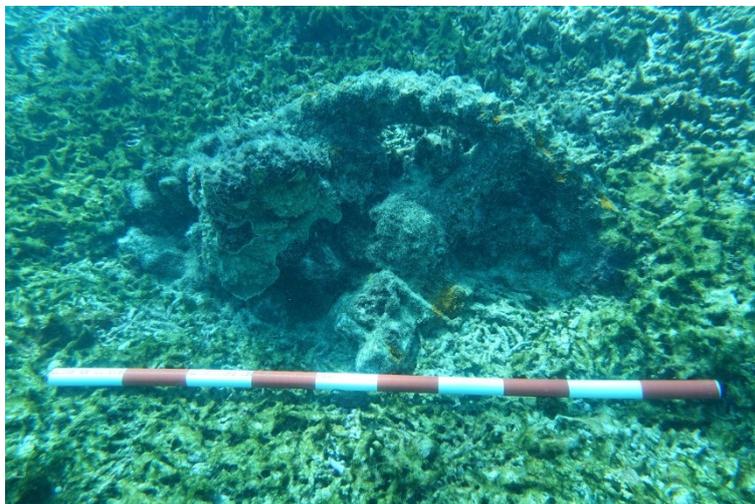
On a previous visit to the site in 2003 the anchor winch was noted to be over 60% exposed. The situation of the winch on this survey is 80% buried, see Figure 7 and Figure 8. It is mostly buried in coral rubble, possibly due to cyclone Yasi in 2011. Unfortunately, no inspection of this site immediately post-Yasi was undertaken so the benefits or not of the cyclone can only be based on decade old data. A possible benefit of a cyclone to a shipwreck is the deposition of rubble onto the wreck which creates a protective layer, negative impacts include removal of material from the site.

Figure 6: Anchor winch covered in coral rubble. One metre scale in 10 centimetre sections.

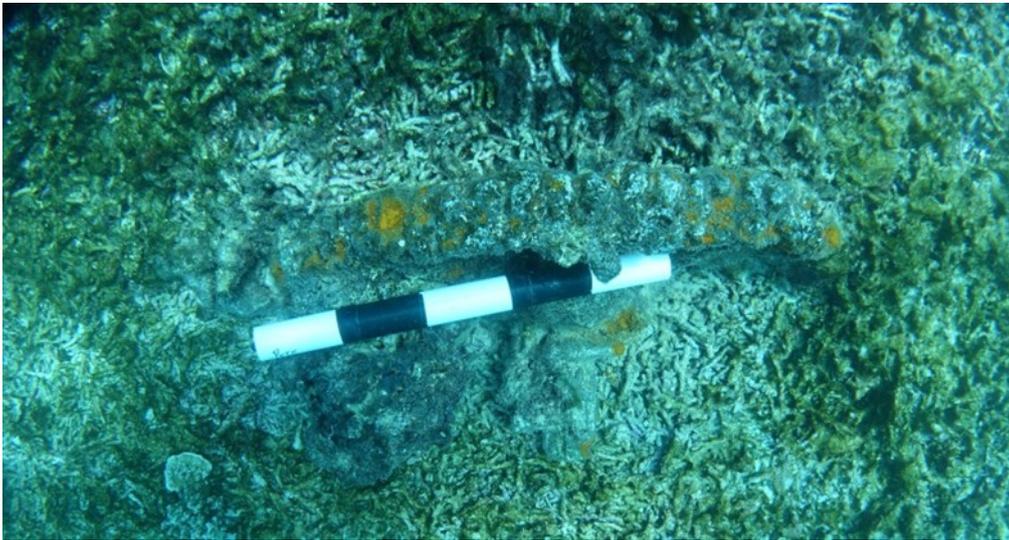
Figure 7: Anchor winch photographed in plan. Note black algae below the 50 centimetre scale.

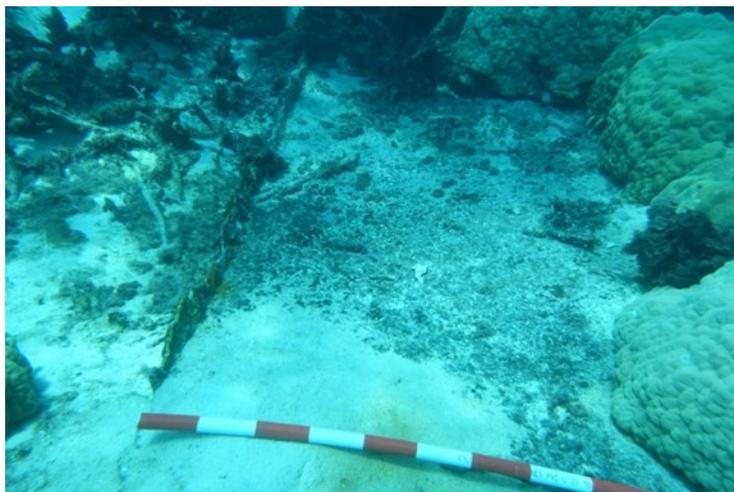
This artefact (Figure 9) was identified as a broken ship tank by a survey team from the Queensland Museum in 1982. The *Foam* artefact is 370 centimetres long by 122 centimetres wide. At first glance, these measurements do not correspond to the standard ship tank dimensions, being a triangle and not a cube as Pearson states. Three standard cubic ship tanks measuring 4 feet (122 - 123 centimetres), 3 feet (92 - 97 centimetres) and 2 feet 6 inches (72 - 77 centimetres) square, are noted by Pearson. The width of the *Foam* artefact does correspond to the width of a standard four foot ship tank. The length, if divided by three, measures 123 centimetres, suggesting that the length measurement noted in this survey is, in fact, three sides of a flattened out tank. As the tank decayed through time, the sides, lacking support, folded out flat. This could not be confirmed on this survey as there are significant *Porites* coral colonies blocking the view (Figure 9).

Figure 8: Possible ship tank partially covered with sand and disappearing under coral. One metre scale in 10 centimetre sections.

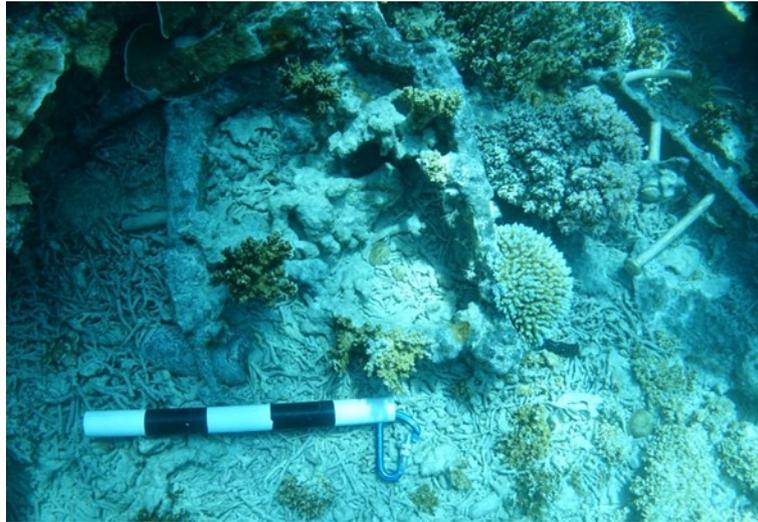
Fastenings on site are either bronze, Muntz metal or iron. One particularly open site to the eastern side of the wreck shows a variety of artefacts representing rigging of the ship (Figure 10).

Figure 9: Various artefacts, including a par buried bottle (above the scale), and a possible chain plate with brass fastenings (to the right of the picture). The U-shaped artefact above the bottle could be part of the rudder assembly, a gudgeon or pintle. Scale is 50 centimetres in ten centimetre sections.

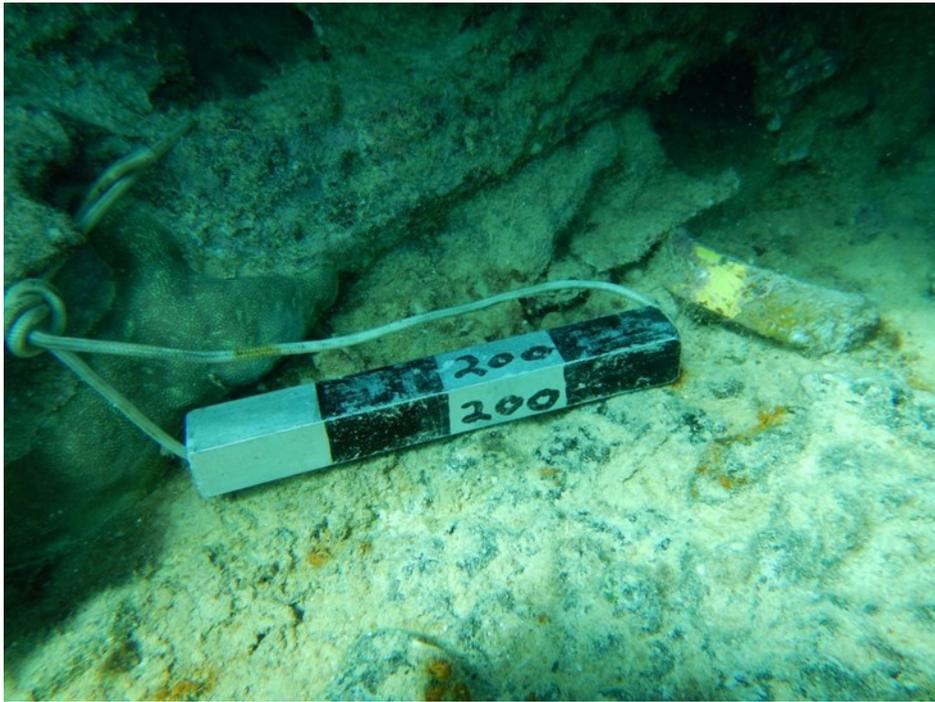
The survey team spent the equivalent of 16.5 person hours between sites. In this period only one arm band was located towards the southern end of the ballast pile under a coral ledge and concreted into the ballast pile. If the marine growth on the found arm band is indicative of the condition of the others they will be difficult to see amongst the coral rubble. Figure 12 shows the arm band after some light cleaning to reveal the yellow colouring. The arm bands were all numbered so it would have been advantageous to know which arm band it was so its voyage around the site may be mapped. As it was concreted into the substrate, identification would have required the breaking away of the item and possible damage to it and the artefacts it is

attached to. FMAP arm bands 15 and 19, as positioned on the map, are the closest and most likely to be the arm band located on this survey.

Figure 11: Foam Maritime Archaeology Project arm band with 20 centimetre (200 millimetre) scale in 5 centimetre sections.

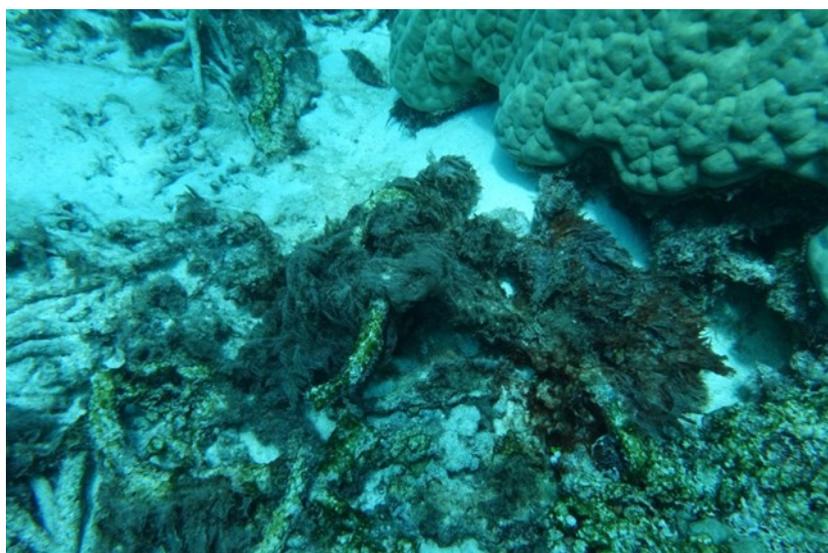
Though not qualifying as a historic shipwreck, the *Florida* is of interest as a monitoring site for infestations of algae associated with iron wrecks which cause black reefs (Kelly et al. 2012, Hatcher 1984). Some iron artefacts on the *Foam* site show signs of this infestation, see Figure 13. Previous research on the *Florida* site conducted by Hatcher (1984) monitored the effects of this iron wreck and its cargo on coral health. It would be useful to compare the current state of the wreck, algal populations, and adjacent reef health, to data gathered by Hatcher (1984). Such a comparison would allow the quantification of any ongoing detrimental impacts of iron shipwrecks on coral health.

Figure 12: Algal growth on the *Foam* wreck site, the basis for "black reefs".

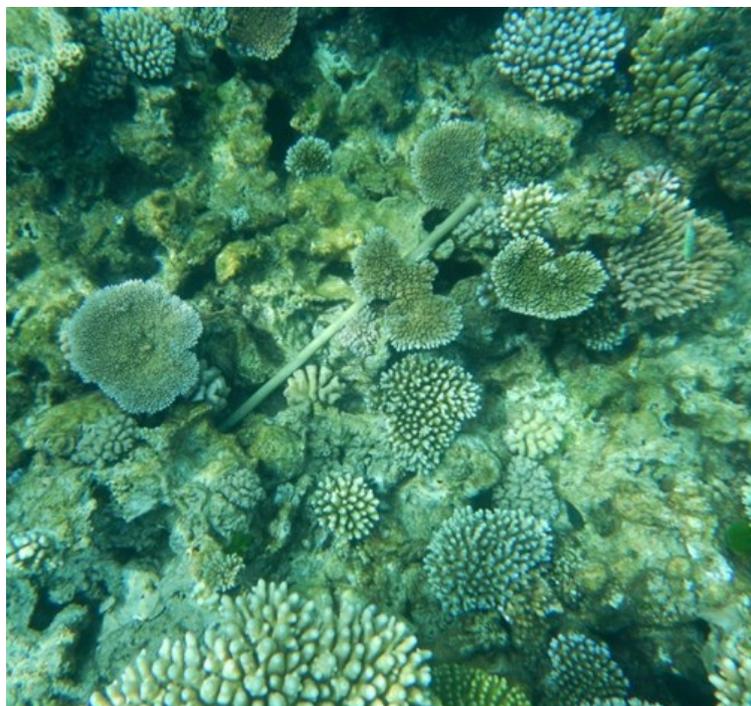
Cyclonic events and storms can certainly also disturb heritage sites by relocating artefacts. Artefacts such as a bronze fastening bolt and an iron knee were found situated in an unusual position on site. The bronze fastening and the knee are sitting amongst live coral as if placed there (Figure 15 and Figure 16). One hypothesis is that the artefacts were dislodged and redeposited by cyclone Yasi and new coral growth has grown up around them over the past five years. A second is that they have been repositioned by people disturbing the site. There was no sign of excavation on site so one must assume it was moved during a storm event, perhaps Yasi.

Figure 14: Bronze bolt sitting unattached amongst the coral.

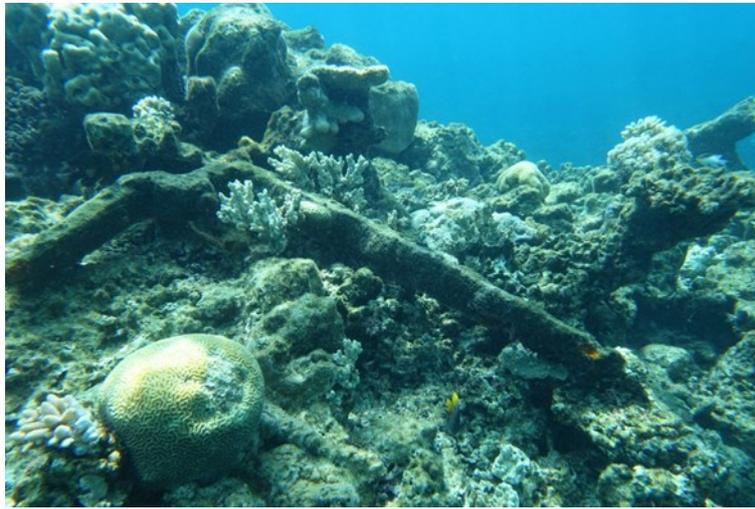
Figure 15: Iron knee loose amongst coral.
