SITE ASSESSMENT OF DAMAGE REPORT

Australian Border Force vessel Roebuck Bay - Henry Reef (12-053)

INCIDENT NAME	Roebuck Bay grounding at Henry Reef (12-053)		
DETAILS	Roebuck Bay – Australian Border Force vessel		
INCIDENT DATE	Day: Saturday	Date: 30-Sep-17	Time:~0030
SAD Date	Day: Saturday, Sunday, Monday and Tuesday	Date: 21 to 24 October 2017	Time: 0900 to 1530
Author	Incident Response Coordinator GBRMPA		
Editorial Assistance	Manager Operations Support		
Investigator	Senior Investigator		
Snr Ranger	Senior Ranger QPWS Far Northern Great Barrier Reef		
SAD Officers	Incident Response Coordinator GBRMPA Marine Parks Inspector QPWS Far Northern GBR Marine Parks Inspector QPWS Far Northern GBR

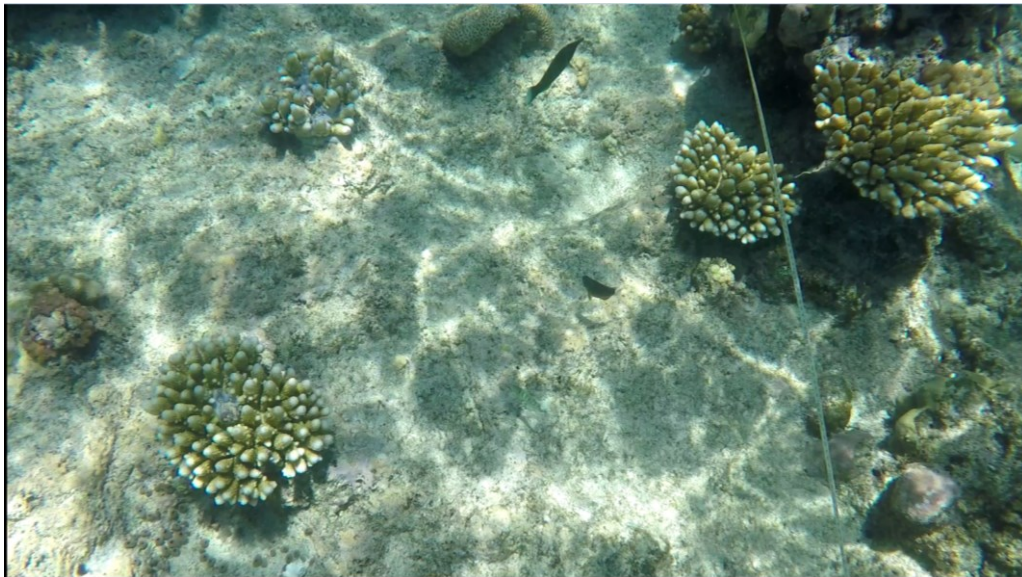
Figure 5 Benthos dominated by live coral rock and digitate *Acropora* sp: Screen grab for Video Transect 2 Wpt 26 to Wpt 25.

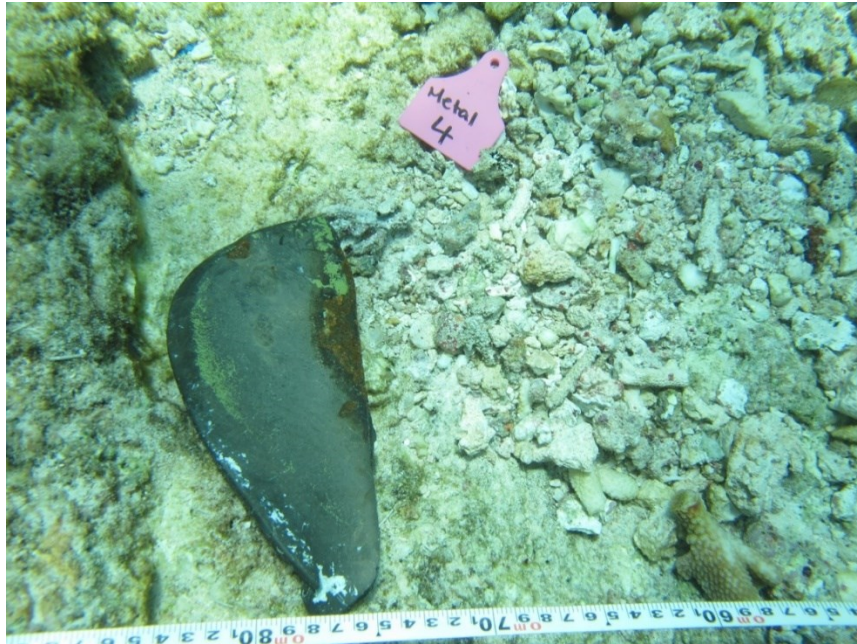
Within the damaged area adjacent to the northern boundary of the damage footprint, pieces of “Type A metal” were observed (Figure 8). These Type A metal pieces are interpreted to be broken fragments of the vessel’s propeller (Figure 9).

Figure 9 Metal fragment 4: “Type A” metal fragment collected 23 October 2017.

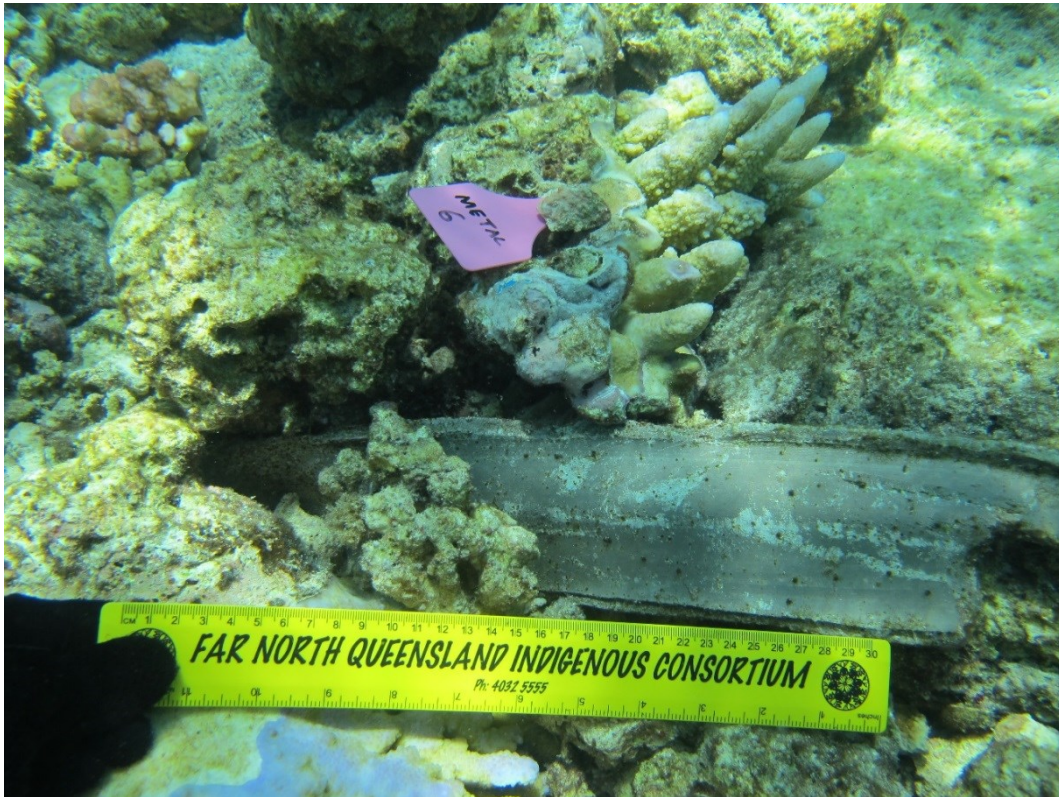
Across the remainder of the damaged area four pieces of “Type B” metal presumed to be aluminium hull fragments were collected as exhibits (Figure 10) and a nally crate full of this Type B metal was collected to remove debris from the site.

Figure 10 Metal fragment 6: Type B metal fragment collected 23 October 2017.

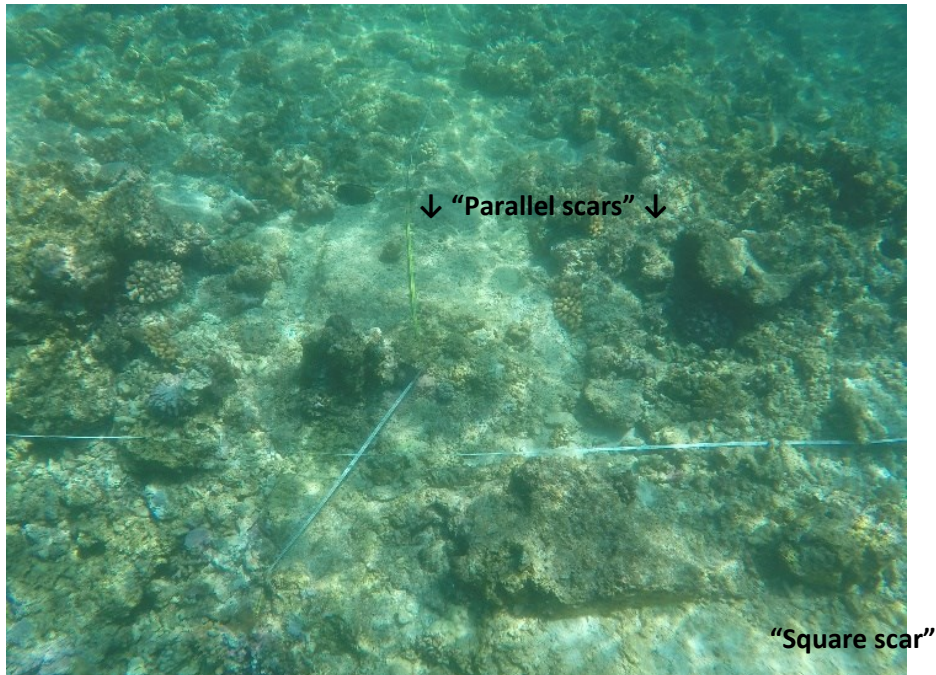
GOPR1955: Transect Alpha-Bravo at 5.7m

Within the north-eastern corner of the damage area (adjacent to Bravo) there was severe damage – extending from 5.7 m (Wpt 34 – Photo GOPR1955) to 12.7 m (Wpt 35 – GOPR1957) along Transect Alpha-Bravo (Figure 11). This area of damage was characterised by linear features running north-south, being two parallel scars approximately 950 mm apart depicted in GOPR1955 are more clearly visible in Figure 12, a screen grab from Video Transect 1 (see Figure 4, table of video transects).

Figure 11 Severe reef damage adjacent to Bravo.

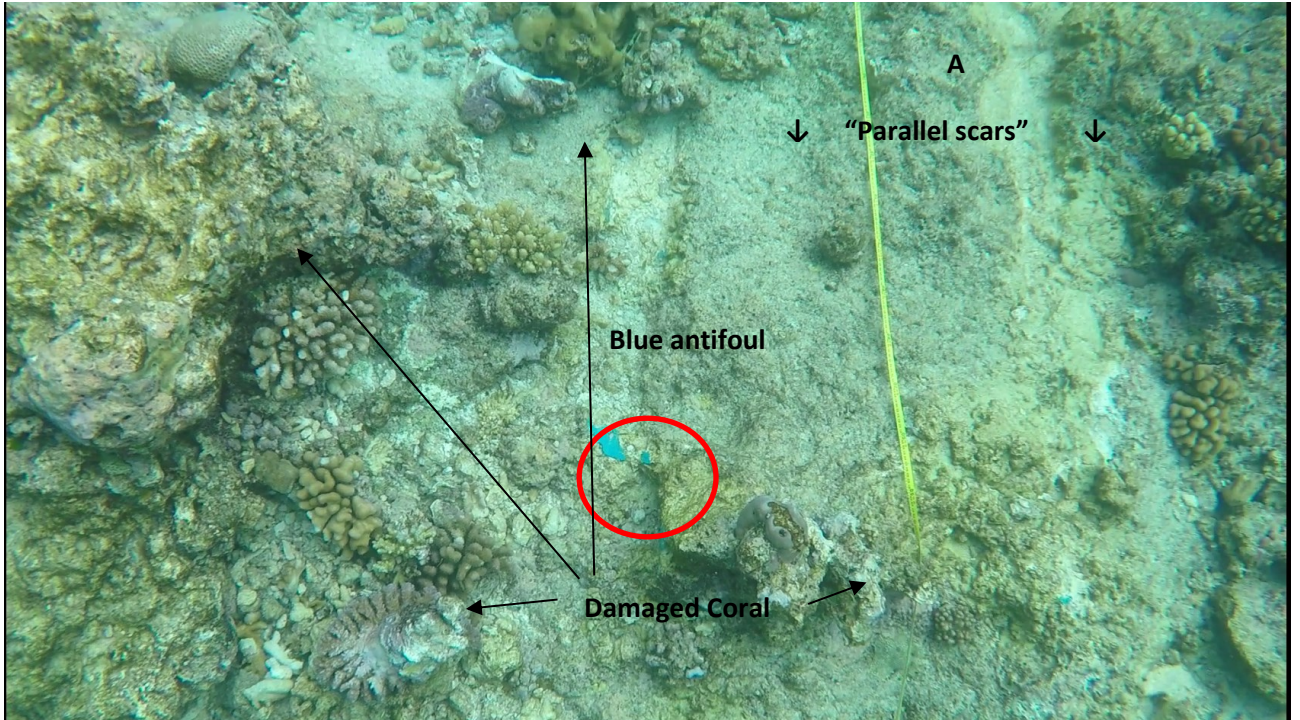
Figure 12 Still image extracted from Video Transect 1 (GoPR1715: 0:25sec); parallel scars running north-south. Evident within the image is: A – parallel scars; B - antifouling paint; C – damaged coral

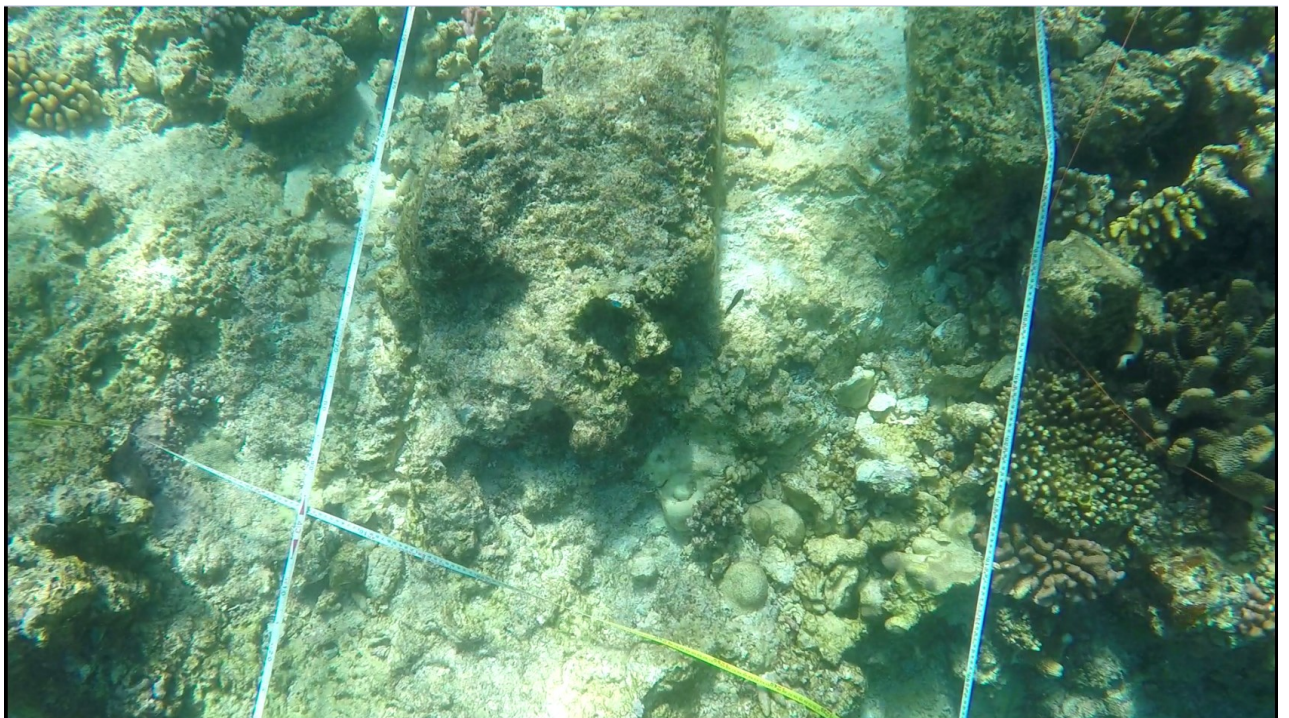
The scars are evident on Video Transect 15 (GoPR1894) between 19.0 m and 31.0 m (12 m) – Figure 13.

Figure 13 Still image extracted from Video Transect 15 (GoPR1894: 0:47sec) showing on the right (north/aft) A - the 300 mm "square scar" and on the left the (southern/forward) B - "irregular scar", separated by a ridge of lesser impacted reef matrix approximately 400 mm wide.

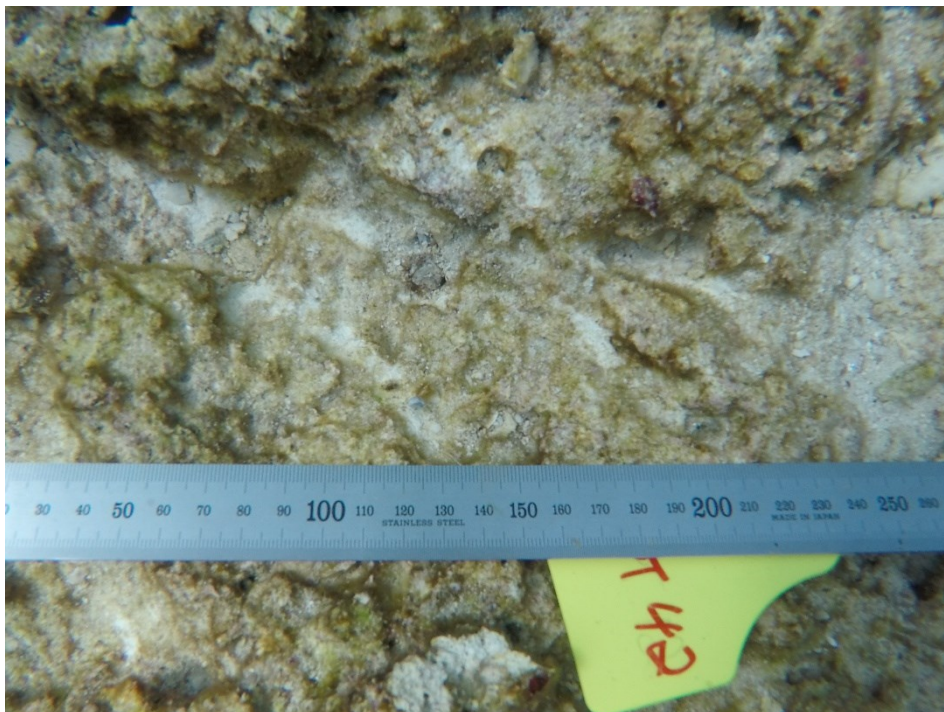
A second set of measurements of distance between internal gouges on the “irregular scar” were taken after reviewing the depth observations. These were variable, ranging from gouges 90 mm long and 67 mm apart to 60 mm long and 33 mm apart (Figure 16).

Figure 16 Close up of the “irregular scar” – Waypoint 42 – GoPR1995)

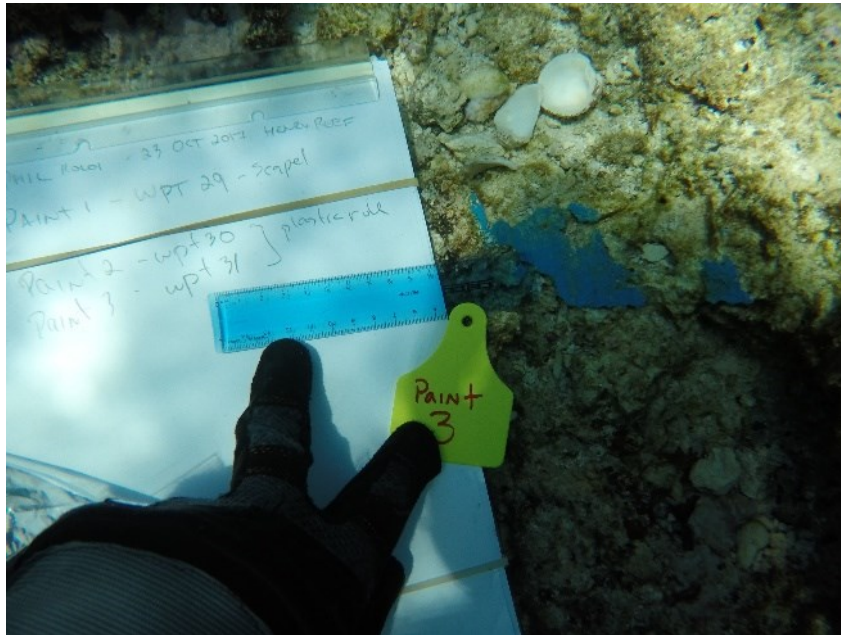
Only a small amount of antifouling was observed on site and 4 samples were taken as evidence exhibits during the survey. Figures 17 to 23 depict the process of paint sample collection, processing and storage.

Figure 17 GoPR1946 – Paint sample 3 in situ

1. Remove the anchor from the site as soon as practicable with care to minimise further coral damage;
2. Remove any further metal debris and antifouling paint from the site; which should then be removed and disposed of at a licenced mainland waste facility;
3. Stabilise mobile coral debris at the site by placing it in a location on the reef that is less likely to be affected by weather and swell. This may expose additional antifouling paint which should then be removed and disposed of at a licenced mainland waste facility.

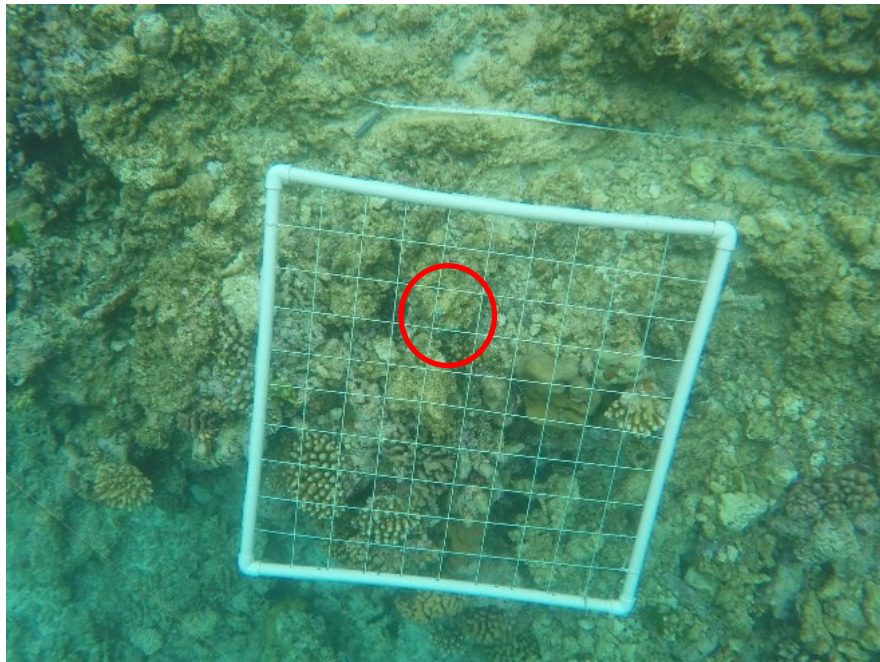
Arm A: Quadrat A20 (GoPR1918) – Impact depicts 16 per cent Hard Coral, 11 per cent Old Rock and 71 per cent New Rock. There is a small amount, less than 10 cm², of antifouling paint evident in the top left quarter of A20.

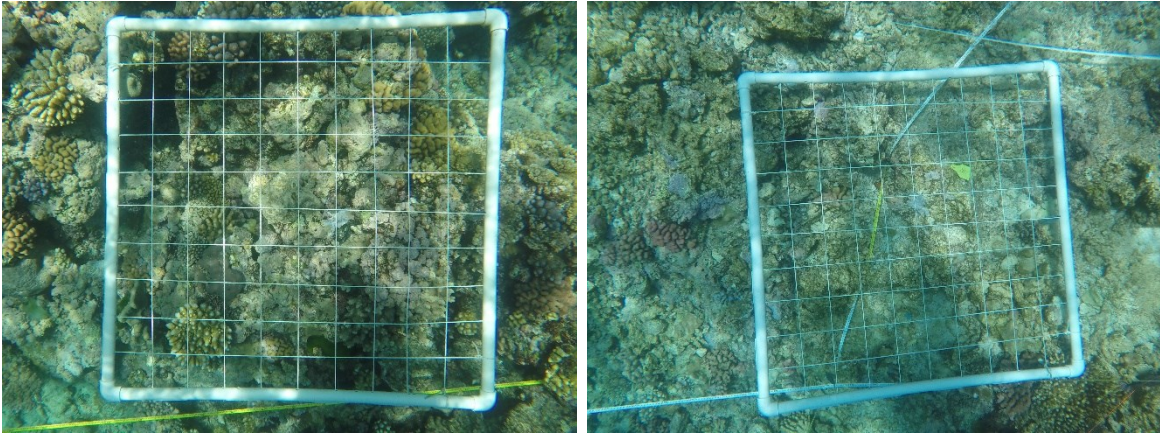
Figure 13 Arm B: B37 - Control

Figure 13 depicts quadrat B22 (GoPR1920) – 88 per cent New Rock, a small smeared area of blue antifouling paint is present in the lower centre of this quadrat. B37 (GoPR1935) – 15 per cent Hard Coral and 84 per cent Old Rock is typical of the un-impacted reef as it drops off the reef flat into the upper reef slope on the north western aspects of Henry Reef.

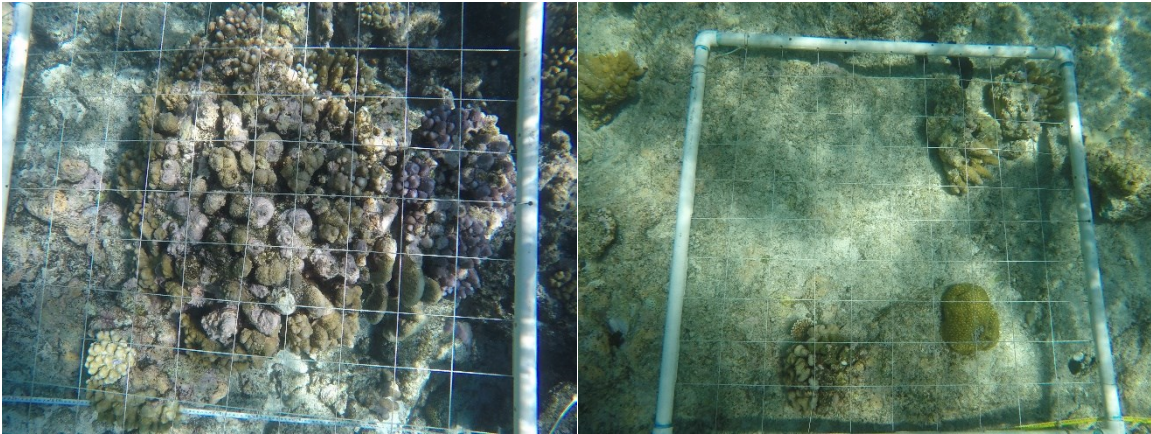
Figure 14 Arm C: C2 – Control

Figure 14 depicts quadrat C2 (GoPR1847) – 33 per cent Live Coral and 65 per cent Old Rock and C19 (GoPR1864) – 4 per cent Live Coral (hard + soft coral), 86 per cent Old Rock and 11 per cent New Rock; of note in this image is the area of “New Rock” in the upper right quadrant. At the time of the Site Assessment of Damage (22 October 2017), the upper surfaces were alive, however the underside had bleached and tissue was undergoing necrosis.

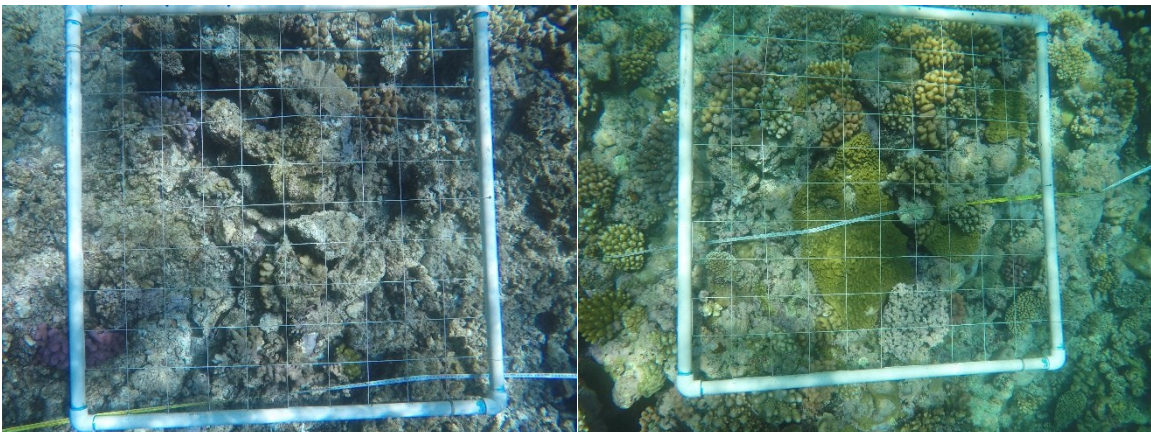
Figure 15 Arm D: D32 Impact

Figure 15 depicts D32 (GoPr1876) – 2 per cent Live Coral and 94 per cent New Rock, this quadrat was dominated by 10 cm to 30 cm diameter chunks of damaged coral. D46 (GoPr1890) depicts 31 per cent Live Coral and 67 per cent Old Rock. A single colony of soft coral in the centre of the quadrat comprises half the live coral cover.

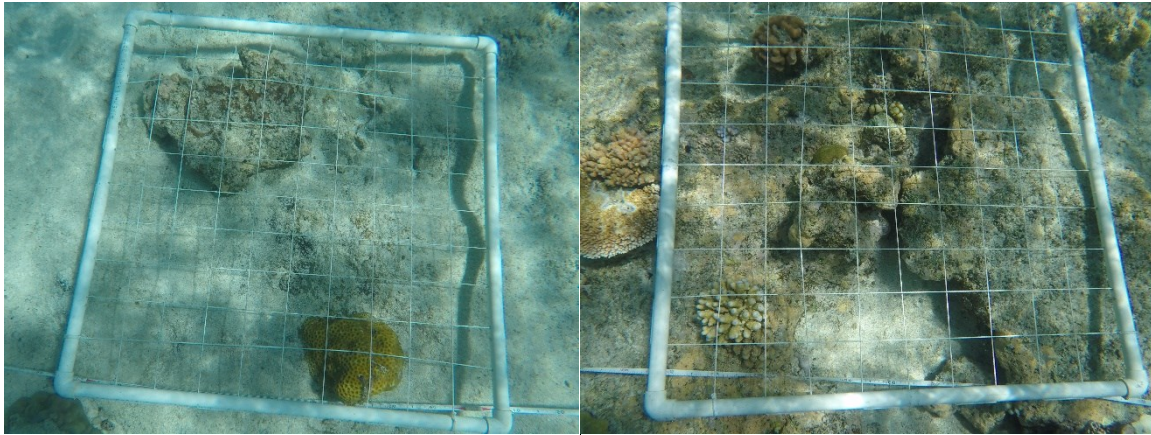
Figure 16 Arm E: E12 Control

Figure 16 depicts E12 (GoPr1731) – 79 per cent Old Rock and 14 per cent New Rock – although this quadrat was initially identified to be outside the maximum extent of damage, the large Damaged coral fragment in the upper left corner of the quadrat is interpreted to be a piece of live coral rock somehow moved they vessel either in the process of grounding or in the process of attempted salvage. E15 (GoPR1728) – 11 per cent Live Coral and 81 per cent Old Rock, although within the maximum extent of damage exhibits no observed vessel induced impacts.

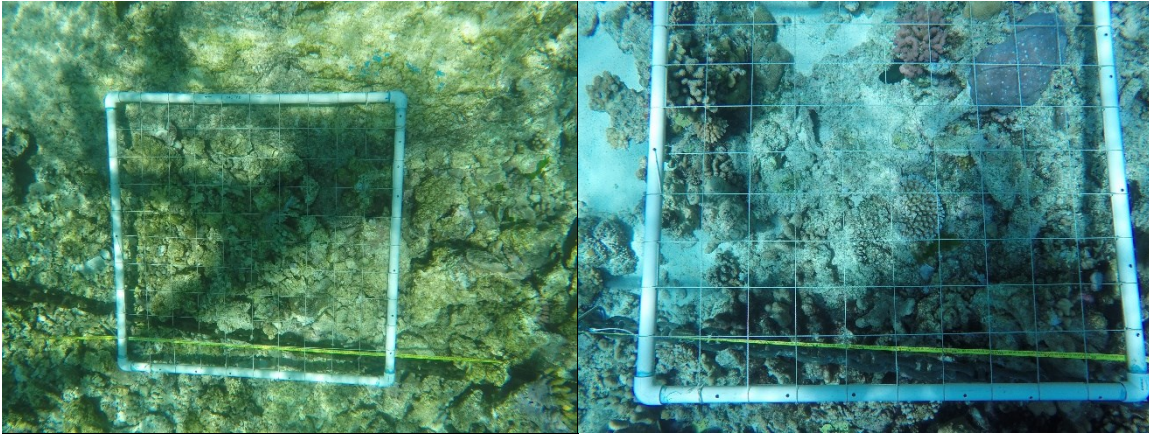
Figure 18 Arm H: H22 Impact

Figure 18 depicts H22 (GoPR1822) – 13 per cent Old Rock and 87 per cent New Rock, this quadrat is dominated by New Rock with a small flake of blue antifouling paint in the centre right of the image and H36 (GoPR1836) – 10 Live Coral and 81 per cent Old Rock.
