DOUGLAS SHOAL REMEDIATION PROJECT Visual Surveys Field Report June 2019

Visual Survey Field Report

Douglas Shoal Remediation Project

Report No: 301001-02112-EN-REP-0002 – Visual Survey Field Report

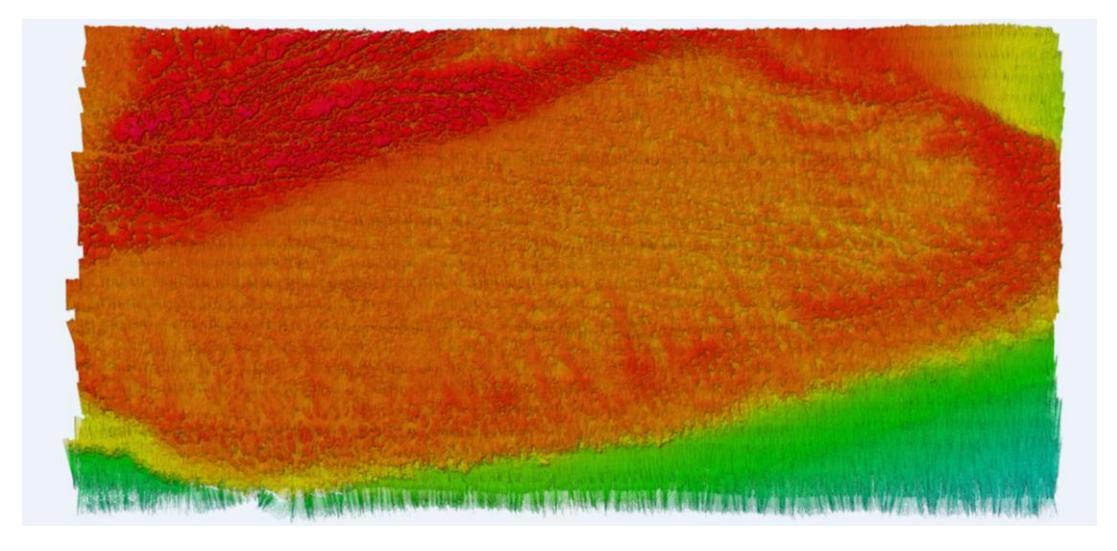
Preliminary results (screen shots) of the bathymetry and backscatter data captured are provided in Figure 2-17 and Figure 2-18. Bathymetry and backscatter images appear to indicate evidence of a flattened area of seafloor in the main grounding. The white patches observed in Figure 2-18 (circled) for priority remediation areas C, E and F may indicate areas where sound pulses sent out by the MBES unit are not reflected to the receiver (typical of flattened solid seafloor). The backscatter data appears to be comparable to that captured by AIMS (Negri *et al*, 2010) just after the grounding incident.

Figure 2-17 Screen shot of the bathymetry captured

- Preliminary sonar survey results including preliminary bathymetry and backscatter data appear to show evidence of a flattened area within the grounding footprint, specifically in the areas where the ship sat for many days.

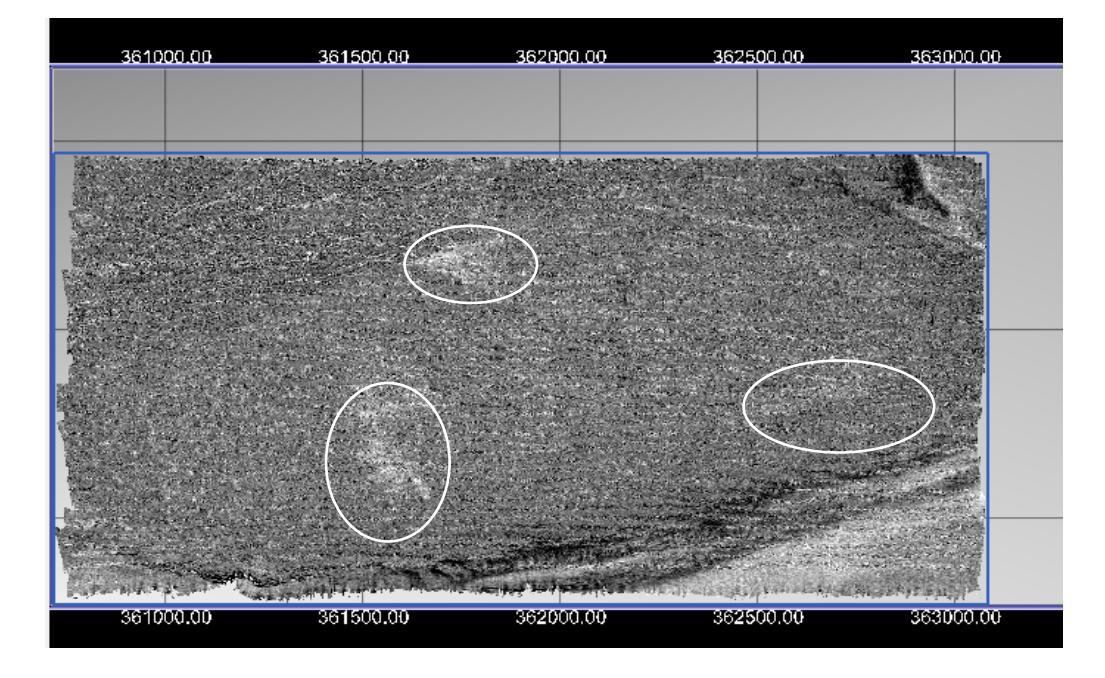
Figure 2-18 Screen shot of backscatter data across the shoal with flattened areas circled

- A preliminary visual comparison between the AIMS backscatter data (Negri et al, 2010) and the backscatter data collected during this field trip appears to show a similar spatial extent of flattened areas.

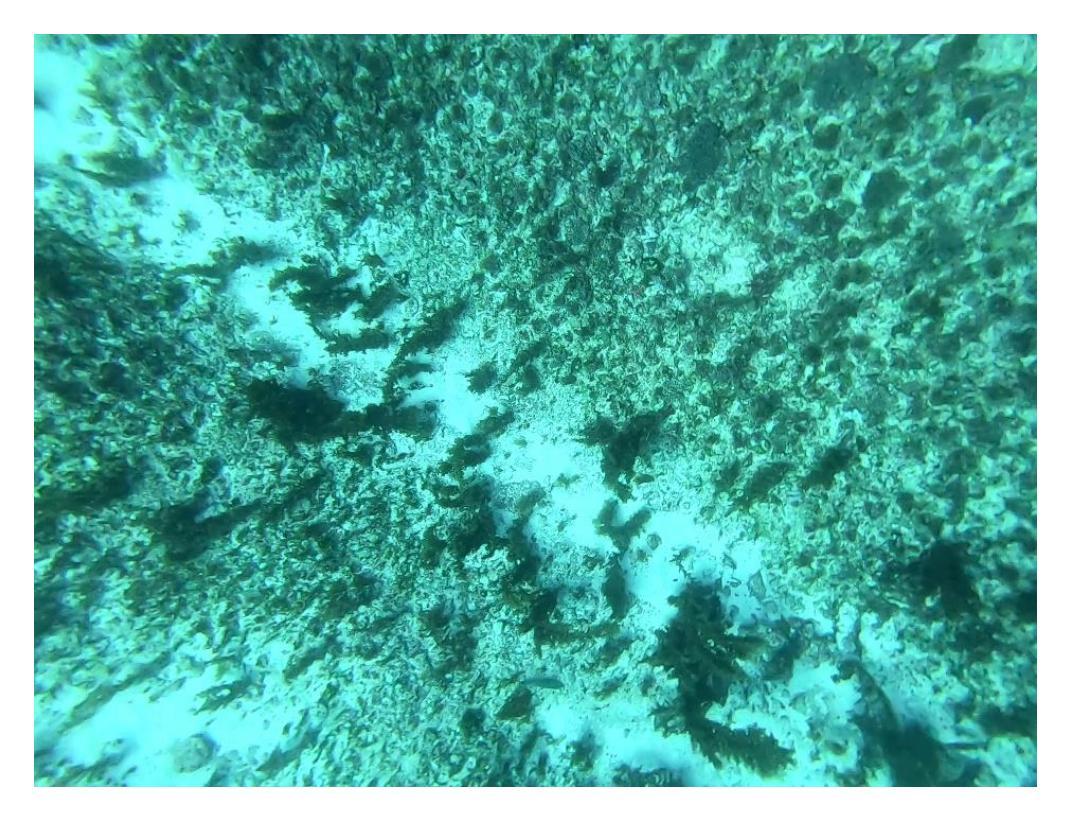
Figure 2-20 Sample of a drop camera image capture of the seafloor in Priority Area C

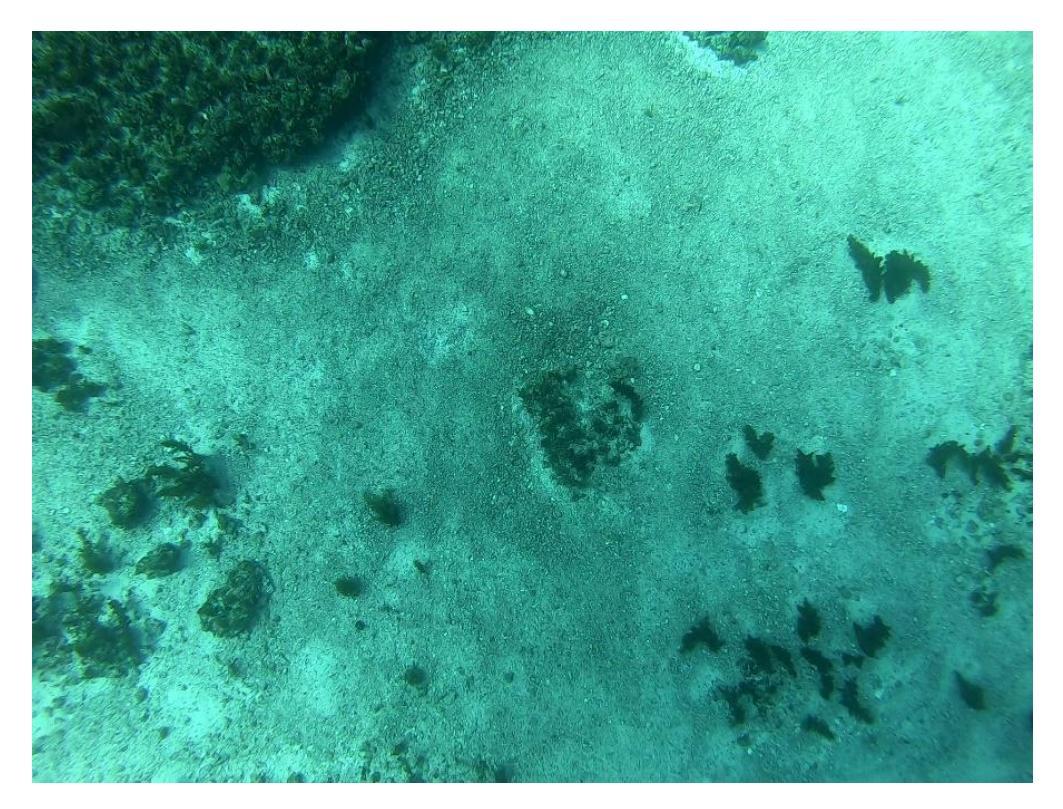
Figure 2-21 Sample of a drop camera image capture of the seafloor in Priority Area F

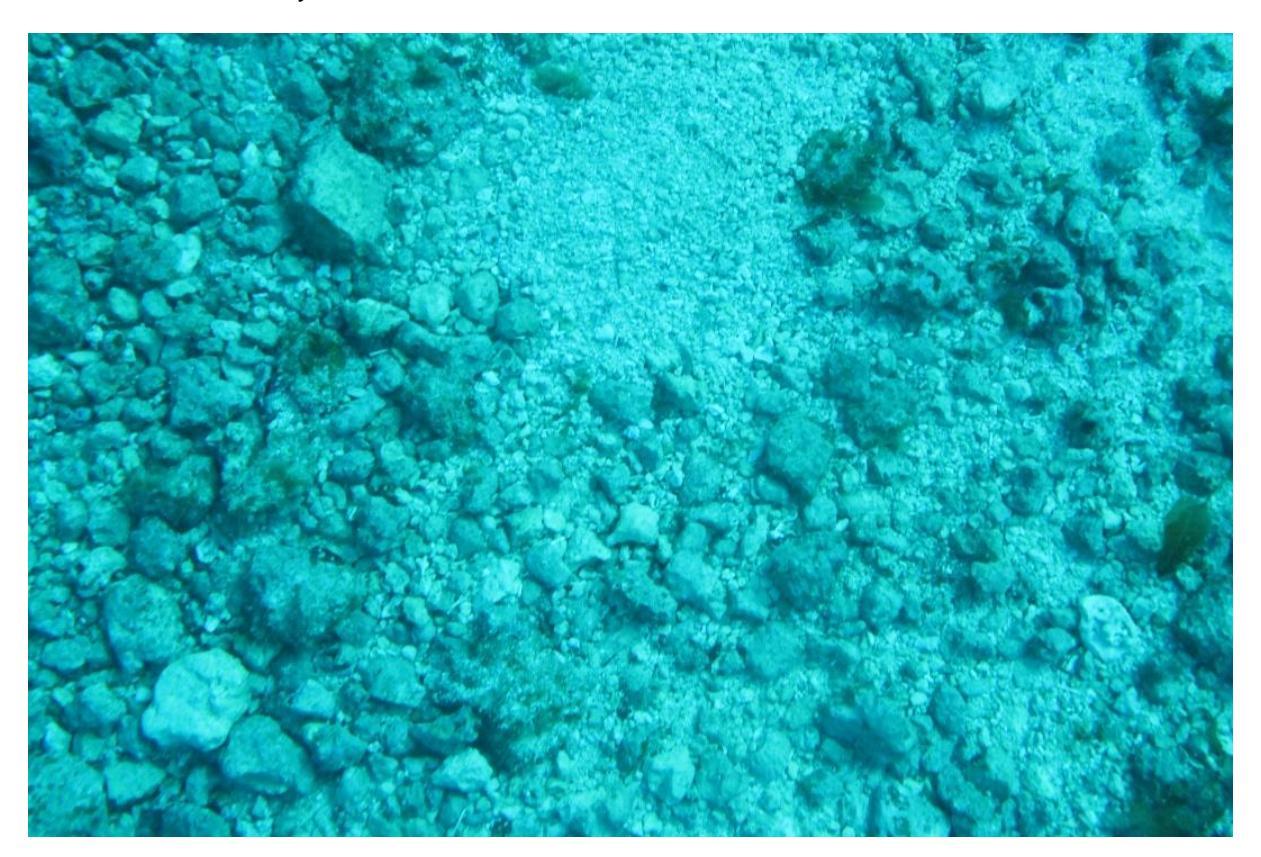
Evidence of the ship grounding was observed in the video footage as the TUV surveys progressed, including large areas of exposed bare substrate covered in a fine layer of sand and angular rubble

(Figure 2-22). In comparison with images shown in Costen et al, 2017 (refer to *Figure 4-2 Image of physical damage*), no large rubble banks or fractured and displaced substrate were observed during the TUV surveys, indicating some level of natural recovery. No evidence of ship hull fragments or AFP flakes were observed by the TUV.

Figure 2-22 Areas of 'angular' rubble in the grounding footprint in Area C

- Evidence of the ship grounding was observed in the video footage as the TUV surveys progressed, including large areas of exposed bare substrate covered in a fine layer of sand and angular rubble.

- In comparison with images shown in Costen et al, 2017, no large rubble banks or fractured and displaced substrate were observed during the TUV surveys, indicating some level of natural recovery.

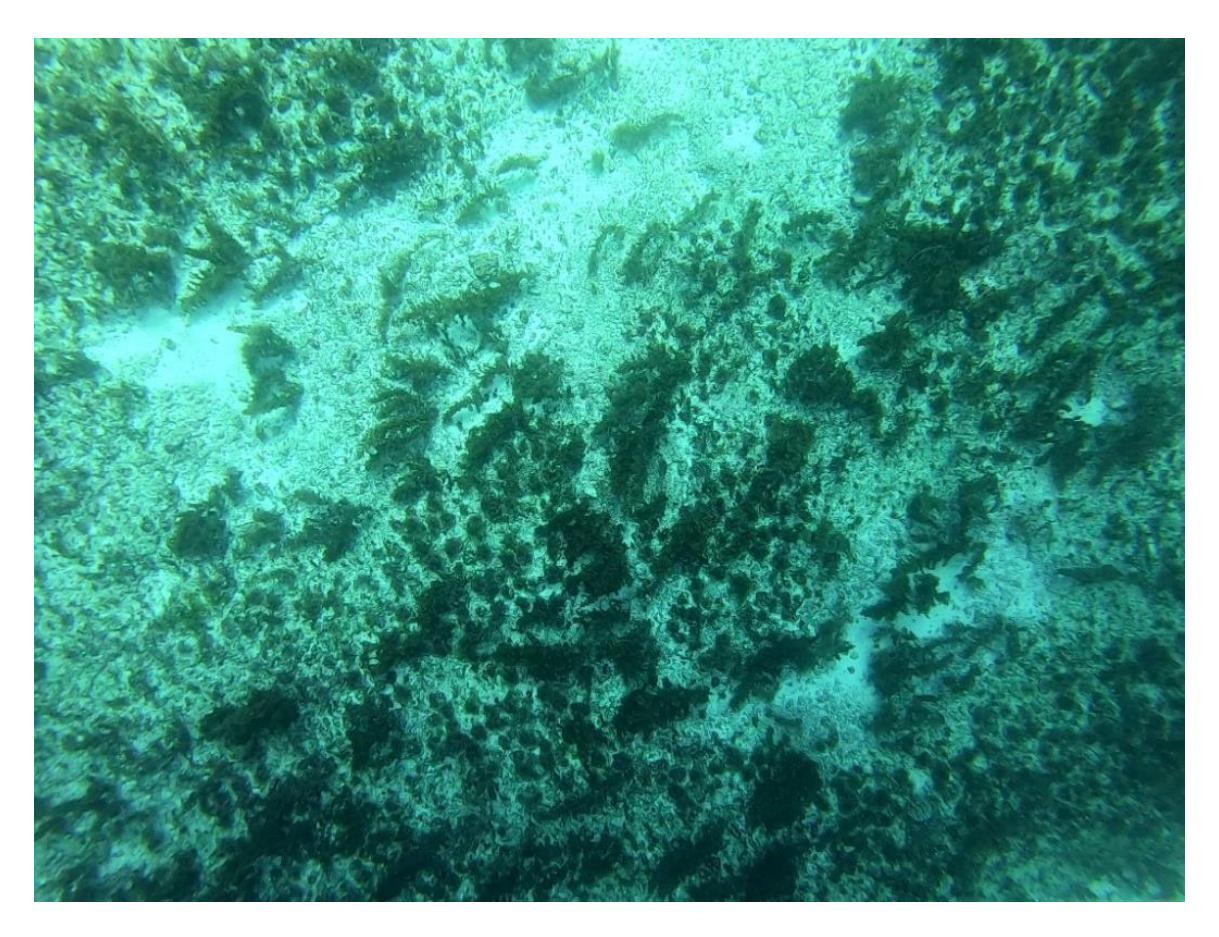
The macroalgae *Sargassum spp.* was found growing on the shoal (Figure 2-23), covering areas of consolidated sediment and rock in stands up to 1.0 to 1.5m high in places. The algae were less prolific compared to that encountered during the sediment sampling surveys undertaken a month prior. The algae appeared to be dying off, with large strands of macroalgae observed drifting on the sea surface.

Figure 2-23 Stands of the macroalgae Sargassum spp. observed in Priority Area E
