THE HISTORY OF DREDGING IN CLEVELAND BAY, QUEENSLAND AND ITS EFFECT ON SEDIMENT MOVEMENT AND ON THE GROWTH OF MANGROVES, CORALS AND SEAGRASS

Great Barrier Reef Marine Park Authority
Research Publication

Ada W Pringle (nee Phillips)

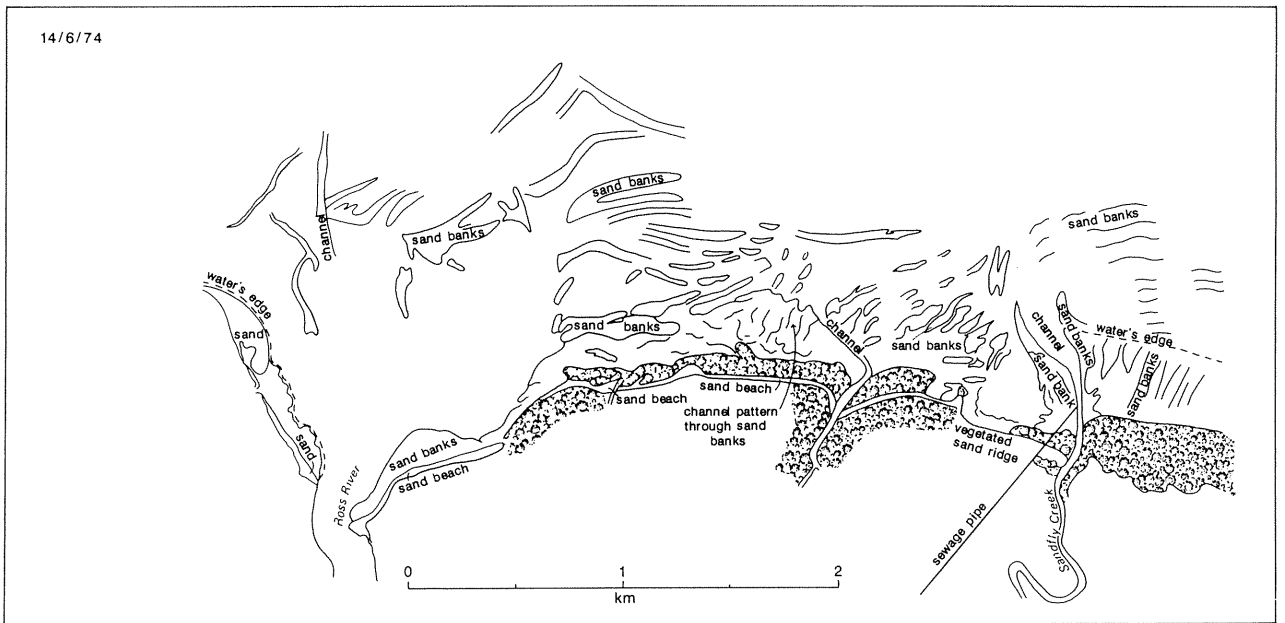
FIGURE 8 Maps of coast between Ross River and Sandfly Creek drawn from aerial photographs taken in 1959, 1974, 1981 and 1985.

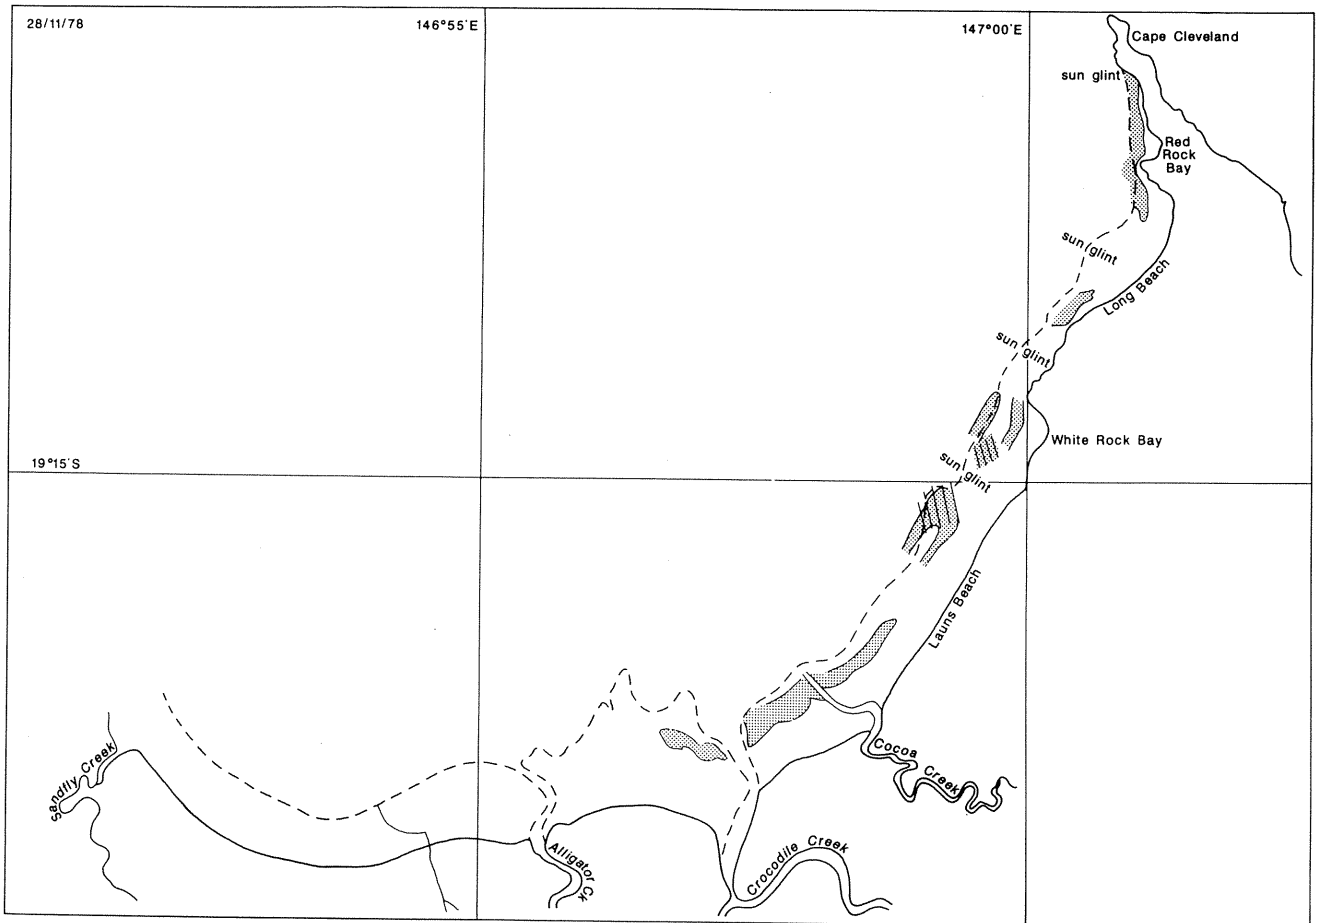
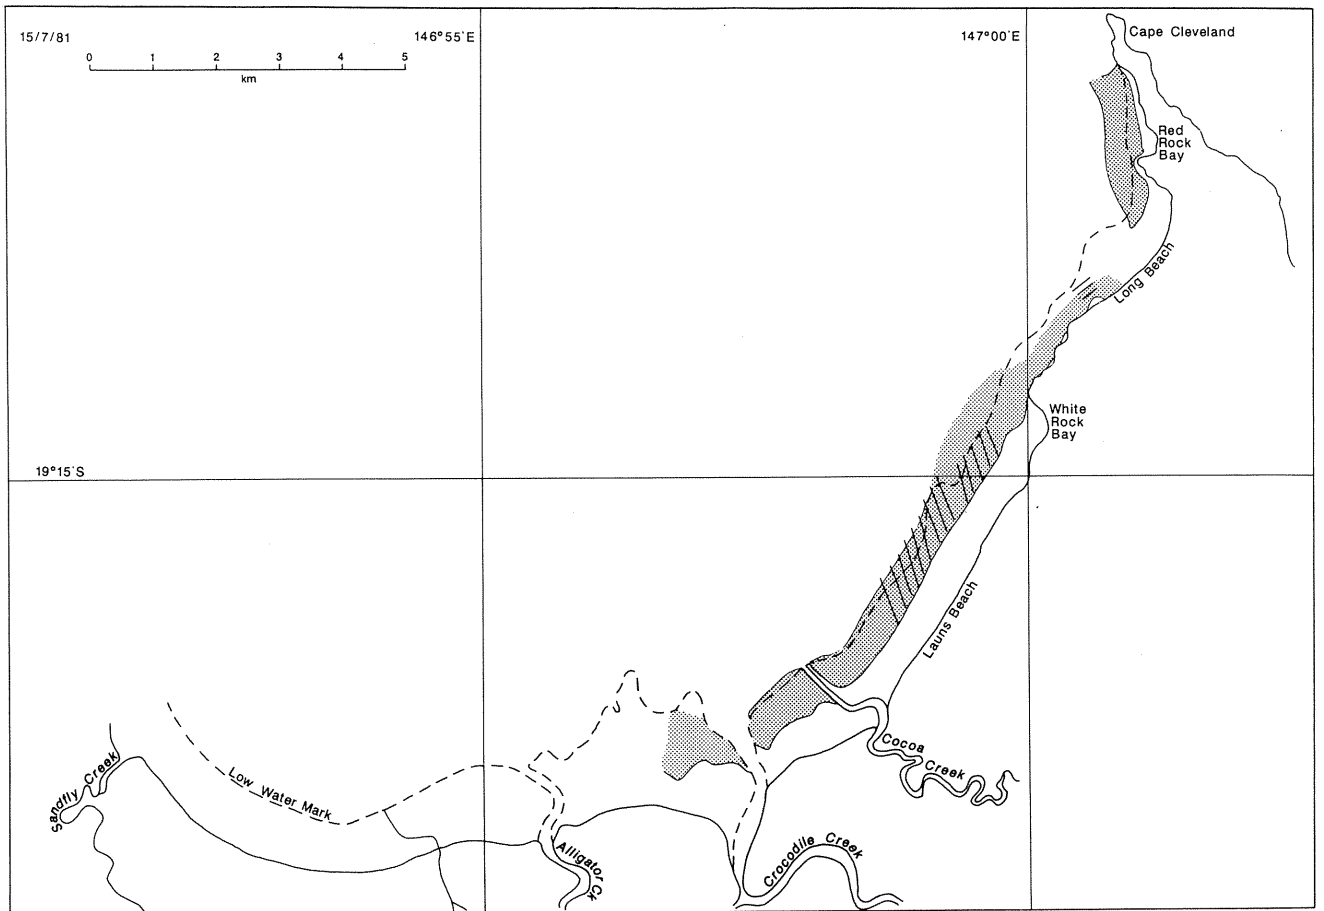
FIGURE 10 Maps of coast between Sandfly Creek and Cape Cleveland drawn from aerial photographs taken in 1974, 1978, 1981 and 1985. Note especially the changing distribution pattern of seagrass.

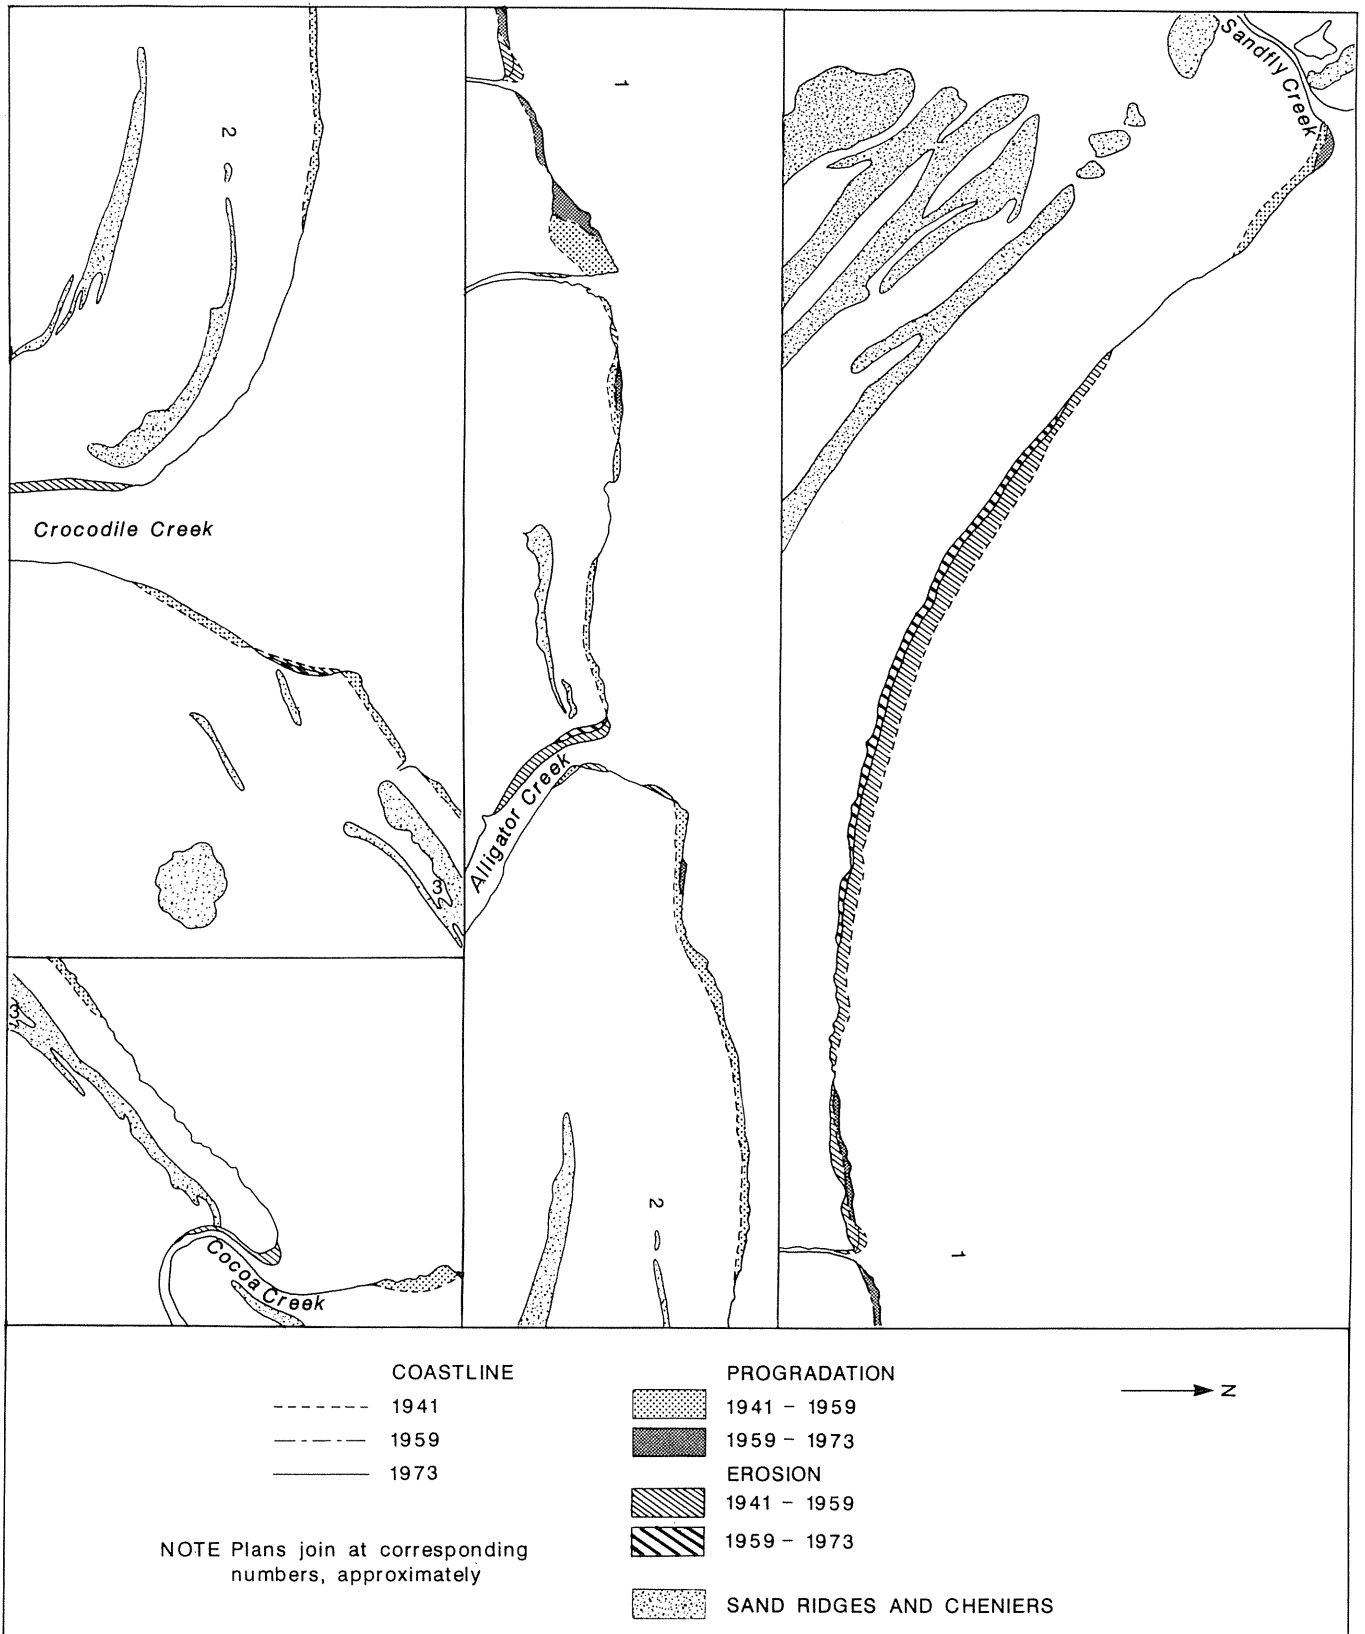
FIGURE 11 Shoreline changes in south Cleveland Bay, between Sandfly Creek and Cocoa Creek 1941-1973. After McIntyre and Associates, 1974.

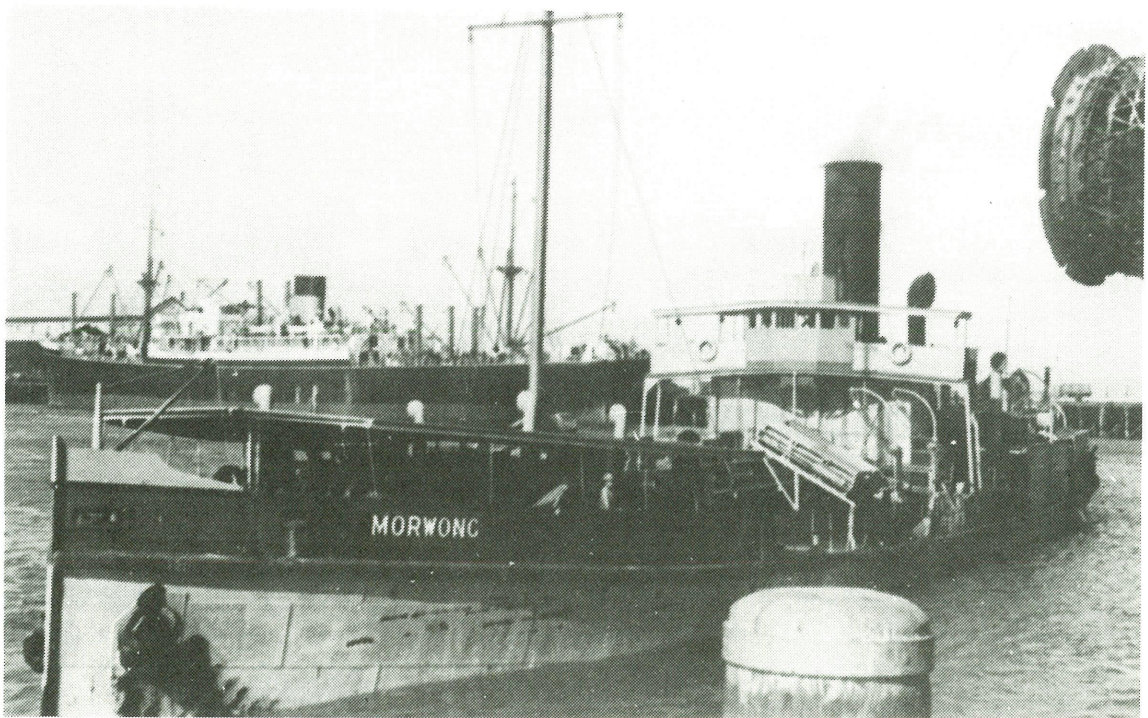
2 Suction Dredge 'Morwong' in October 1946.

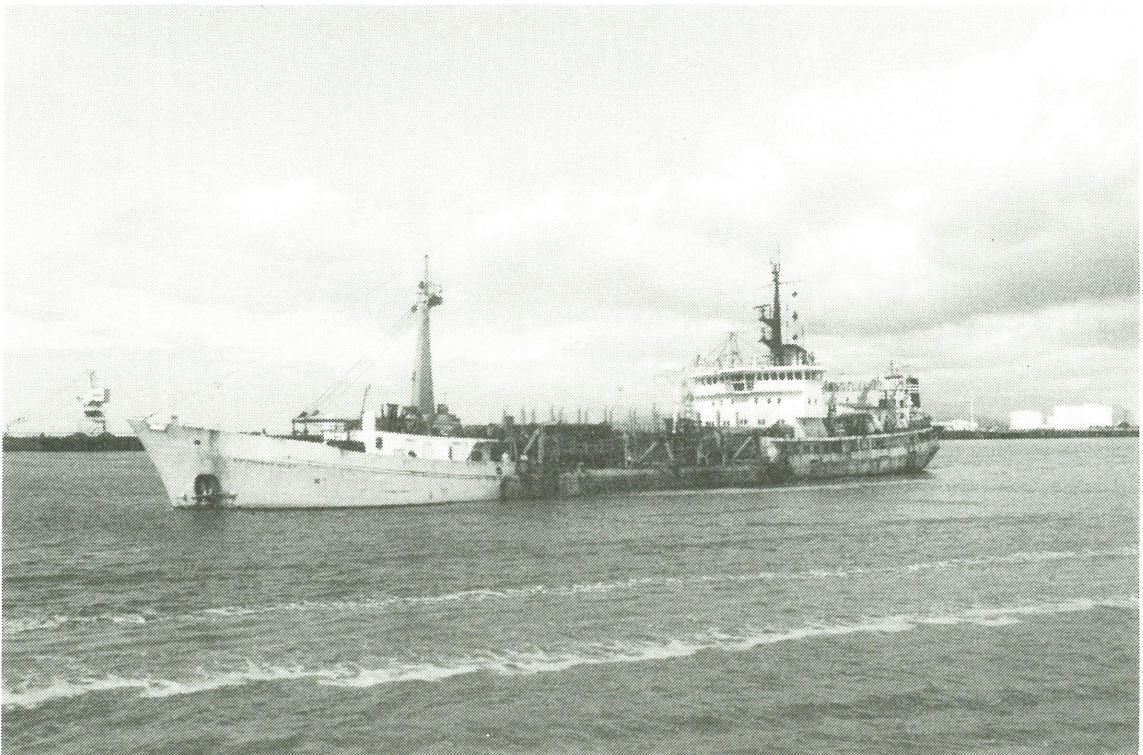
6 Trailing Suction Dredge 'Sir Thomas Hiley' carrying out maintenance dredging in the Swing Basin in June 1988.
