11.4.2. Corio Bay Wetlands

11.4.3. Fitzroy River Floodplain

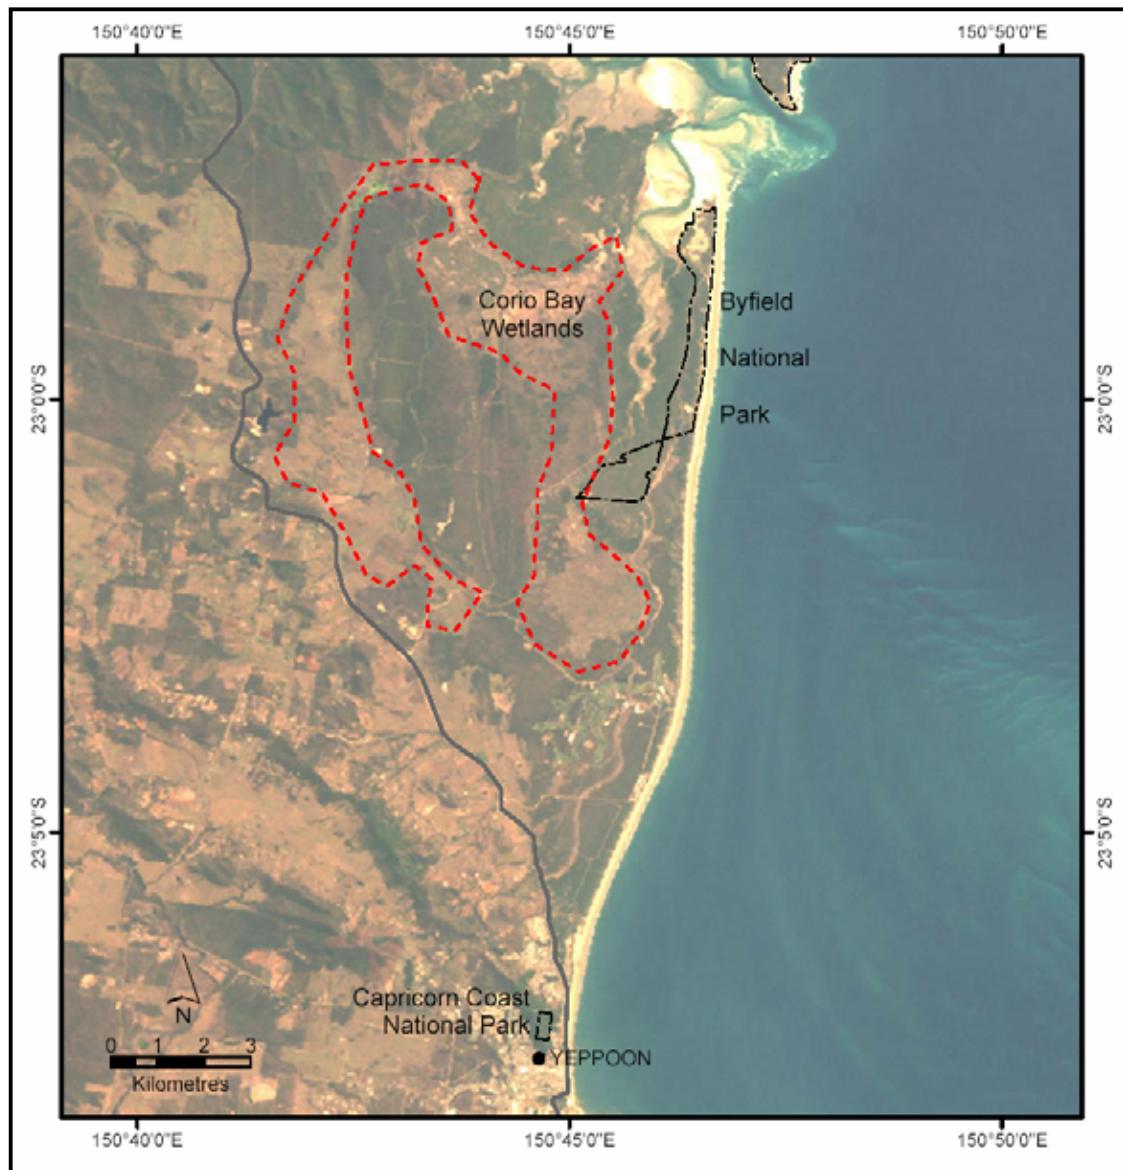
Figure 52: Corio Bay wetlands north of Yeppoon

The Corio Bay wetlands (*figure 52*) are an extensive area of coastal wetlands to the north of Yeppoon on the southern side of Corio Bay. The wetland area has a series of bund walls that separate freshwater wetlands from the tidal creeks. The walls have some low areas that allow fish passage during flooding however passage is limited at other times. Capricorn Sunfish (Sawynok, 2002, 2003) and DPI&F (Hyland, 2002) have monitored fish use of this area. The wetlands vary in type from bulkuru swamps to melaleuca and palm forests and open wetland areas.

The Corio Bay wetlands have virtually no grazing and this is leading to an increase in grassy weeds such as para grass. There are also areas of woody weed that require ongoing management. While some areas of ASS have been allowed to oxidise, the impact appears minimal due to the waterlogged nature of the area for substantial periods of time.

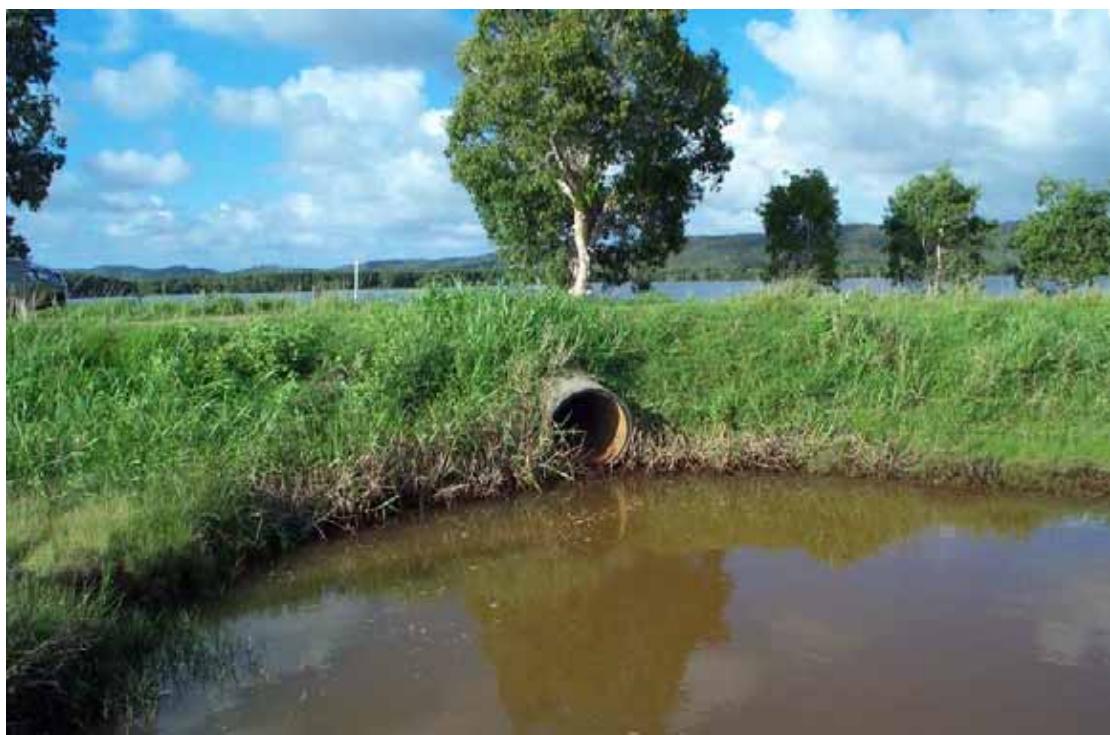
Figure 53: Pipe under the roadway and levee bank separating brackish water in foreground from freshwater wetlands in background (juvenile barramundi and other species have been recorded below the pipe)

The wetland includes an artificial saltwater pondage in an area adjacent to Fishing Creek where material was extracted for road construction in the 1980s (*figure 53*). This pondage is connected to the creek on king tides and 38 species have been recorded using this habitat (Sawynok, 2002, 2003). While the creation of this wetland was largely incidental it demonstrates that viable wetlands can be created to replace those that have been lost.

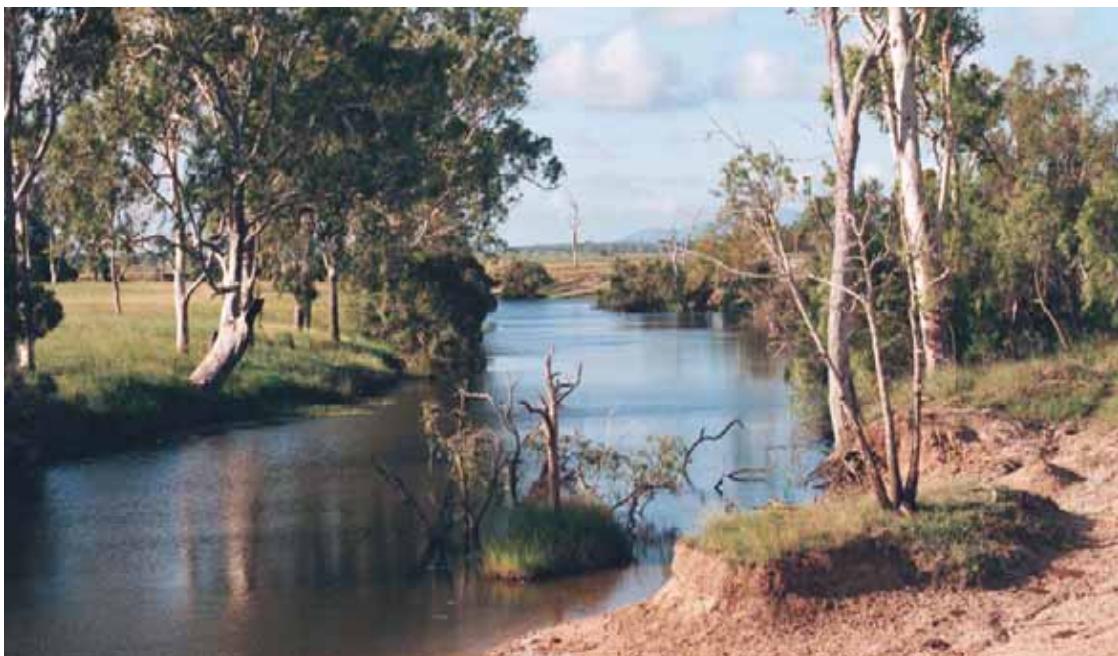
Figure 55: Hedlow Creek has good in-stream habitat with modest riparian vegetation

Riparian vegetation is poor along both Hedlow Creek (*figure 55*) and Serpentine Lagoon however is more natural along Canal Creek.

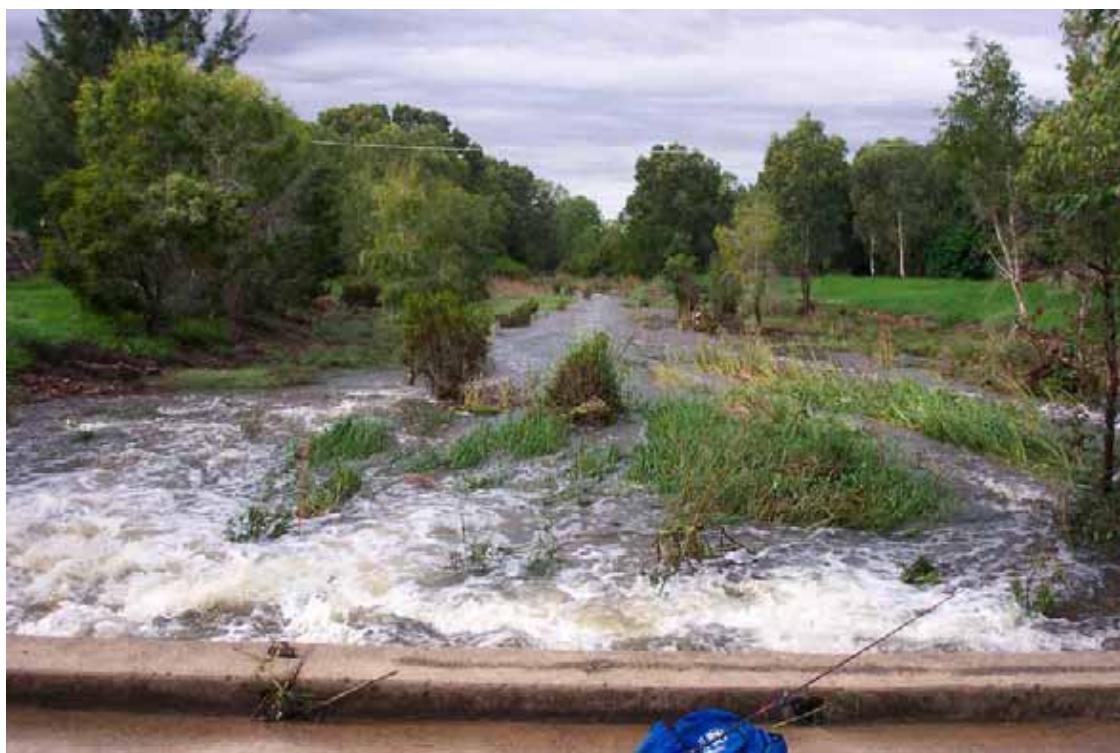
Figure 56: Moore Creek causeway at the upper tidal limit after moderate rain

vegetation. A low causeway separates the saltwater and freshwater reaches of the creek (*figure 56*). It has some weed infestation and is shallow but now has permanent flow due to seepage from residential and parkland irrigation and water quality, although impacted, supports fish life.

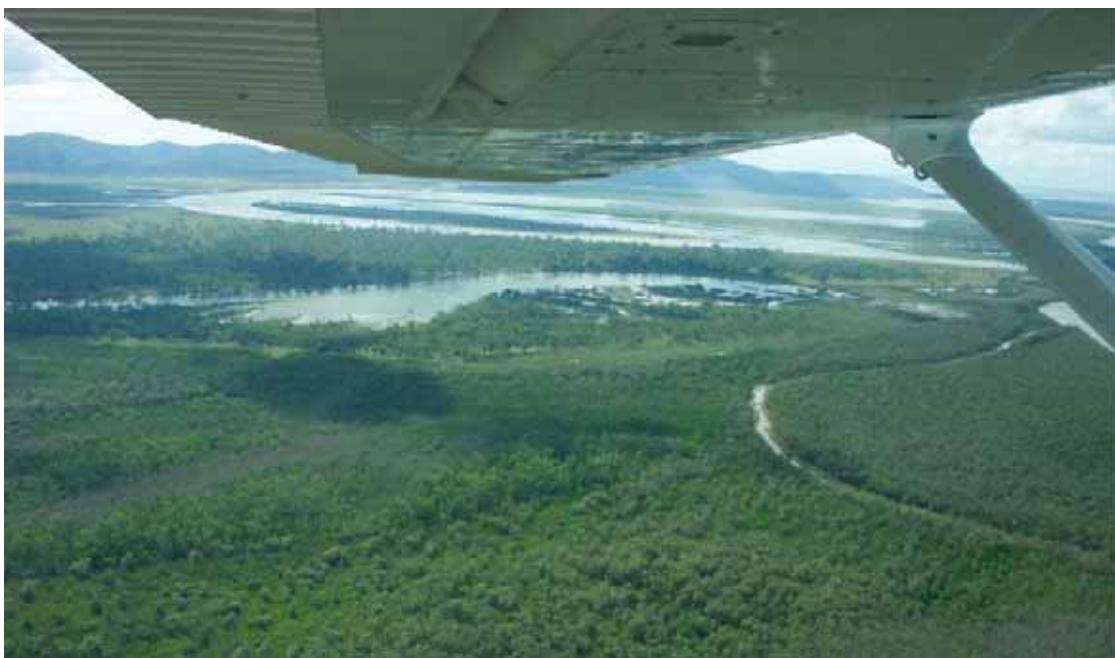
Figure 58: Oxbow lagoon east of Nankin Creek and part of the Nankin wetlands

1. Depth reduction as a result of siltation of the oxbow lagoon.
2. Lack of riparian vegetation.

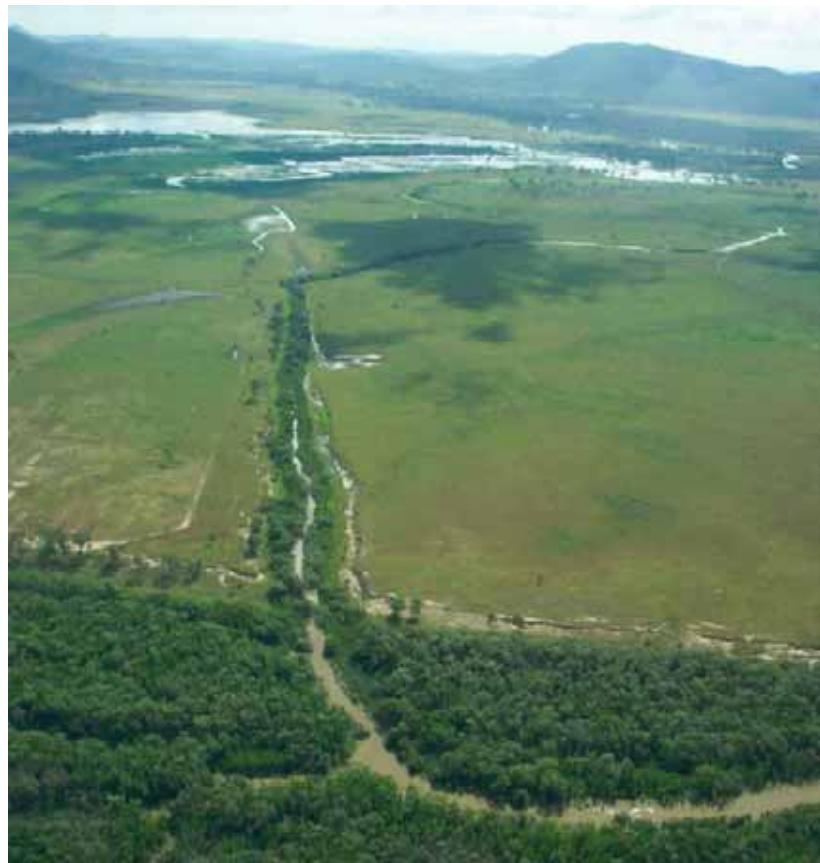
While the Nankin Creek wetland is almost devoid of trees, a narrow riparian strip within the creek banks occurs along most of the length of the creek (*figure 59*). During heavy local rainfall and flood events, numerous shallow wetlands form on this floodplain. While some of these dry completely during long dry spells these shallow ephemeral wetlands are important to fish and birds.

Figure 59: Nankin Creek saltwater-freshwater interface with ephemeral wetlands in the background

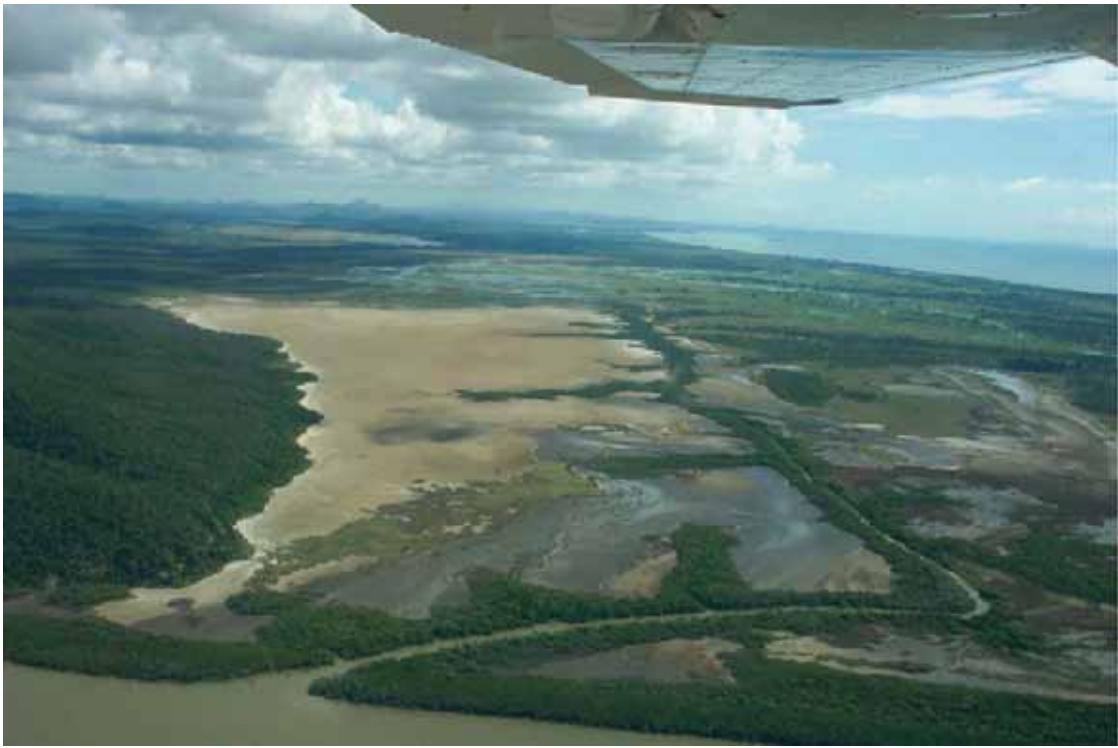
Barramundi Creek is a relatively small tidal creek that joins the Fitzroy River near its mouth and drains extensive coastal wetlands that extend northward behind the coastline in the area known as Red Hill (*figure 60*). Barramundi Creek has a barrier at the upper tidal limit that allows ponding of freshwater on the wetlands but limits fish access. Although this system has been subjected to the development of ponded pastures, no on-ground monitoring of fish use has been undertaken. The Coastal CRC and Capricorn Sunfish have undertaken aerial assessments of this area and these wetlands are considered likely to be of significance to fisheries resources. After rain, wetlands connected to Barramundi Creek and smaller coastal creeks extend for approximately 15 kilometres from the mouth of the Fitzroy River to Joskeleigh with extensive shallow areas and some apparent deep areas that may act as refuge during dry periods.

Figure 60: Barramundi Creek showing the interface between freshwater wetlands and tidal creek

This wetland area may be one of the most significant remaining in the lower Fitzroy River and a priority is to assess its value for fisheries resources to determine if its values should be protected and enhanced where possible.

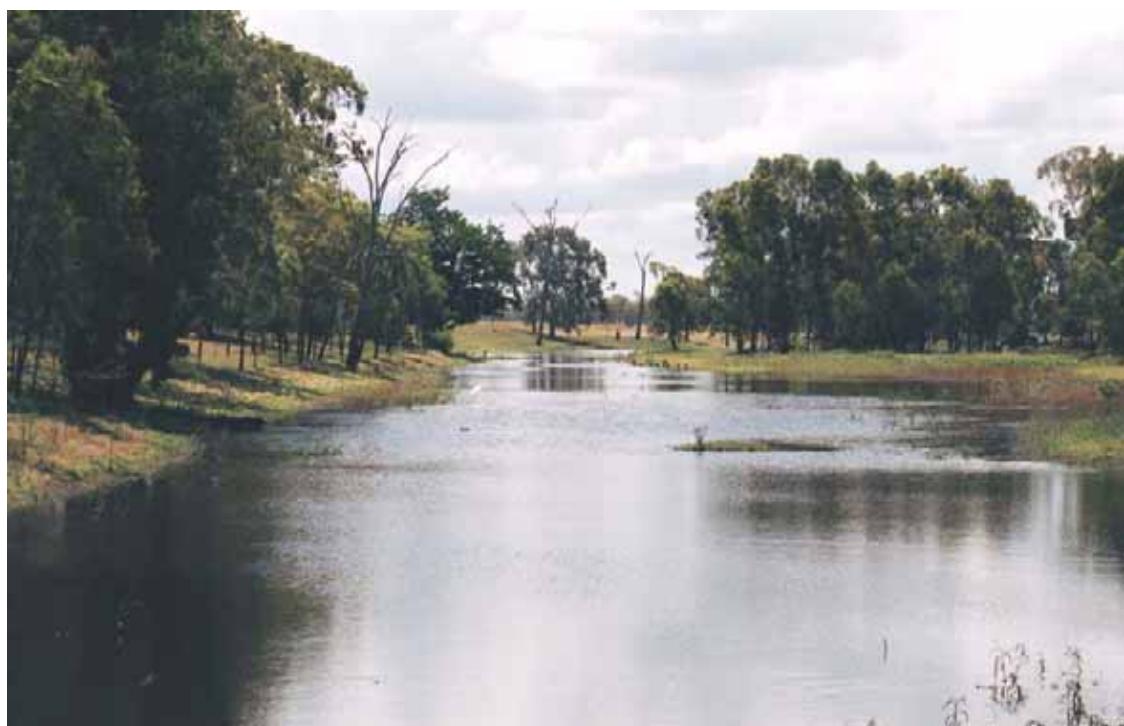
Figure 62: Woolwash Lagoon on the Fitzroy River floodplain

along a riparian section of Woolwash Lagoon. Para grass and other weed invasion of this section of the lagoon have been treated and infestation is now light. Cattle keep invasive grasses in check in other areas of these lagoons.

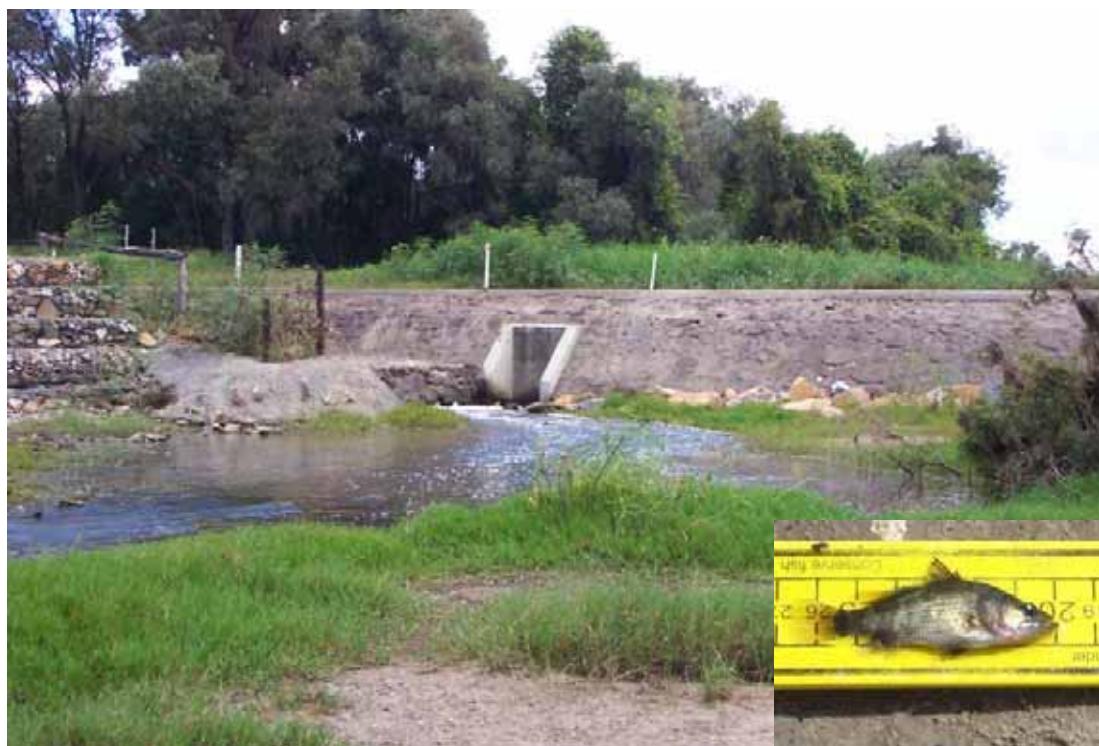
Figure 63: Bajool weir showing the overflow pipe on the downstream side
Inset: Juvenile barramundi of 67mm caught below the weir

8 Mile Creek has a range of in-stream habitat including some permanent and semi-permanent shallow pools from the tidal reaches upstream to the Bajool Weir, a distance of approximately two kilometres. Riparian vegetation along the creek is mostly sparse and disconnected however where present it provides an important contribution to habitat. The weir wall is part of the Port Alma Road and the dam supplies water to the nearby township of Bajool. The weir wall prevents further upstream access to fish except in periods of major flooding. Juvenile barramundi and other fish species can migrate upstream as far as the weir but when water stops flowing through the overflow pipe, they become

trapped in shallow ponds that dry up at its base (*figure 63*). This causes in regular fish kills of small fish trapped at the weir wall.

During a field inspection in early January 2004, a barramundi 67 mm long was caught and released below the weir. Further small barramundi were caught in the same location in the following weeks, while there was flow in the creek. Some of these barramundi were released upstream above the weir.

This creek is important for fisheries resources and consideration should be given to modifying the overflow arrangements so that fish passage can be restored. As the height of the wall is only around two metres and passage is only required on high flow conditions the fishway technology to deal with this is available. There is an opportunity for such works to be included in upgrade or maintenance plans for the road.

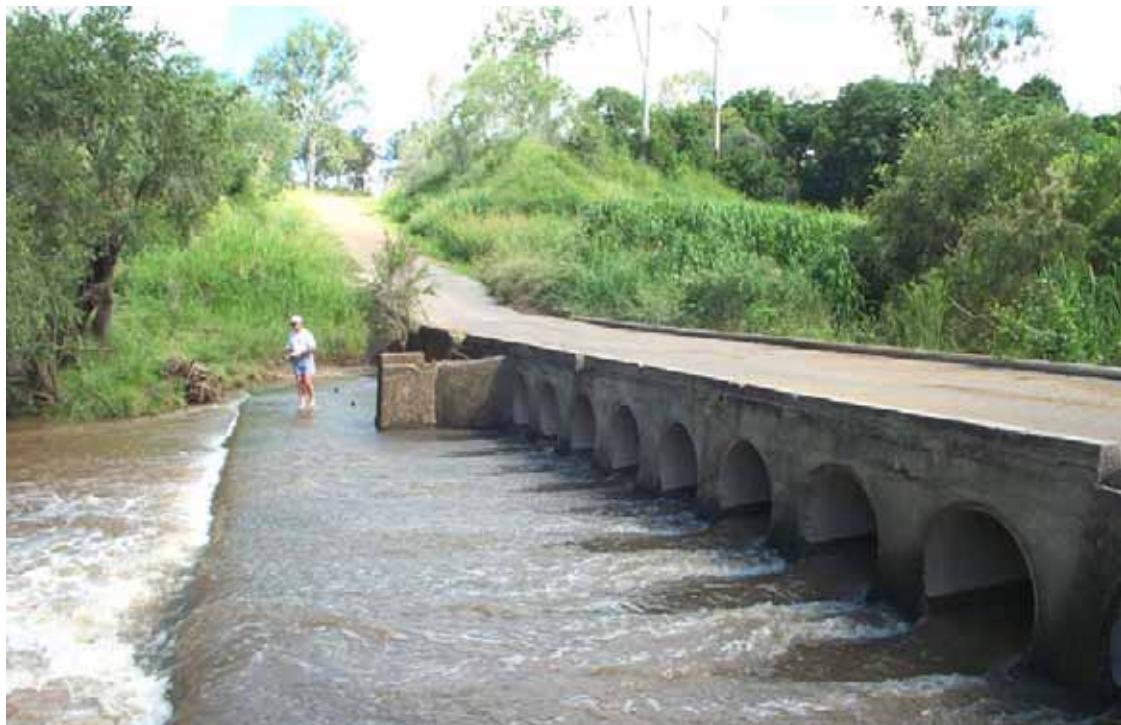
Fish passage, particularly upstream migration of barramundi to Blacks Hole, has been effectively stopped during low flow periods following the upgrading of an old wooden bridge to a culvert on Raglan Station Road in 2003 (*figure 66*). A

300mm drop in water level below the culvert now effectively prevents migration during low flows where previously fish were unimpeded in their upstream movement. Further upstream, the old highway culvert also presents a barrier to migration (*figure 67*).

Figure 66: The causeway on Raglan Creek during a flow event indicating obstacles to fish migration

Raglan Creek is one of the least impacted and more important wetland systems in the developed GBR catchment and should be considered for the development of a neighbourhood catchment plan to maintain and improve its habitat and fisheries values. Resolution of the fish passage issues is a priority.

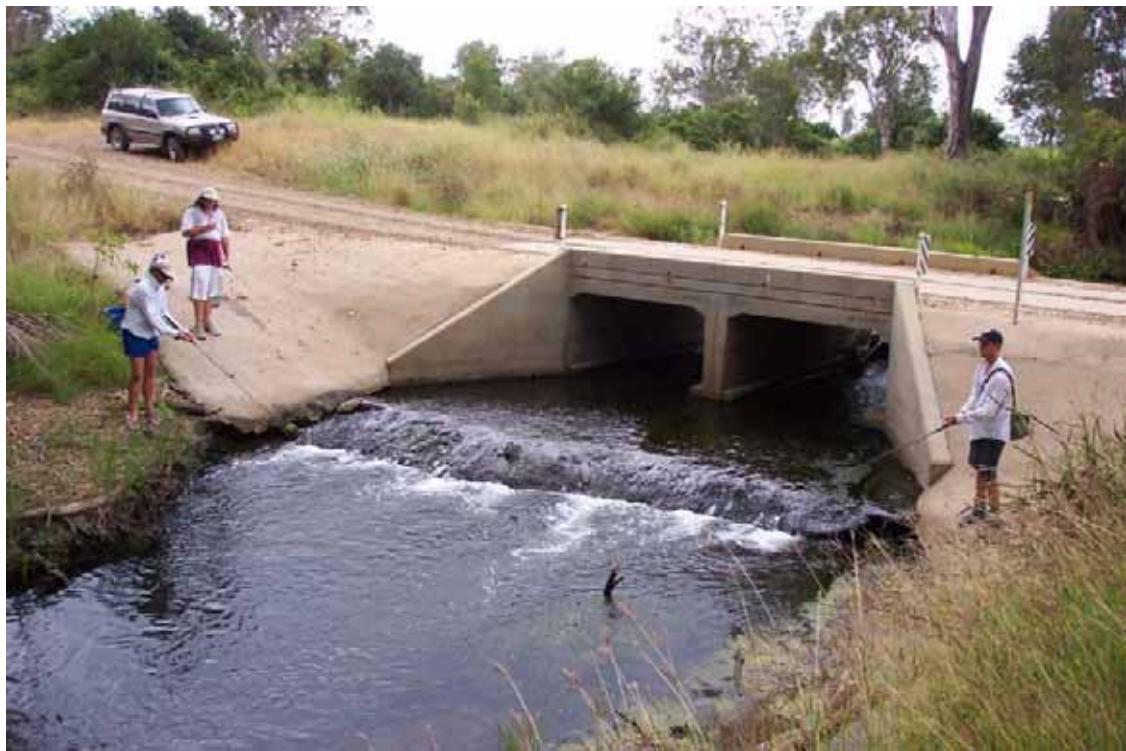
Figure 67: The culvert on Raglan Creek that now prevents upstream migration of juvenile barramundi

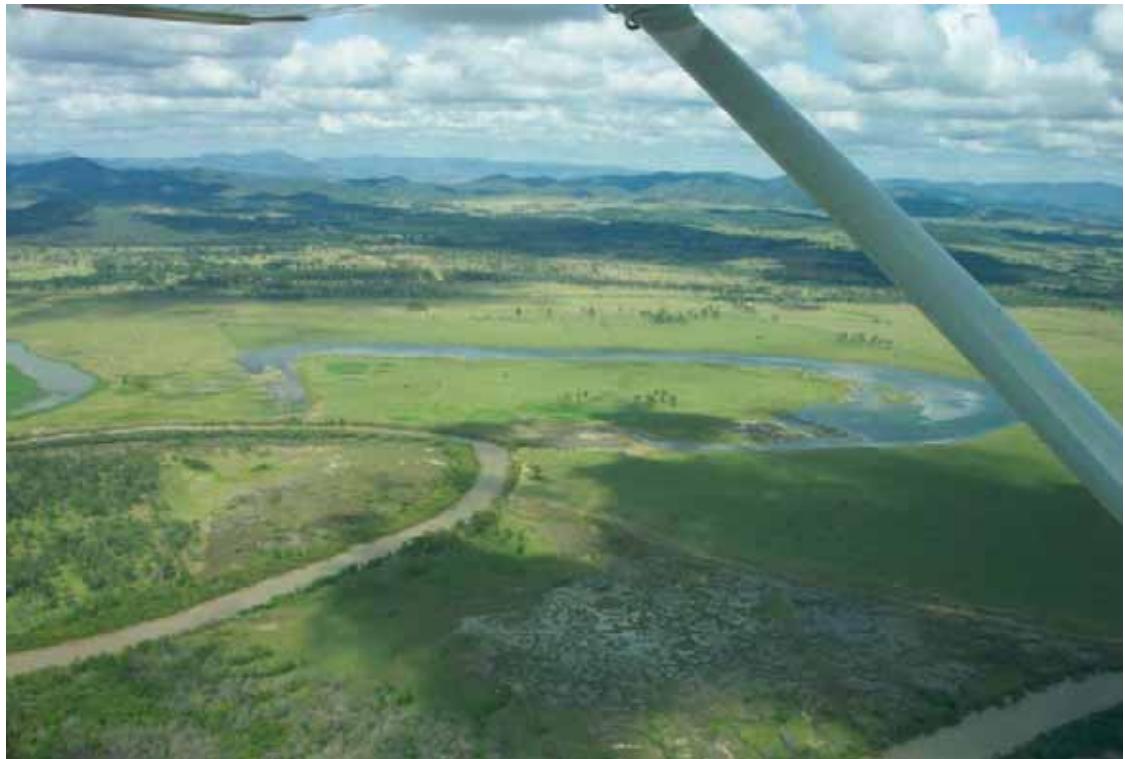
Figure 68: Pelican Lagoon adjacent to Raglan Creek showing the lack of riparian vegetation

Raglan Creek also has an off-stream freshwater to brackish wetland adjacent to the tidal reaches of the creek to the northwest of Raglan. Pelican Lagoon has good connectivity to Raglan Creek but it has no riparian vegetation and its water quality is unknown (*figure 68*). Local anecdotal information indicates that barramundi use this wetland but no investigation of its use by fish has been undertaken. The lagoon is located on private property.

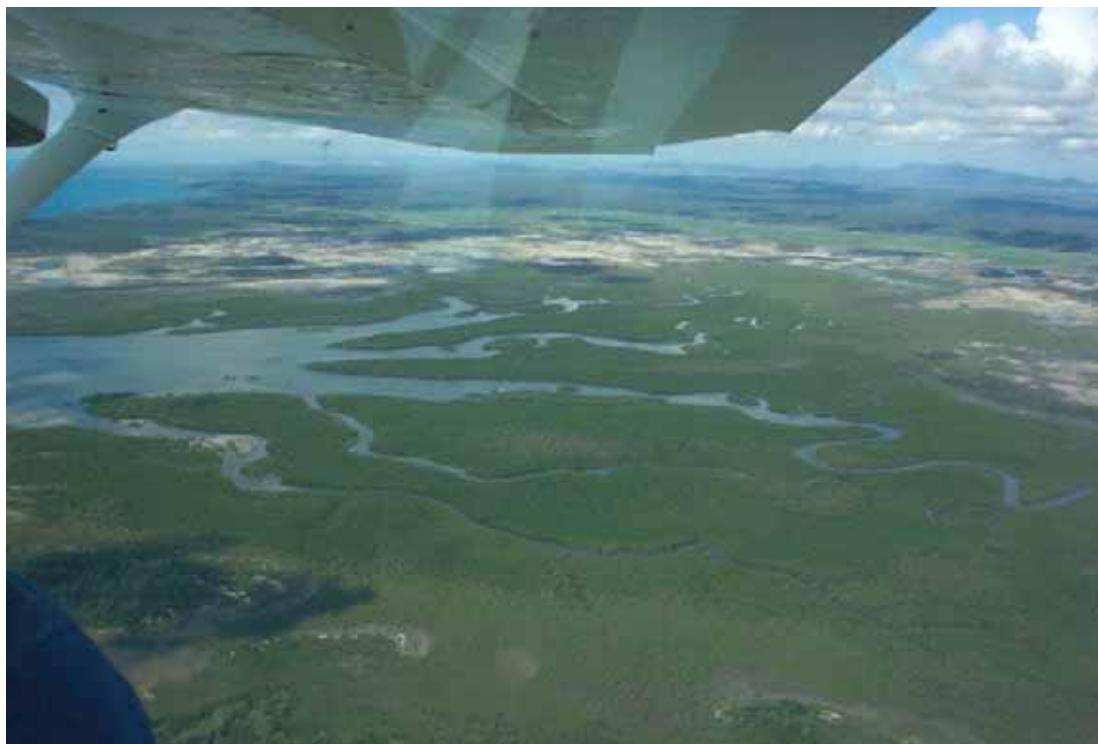
Figure 69: Aerial view of the extensive freshwater wetlands upstream from Yellow Patch on Curtis Island

An extensive wetland area exists at the northern end of Curtis Island that feeds into the Yellow Patch Creek system near Cape Capricorn. This wetland area has an old bund wall that was built to separate freshwater and saltwater areas of the wetland. This is an extensive grassed, mostly treeless wetland of about 30km² but it has little or no permanent freshwater and is not considered significant to fish (*pers comm. P Stoneley*) (*figure 69*).

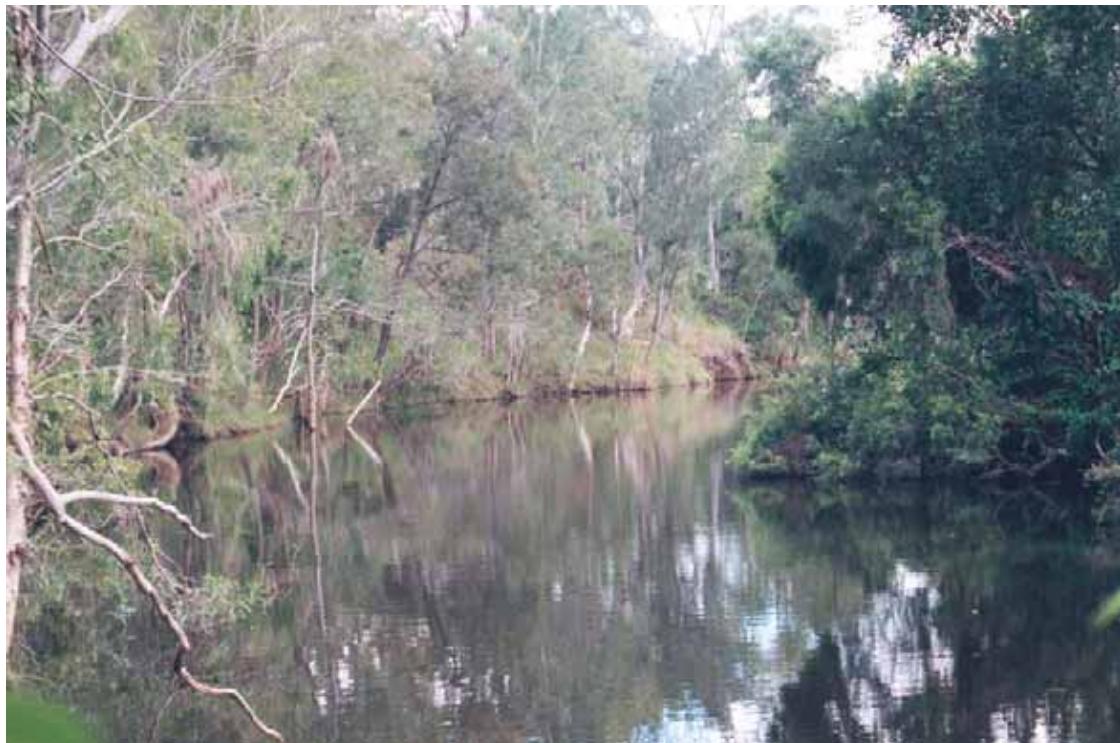
kilometres above the tidal limit (*figure 71*). Mullet have been observed in this waterhole and there is anecdotal evidence of juvenile barramundi (*pers comm.* P Stoneley). Upstream of the State Forest area the creek runs through grazing country that has been mostly cleared although there is a continuous narrow riparian vegetation strip within the banks of the creek. There are no permanent waterholes or wetlands above the State Forest area.

Figure 71: Near pristine in-stream freshwater lagoon on Munduran Creek

Water temperatures in the tidal lagoon are consistently higher than in similar adjacent creeks and can be high enough to restrict use by some species. The water temperature has been measured above 35°C regularly during summer months (Sawynok, 2002). There are no artificial barriers to prevent migration and the area is protected by its present land tenure. Some rubber vine exists along the creek but weed levels are generally low and the only impact is from sediment run-off from dirt roads in the area. Although saltwater stretches of Munduran Creek are monitored regularly by Capricorn Sunfish, no monitoring has been undertaken above the tidal limit. The Coastal CRC will begin monitoring the creek for fisheries resources in a current project.
