#### 11.1.10.1 Mandam Wetlands

#### **11.1.10.2 Seymour River and Ripple Creek Sump**

## **11.2. Townsville Region**

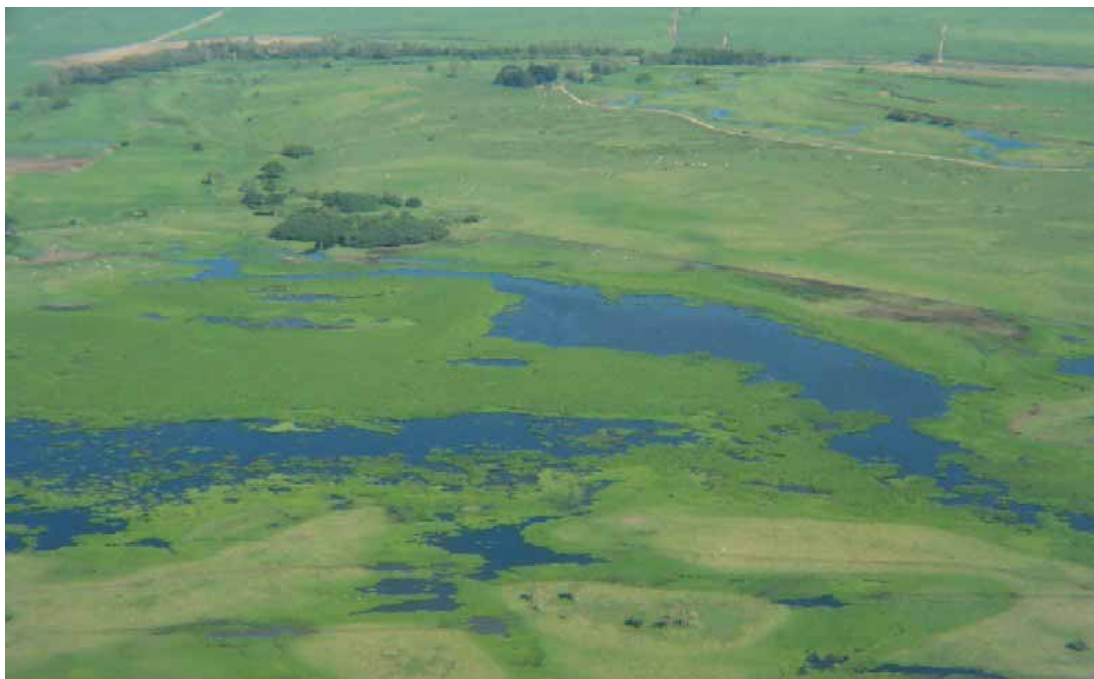
Figure 28: Part of Mungulla wetlands on the Herbert River floodplain showing lack of riparian vegetation

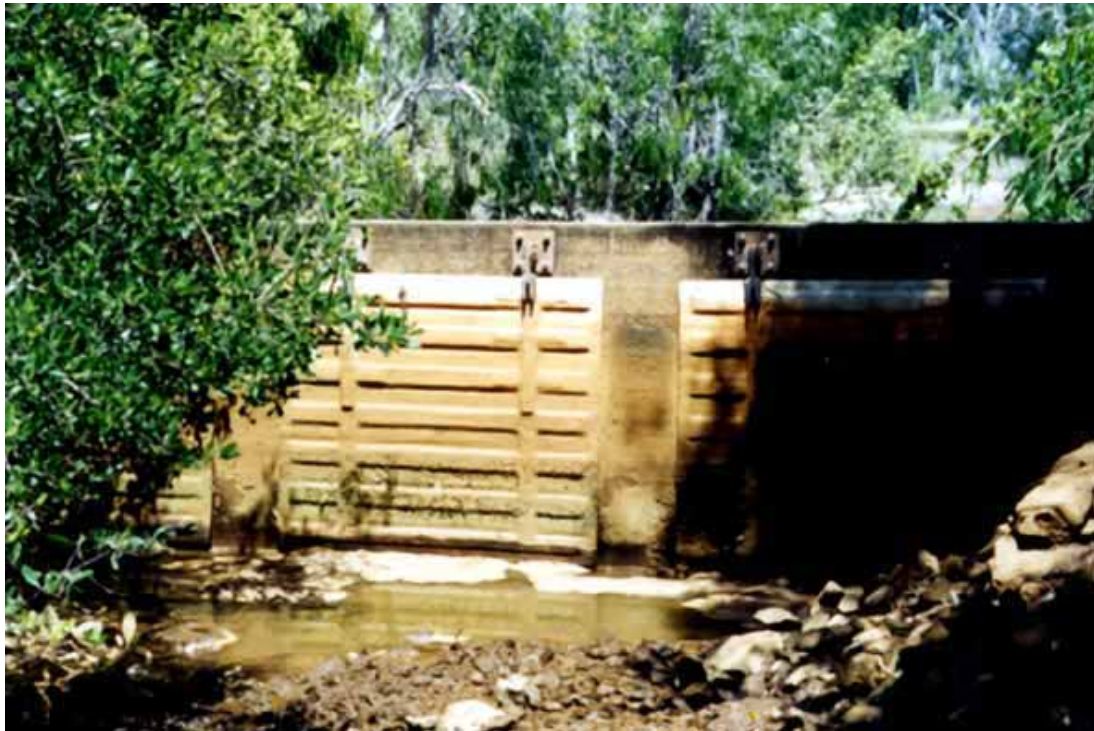
The Mandam wetlands are impacted with artificial flow paths cut through the mangroves that resulted in disturbance of ASS; tide gates increase the impacts of this disturbance (Sammutt et al, 1994, 1996; White et al, 1996) (*figure 29*). While some areas close to the coast remain in good condition (Blackman et al, 1999) they are connected to tidal areas through farm drains that are potential barriers due to water quality issues.

Figure 29: Floodgates preventing tidal intrusion on Mandam wetlands

While works are being undertaken on this catchment through the SIIP, restoration of these wetlands to improve fishery productivity would be costly and should be considered lower priority in this district compared to less affected wetlands.

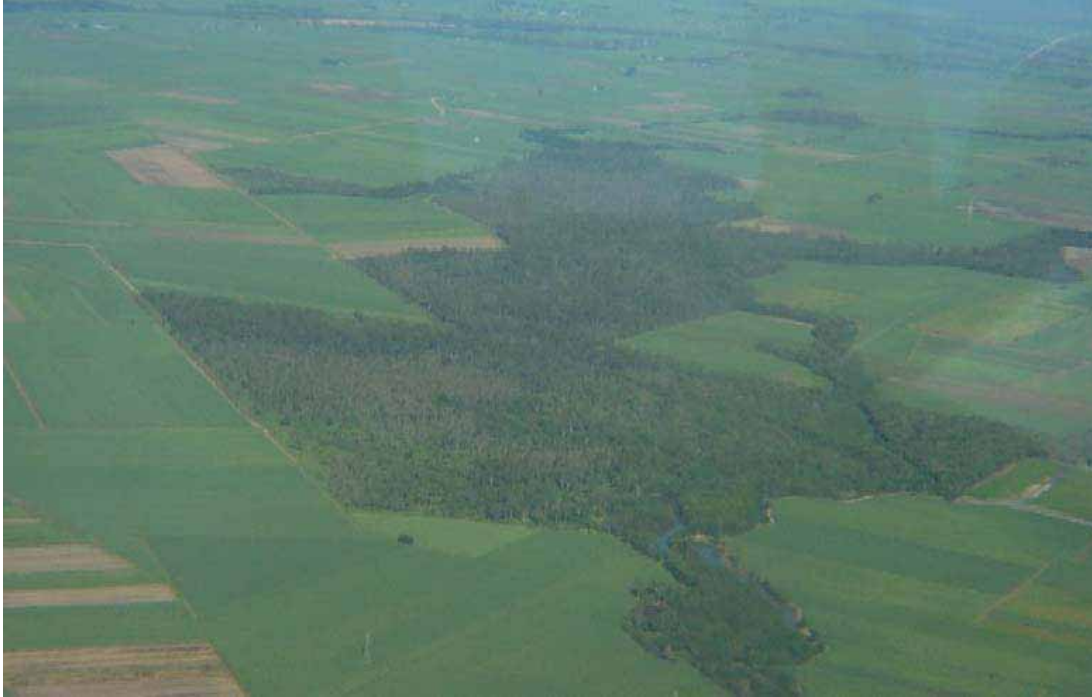
Figure 30: Ripple Creek sump

Ripple Creek Sump (*figures 30 and 31*) is still a valuable and significant wetland but floodgates approximately 100 metres upstream from its present junction with the Herbert River reduce its value to fish. In addition, recent works by an adjacent landholder appear to have intersected a shallow aquifer that in the past has leached fine sediments into the sump. Recent sampling of Ripple Creek Sump has shown improved water quality but this may not be representative due to the recent drought and further monitoring needs to be undertaken during and following wet periods to assess the impacts of these works.

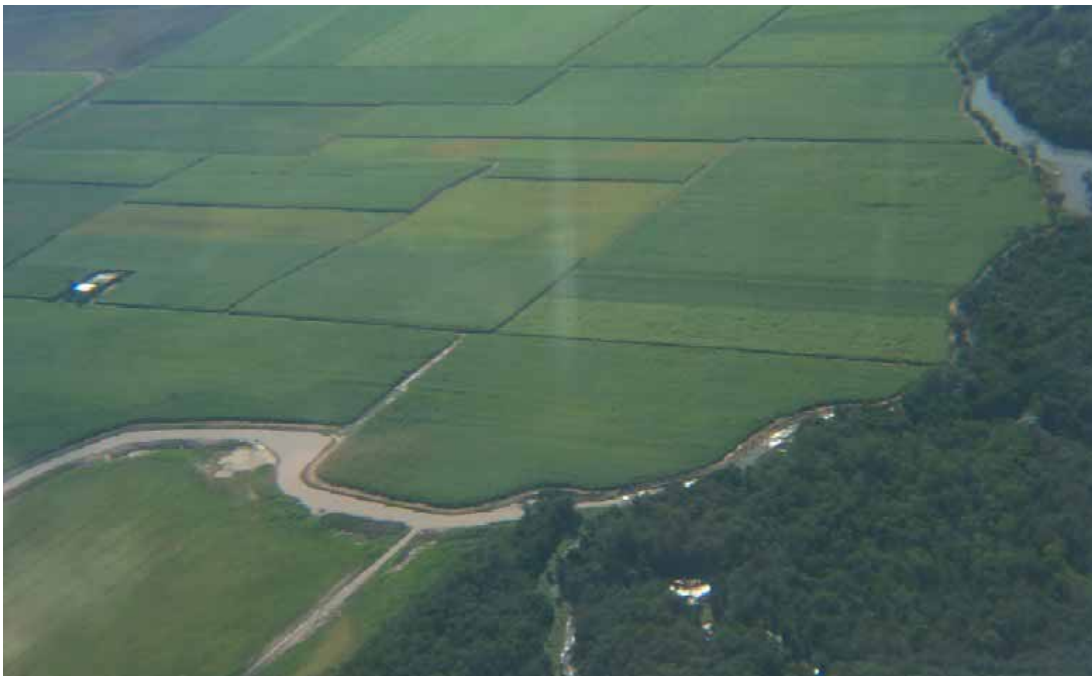
Figure 31: Ripple Creek sump at top right and farm detention area at middle left after moderate rainfall.

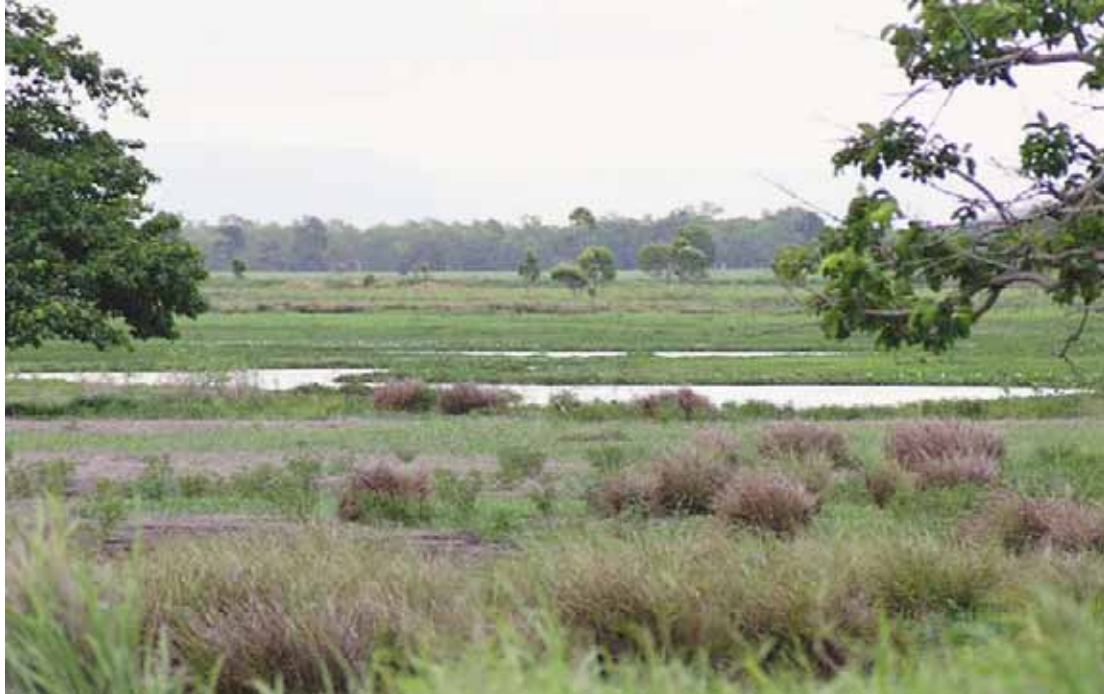
Figure 32: Cattle Creek wetlands

The development of the Pomona area in the early 1990's has substantially impacted on the fishery values of Cattle Creek. Since then, sediment and nutrient runoff, irrigation from adjacent aquifers and levy construction for flood mitigation have impacted heavily on both the habitat quality and water quality. The fish habitat values of wetlands are significantly impacted by hydrological changes (Johnson *et al*, 1997) in this area.

A small range of fish species still survive in low numbers but Cattle Creek is no longer considered significant to fishery resources. Sampling of water quality undertaken for assessment for fish stocking showed Cattle Creek to have chronic oxygen depletion (Hogan and Vallance, 1999). Invasive weeds, particularly water hyacinth and hymenacne, have choked the wetland in recent years significantly reducing its value as a fishery resource. Ironically, the preferred method of weed control in the Herbert Valley (herbicide spraying) (*pers comm.* V Vitale) may be compounding the problem by leaving the dead weeds in situ as well as providing another threat to fish through poisoning.

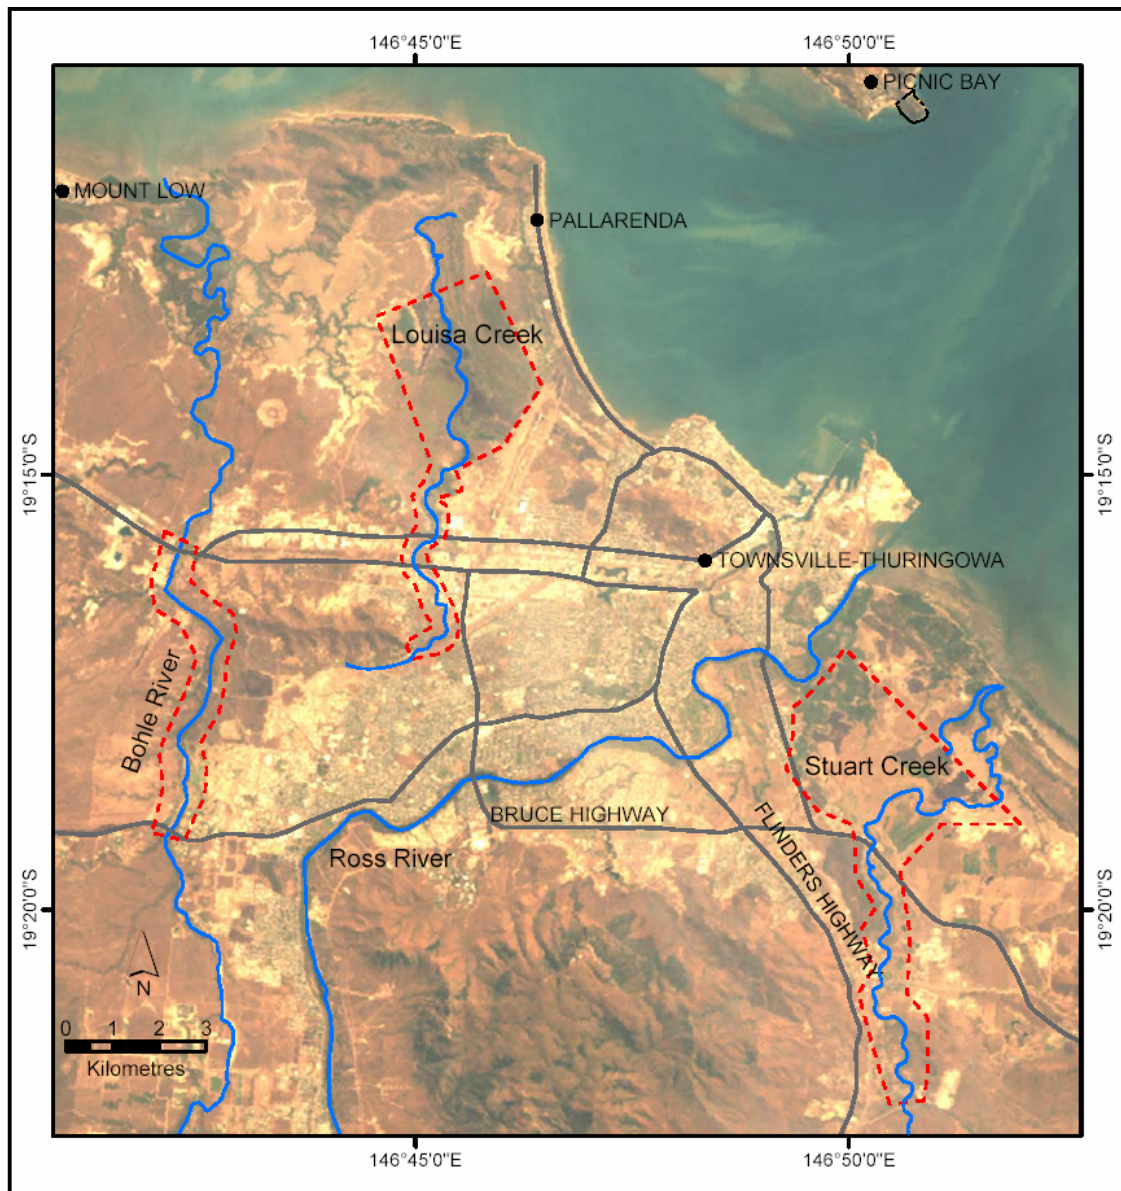
Figure 33: Wetlands on waterways in the vicinity of Townsville

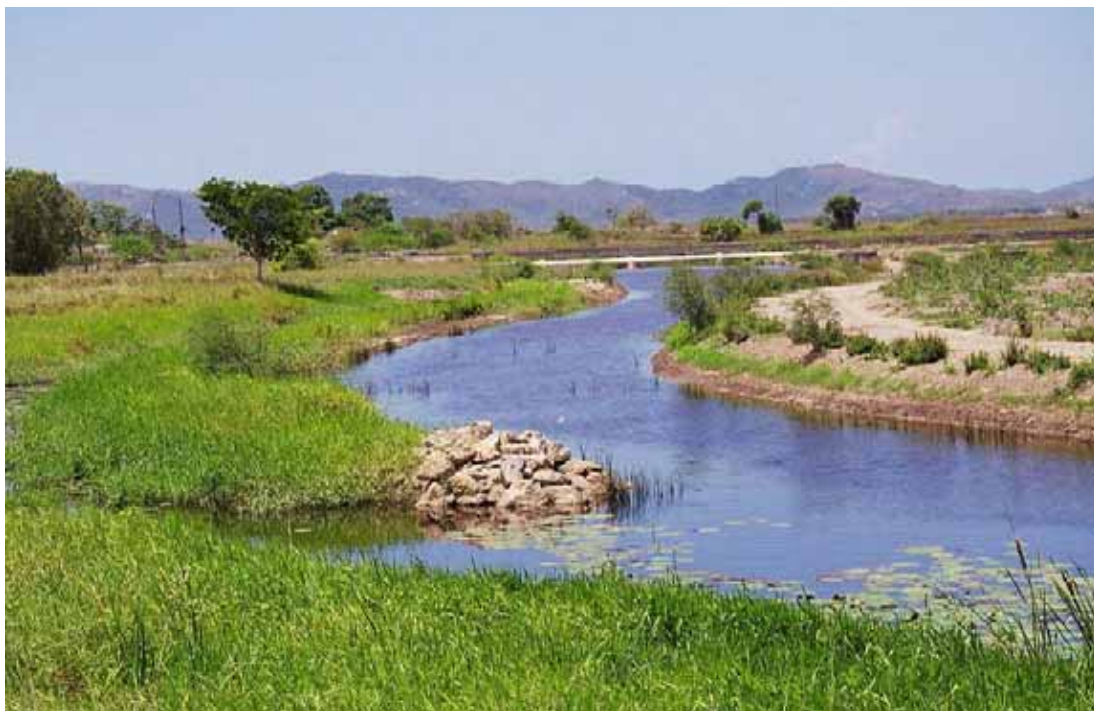
potential without further major works to address water quality and connectivity issues in the remainder of the catchment. The upper reaches of Louisa Creek have heavy infestations of introduced weeds, particularly singapore daisy and chinee apple (*pers comm.* S McDermott). Nutrient runoff from adjacent residential properties exacerbates the weed growth and leads to exotic aquatic plant outbreaks and algal blooms (Lukacs, 1996). As a result, the upper reaches suffer from chronic depletion of dissolved oxygen in the water (*pers comm.* D Reid). Further downstream, para grass and other invasive weeds choke the waterway at a number of sites and provide effective barriers to fish migration.

Figure 34: Middle reaches of Louisa Creek

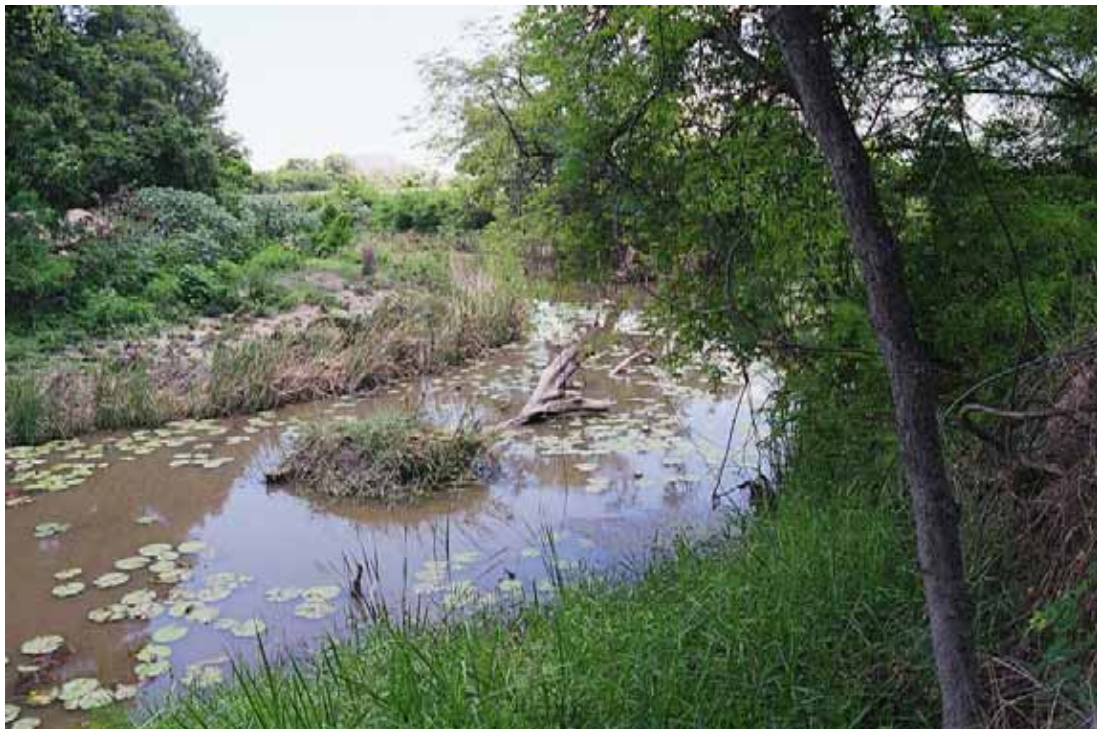
Stuart Creek is a distributary system on the floodplain. Below the Bruce Highway it becomes indistinct and has numerous flow paths. There is a network of small freshwater wetlands (*figure 35*) above the tidal limit with some including Stuart Creek above the highway maintaining permanent deep water areas that are refuges for many species.

Figure 35: In-stream freshwater pool on Stuart Creek
