11.2.5. Burdekin River Floodplain

11.2.5.1 Haughton River and Cromarty wetlands

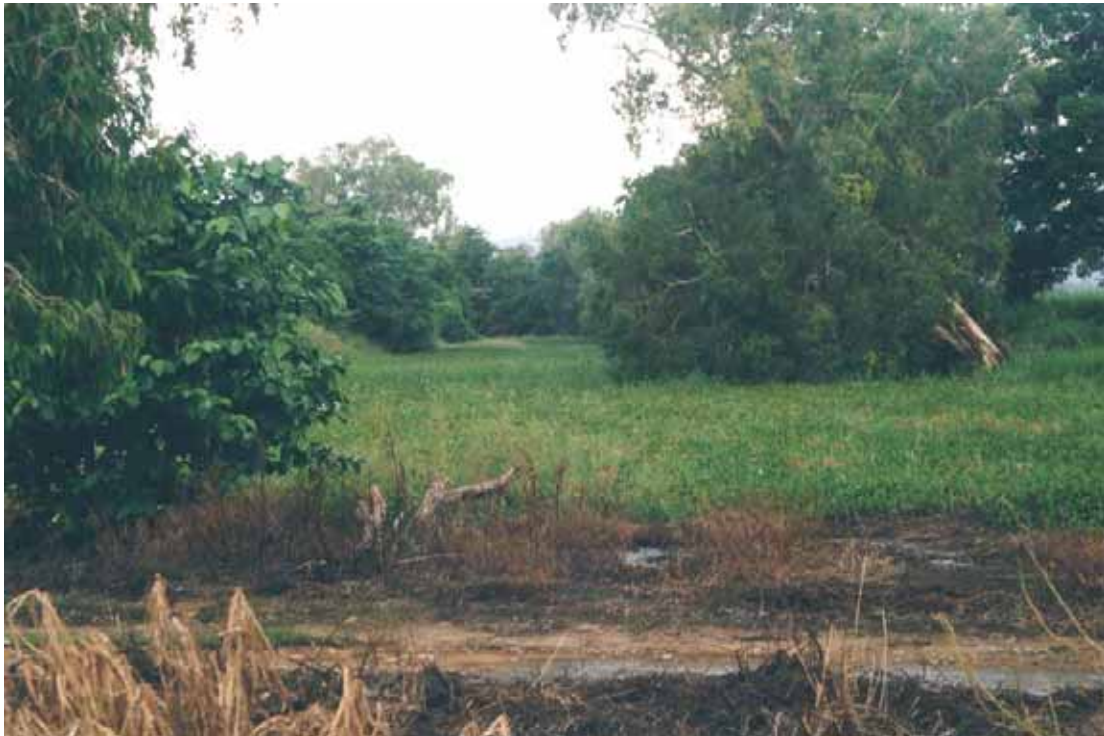
The Haughton River has large lagoons on both sides of the river. To the west, the Ironbark Creek network flows through two significant lagoons before draining into the tidal Cromarty Creek (*figure 36*). Healey Lagoon is approximately five kilometres long but narrow, averaging less than 35 metres width. It is heavily impacted by introduced aquatic plants including water hyacinth and pistia and introduced pasture grasses including para grass and hymenacne (*figure 37*).

Figure 37: Healey Lagoon covered in water hyacinth, pistia and other aquatic weeds (Oct 2004)

An inspection in January 2004 noted toxic smells of hydrogen sulfide coming from the water, probably as a result of the northern end of the lagoon being choked with aquatic weeds on the surface with dead rotting weeds beneath. This has been recorded previously (Burrows, 1998). It is likely that this water was toxic to fish. It was overflowing from Healey Lagoon downstream into the Reed

Beds Lagoon (see below). In the past, Healey Lagoon was a significant resource for at least 20 species of native fish such as barramundi (Burrows, 1998) but weed infestation and resulting poor water quality may limit its current value.

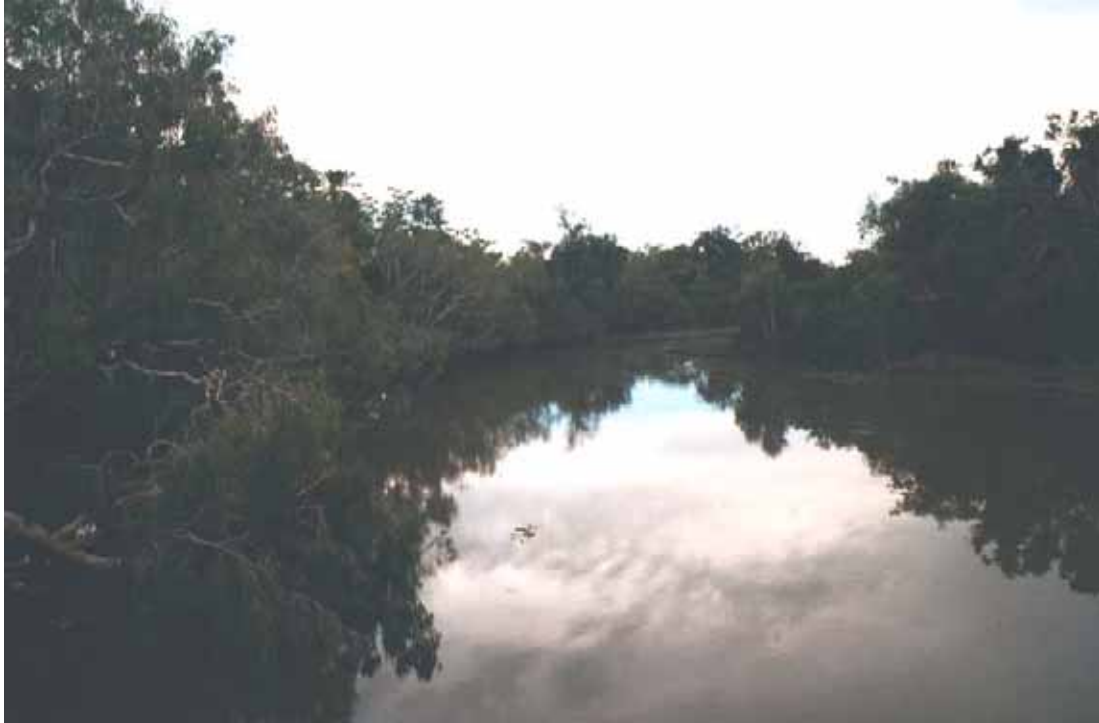
The Barratta Creek system (*figure 38*) is an overflow system for both the Burdekin and Haughton rivers. In its natural state, Barratta Creek was once a series of isolated in-stream lagoons that were connected during flooding. It is now used as an irrigation and tail-water canal and runs perennially with the associated concerns that this can have on fish migration and spawning (White and O'Brien, 1999). Barratta Creek is the healthiest system still remaining in the Burdekin District. It has relatively wide riparian vegetation for most of its length and pockets of land adjacent to the creek have been reserved as habitat areas. In the mid 1990's, Barratta Creek suffered from unacceptably high nutrient loads (Congdon and Lukacs, 1996). Recent improvements in Sunwater's channel flow management to reduce nutrient loads have resulted in a reduction of algae and aquatic weeds (*pers comm.* J Tait) whilst providing benefits to farmers with water and sediment recycling.

Figure 38: Freshwater lagoon on Barratta Creek

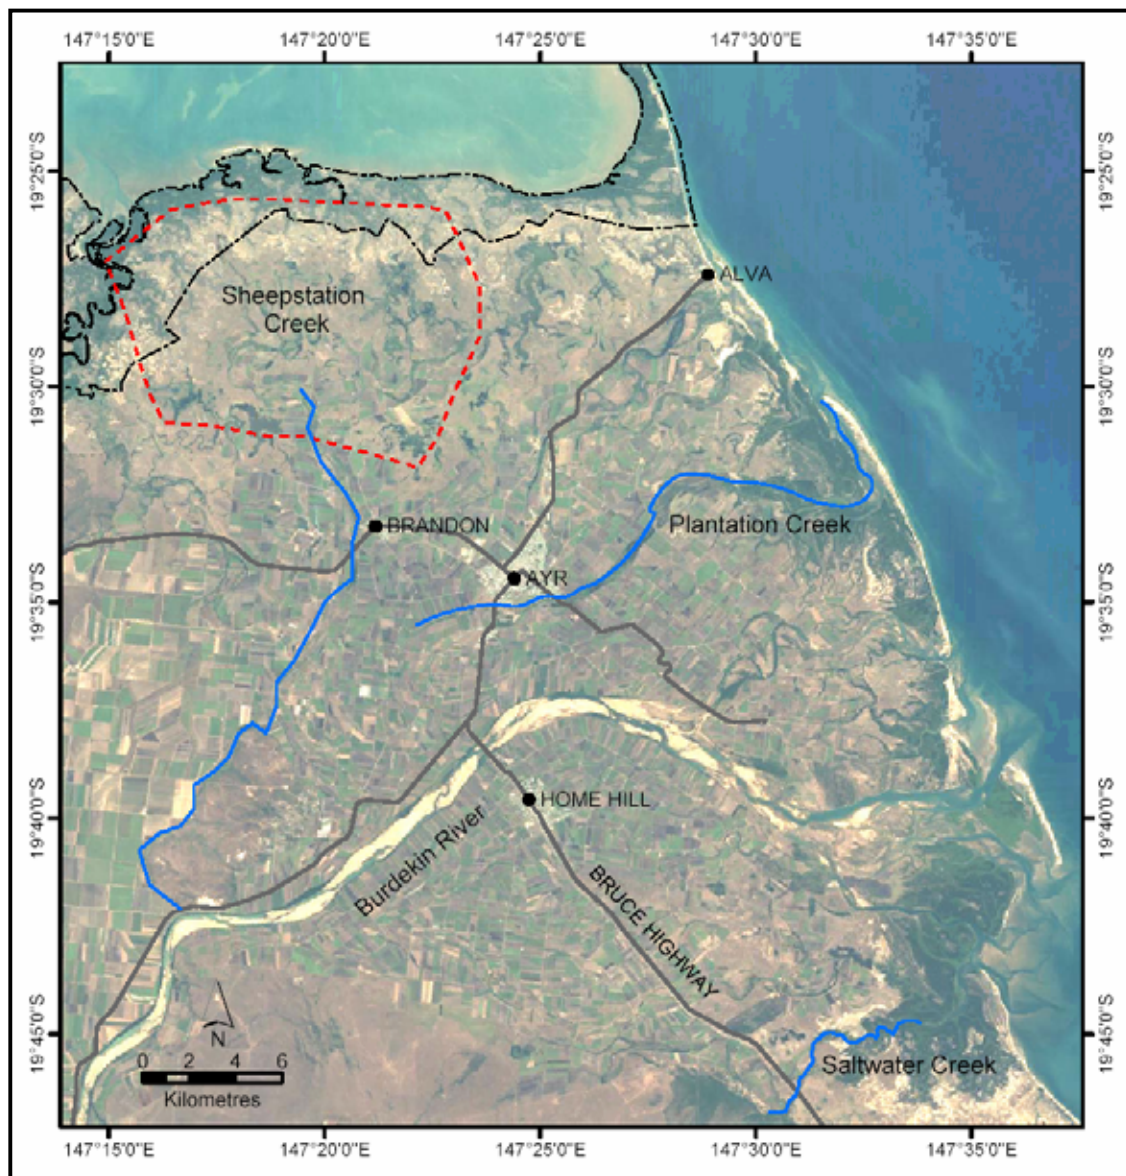
Sheepstation Creek (*figure 39*) remains one of the major overflow paths for the Burdekin River in flood events that occur, on average, once every 20 years. Sheepstation Creek has a series of deepwater lagoons that are now permanently used as irrigation canals and aquifer recharge pits. In their natural state, these lagoons had significant depth fluctuations and some have been observed almost dry during droughts prior to water diversion from the Burdekin River. The network of wetlands includes at least eight lagoons between 500 metres and two kilometres long and up to 100 metres wide with numerous smaller lagoons. In the past, this entire network held the full diversity of native fish that could be found in this type of habitat but various factors now restrict a number of species from using this system.

Figure 39: Burdekin River floodplain and associated wetlands

The Stokes Range restricts the Burdekin River overflow paths to the east and south. There are a few small wetlands upstream of the range on Cassidy Creek but their fishery values are unknown. Saltwater Creek is the main flood flow path on the south side (*figure 39*) of the river when it breaks its banks in the vicinity of The Rocks.

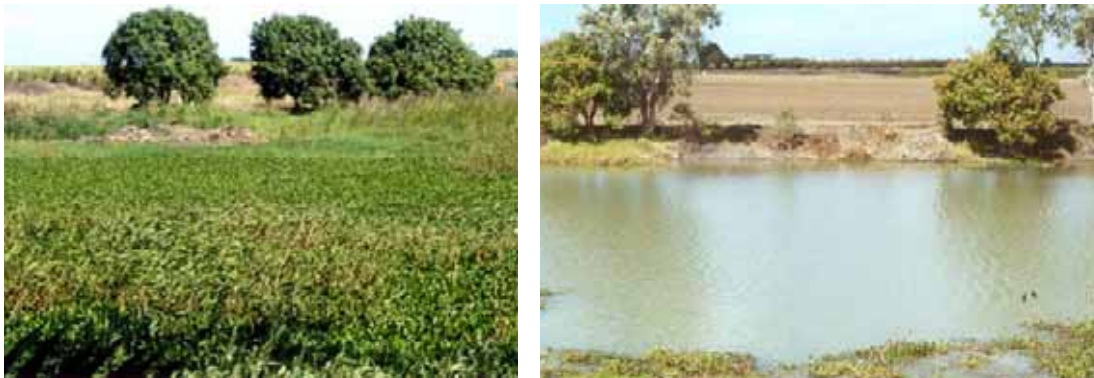
Until 1999, these wetlands had been allowed to degrade to weed infested swamps that could not sustain most native fish. Despite being metres deep, weed infestations were so thick that it appeared there was no water at all (*figure 40*). A commitment by the community and support by the Queensland Government resulted in a weed harvester being trialled on Payard's Lagoon. The trial was so successful that the Queensland Government subsequently purchased a machine for use in the district (*figure 41*). This was a very successful initiative and there is now continual improvement to the health of wetlands throughout the Burdekin floodplain. Despite this, weed control will be needed in perpetuity on the Burdekin floodplain and an ongoing commitment is required to ensure that these wetlands do not return to a degraded condition.

Figure 40: Before and after water hyacinth harvesting on Payard Lagoon

The removal of weeds brought about an almost immediate improvement in oxygen content of the water, and within days, bird populations on the wetlands had increased and diversified (*figure 40, 41*). Fish species diversity improved over a period of about seven months and continues to improve (Perna, 2003). Despite the improvements in water quality the system continues to be restricted from a fishery perspective due to physical barriers.

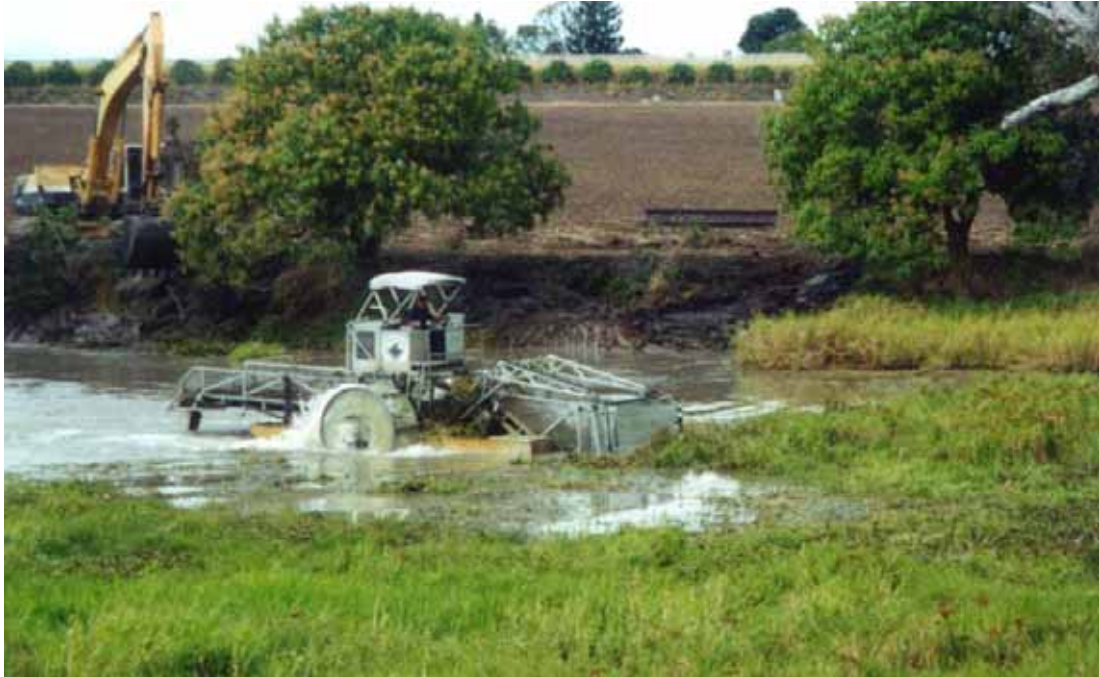
Figure 41: Aquatic weed harvester on Payard Lagoon

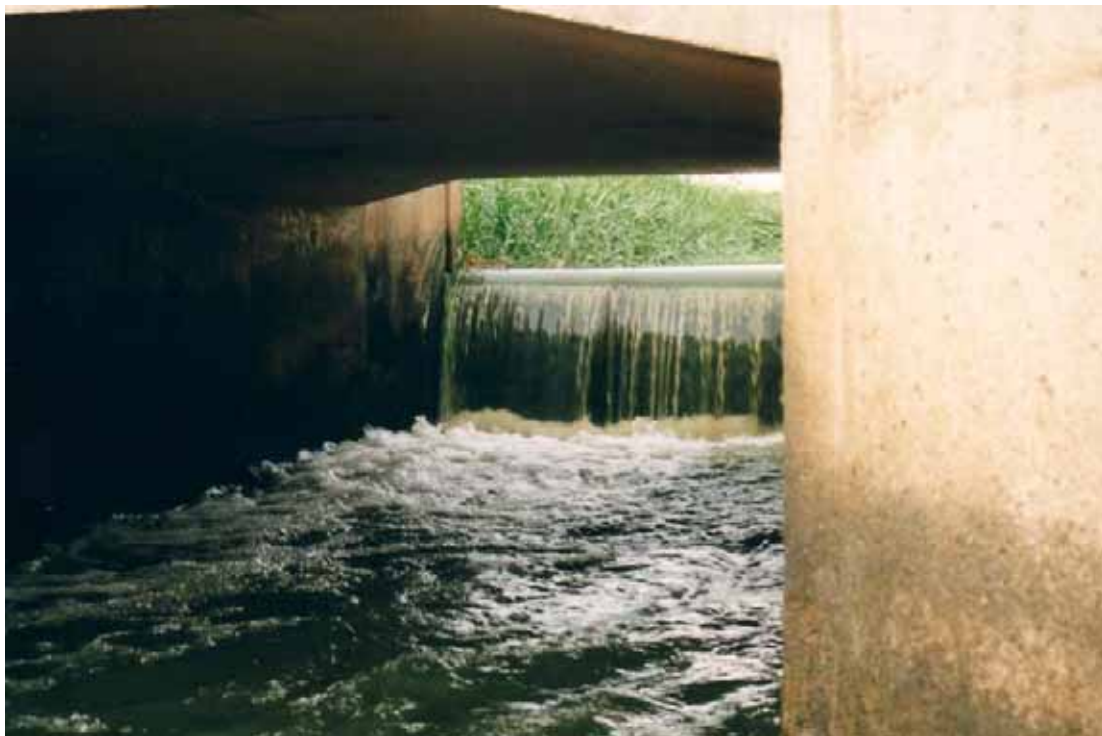
The Sheepstation Creek lagoons are connected by a series of irrigation channels. Long, narrow channels have water running on average at significantly more than 0.3 metres per second and are not conducive to fish migration as most native fish cannot sustain this swimming speed (Clague, 1991; *pers comm.* A Hogan). In addition, there are significant barriers to migration in the form of drop boards that, although less than a metre high, in most cases prevent fish migration (White and O'Brien, 1999) except during major floods.

Figure 42: Drop boards on Sheepstation Creek that prevent fish migration except in flooding

For the Sheepstation Creek wetlands to again become significant to coastal fishery resources, a system of fish passage devices will need to be designed and installed. While passage at drop boards could be achieved simply (*figure 42*), improving fish migration opportunities in the irrigation channels that join the lagoons may be more difficult.
