DOUGLAS SHOAL REMEDICATION PROJECT

Sediment Sampling Field Report

June 2019

Report No: 301001-02112-EN-REP-0001 - Sediment Sampling Field Report

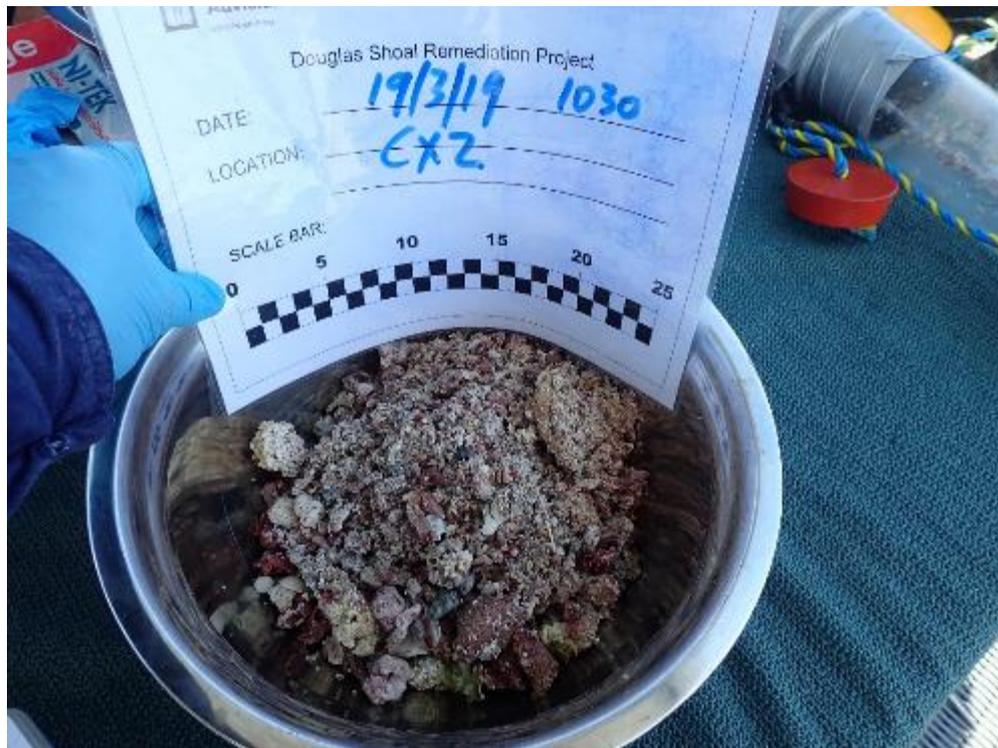
Figure 2-13 Sediment log sheet with unmixed sample from sample site CX-2

4. The sample would be carefully tipped into a large clean stainless-steel mixing bowl and the sampling tube set aside.
5. Prior to mixing, a site-specific sediment sampling sheet with a measurement scale and which is marked with the sample identification, date and time is placed in the mixing bowl with the sediment and a photo is taken of the sheet and sample. The sheet is removed, and two more photos are taken to form the sediment log.

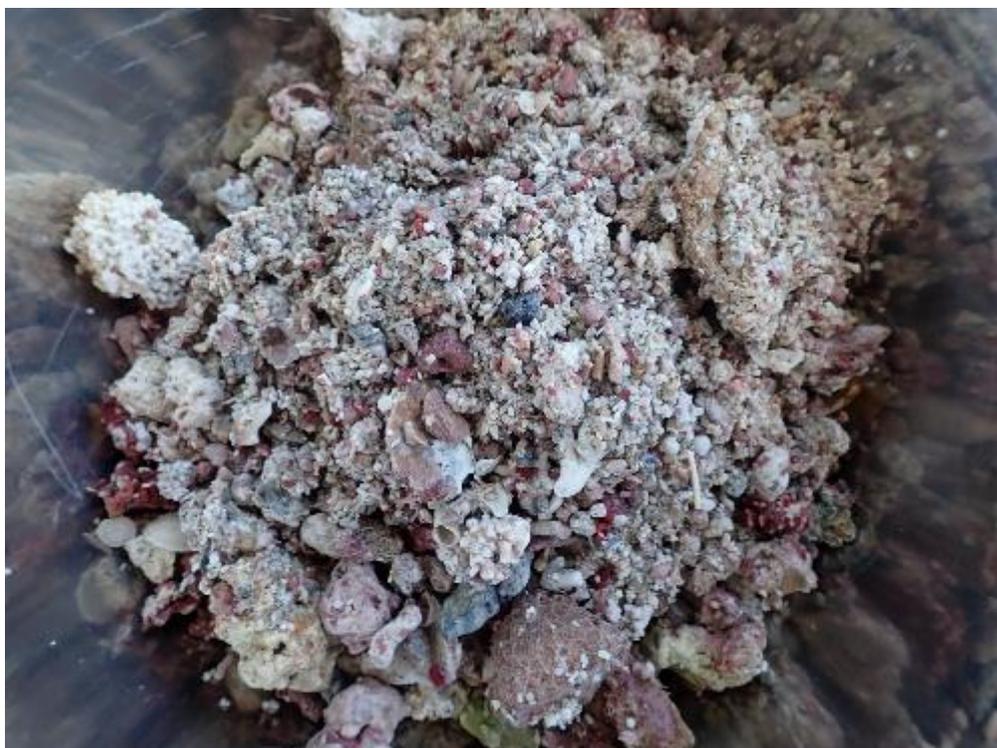
Figure 2-14 Close up of sediment sample in the mixing bowl from site CX-2

- b. The sediment samples were processed on board the support vessel by an experienced Advisian staff member. The sediment from each site was placed in an uncontaminated stainless-steel bowl and mixed thoroughly using a clean stainless-steel or plastic spoon. Sediment samples for tributyltin (TBT), Zineb and metals were then placed into appropriate jars.

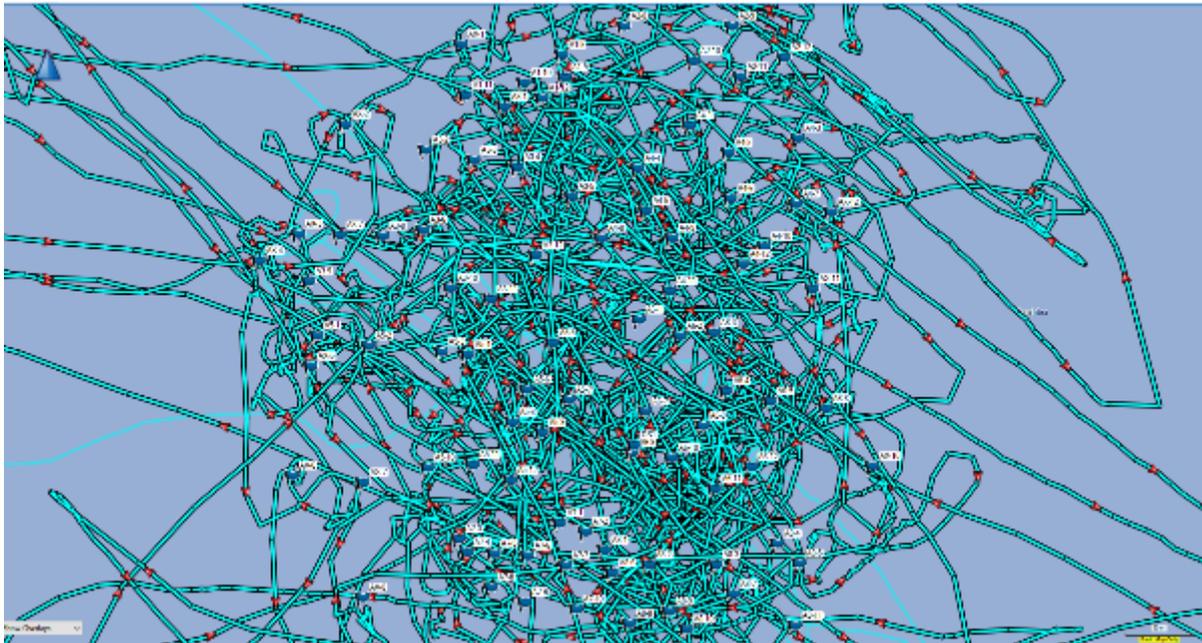
Figure 2-20 Example of the GPS tracks in Priority Area A for the Brynda

During the 12 days of work at Douglas Shoal the work vessels covered approximately 100 kilometres per day each (a total of >1200km over 12 days) which included travelling to and from the shoal and manoeuvring to each site for diver drop off and pick up. An example of vessel tracks in Priority Area A is provided in Figure 2-20.

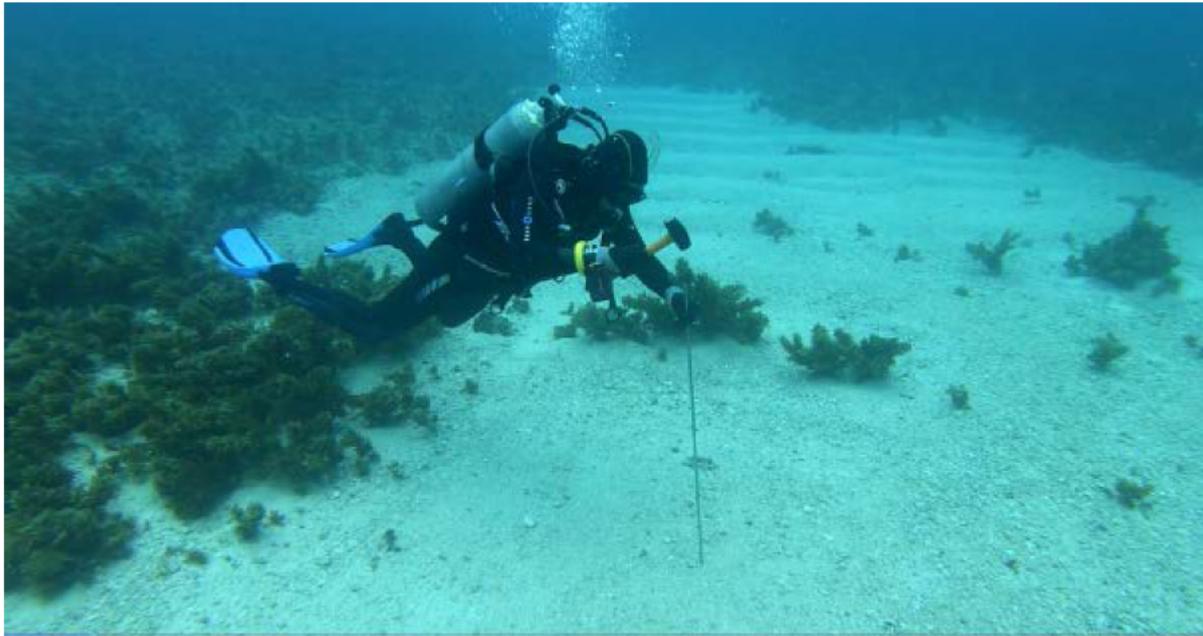
Figure 2-21 Diver hammering in scaled stainless steel rod in Priority Area F to measure sediment depths

The method used to measure the depth of the sediments involved the diver hammering a scaled (5cm scale) stainless steel rod into the seafloor at five random locations within 10m of each sediment collection site (Figure 2-21).

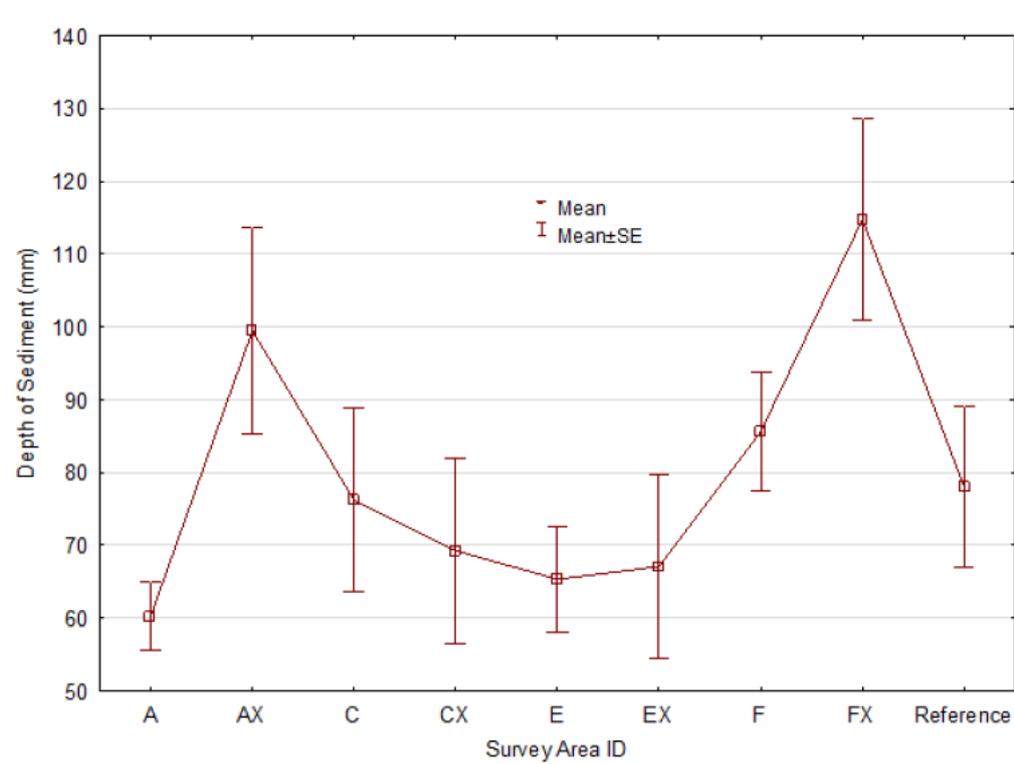
Figure 2-22 Graphical representation of the mean depths of sediments (mm) in each sampling area

The depth of sediment at each of the sampling sites ranged from 5mm to 400mm, averaging 73mm across all sites (Table 2-7 and Figure 2-22). The areas AX and FX contained the deepest sediments, averaging 99.5mm and 114.8mm, respectively. The sampling sites in these areas were located outside of a priority area, and in some cases in deeper water. The sediment depths may be greater at these sites due to the lower energy environment found in the deeper water which may allow for more settlement.

Of the areas sampled, Priority Area A had the shallowest sediments. This may reflect the structure and location of the area. This site is the most uniform of the priority areas in terms of seafloor structure and is the most exposed of the priority areas in terms of prevailing winds and swell. This may cause resuspension of sediments rather than the accumulation at this location.

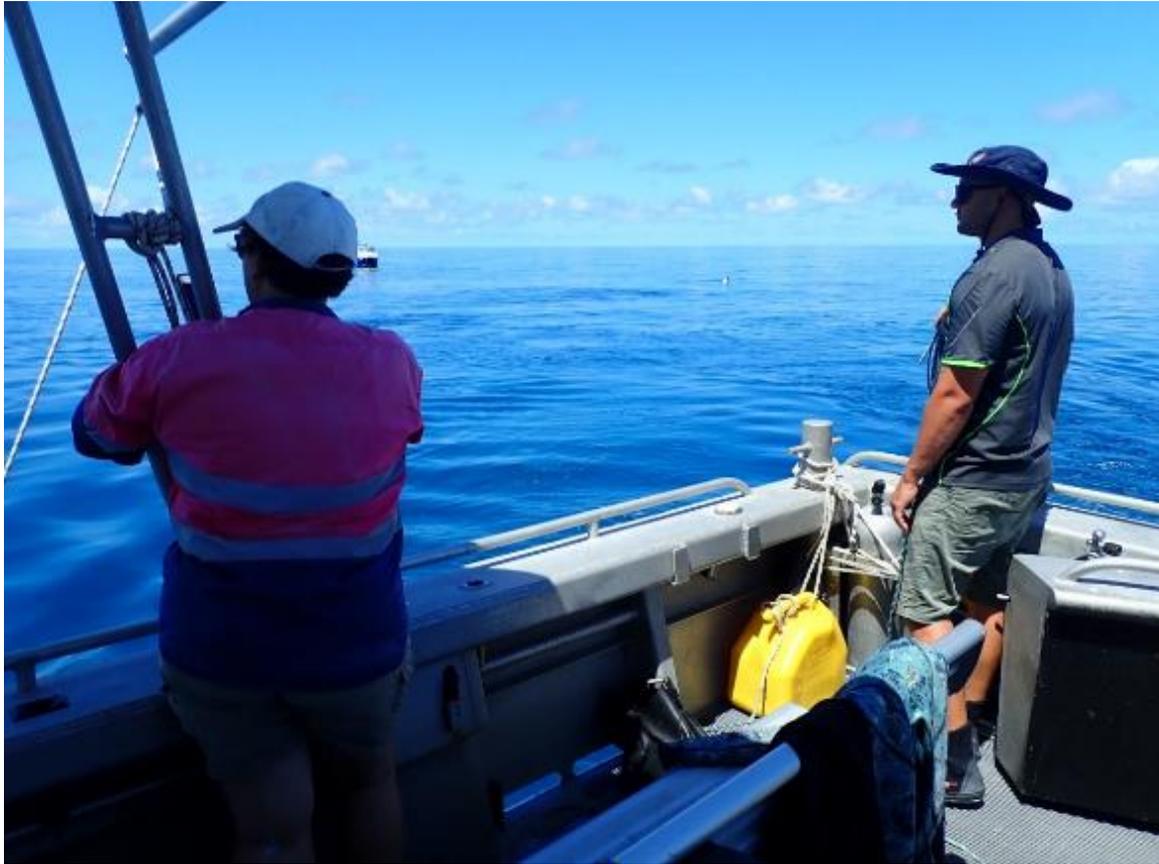
Figure 2-23 Calm weather on Day 13 of the field trip

During the 12 days on site at Douglas Shoal 13 vessels were sighted within 2km of the diving operations. Many of the vessels were less than 10m in length and were either drift fishing or spearfishing. The weather during this period was exceptional – predominately 10kts wind and less than 0.5m (Figure 2-23) swell which meant the 40-60km distance from the mainland to the Shoal was easily traversed by most vessels. No low-level aircraft were observed flying over the shoal.

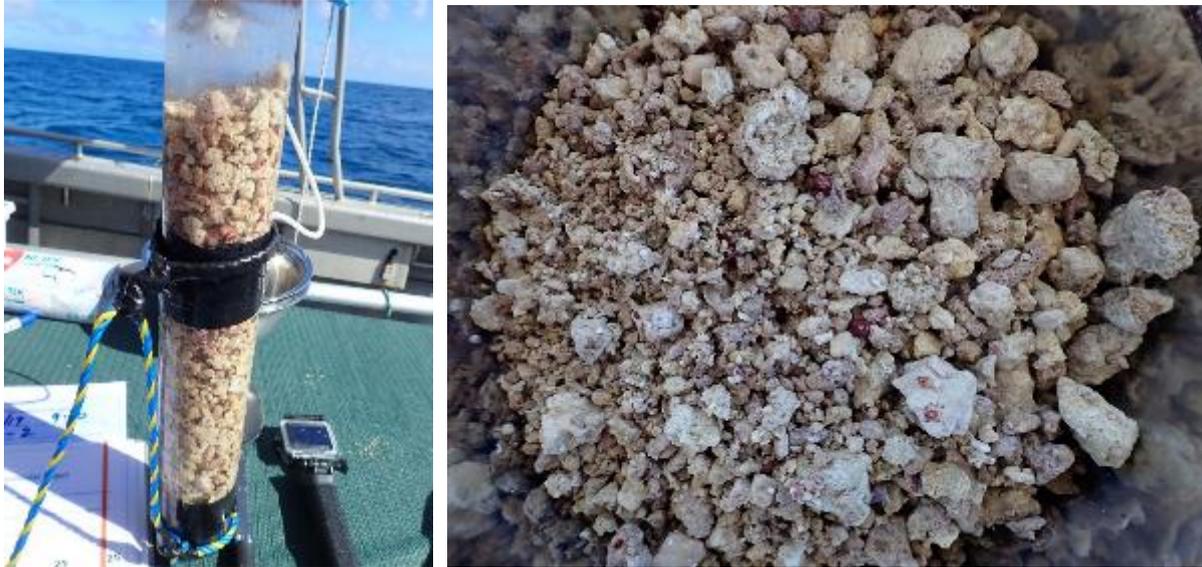
Figure 2-24 Sediment collected from Site A6-2 in Priority Area A (sampling tube (left) mixing bowl (right))

An example of the angular rubble found at the initial grounding sites in Priority Area A is provided in Figure 2-24, which is typical of the rubble found in the grounding areas.

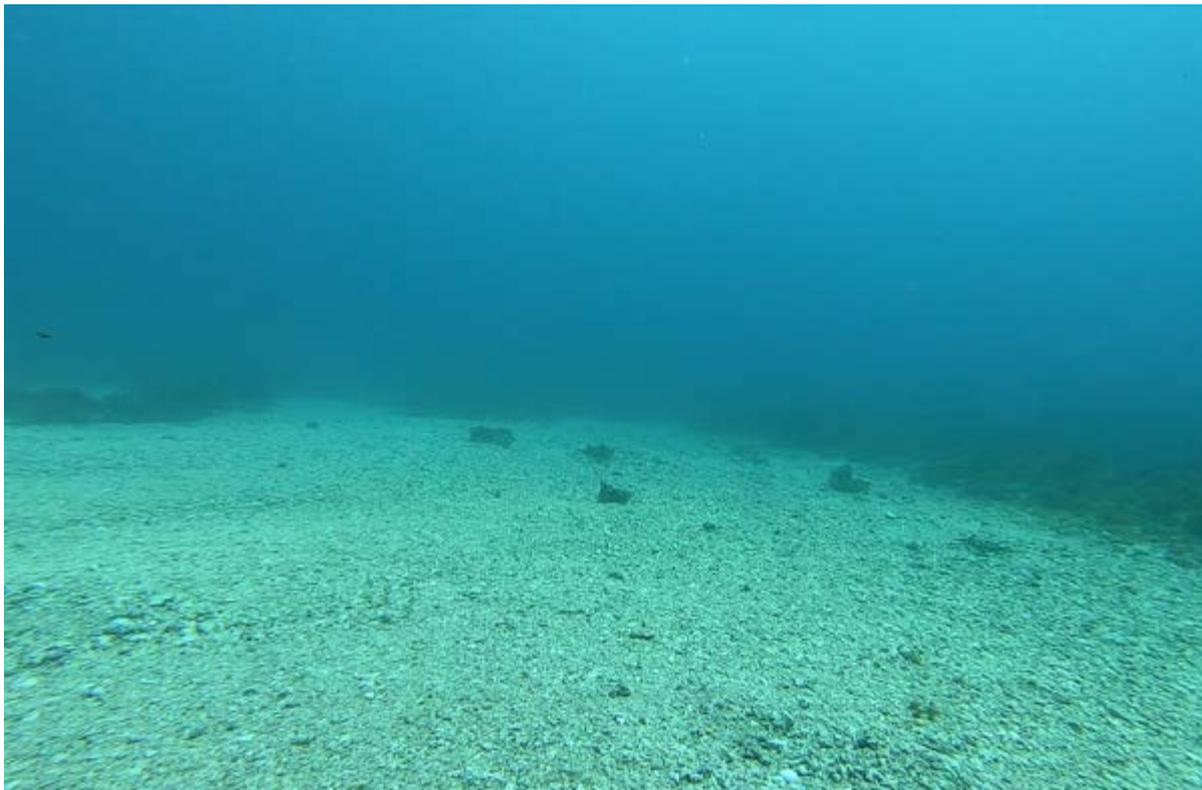
Figure 2-25 Image of the seafloor in Priority Area F (site F2-8)

Divers observed evidence of the ship grounding, noting large areas of exposed bare substrate that were covered in a fine layer of sand and angular rubble, or areas of large angular rubble overlaid on solid substrate. No evidence of ship hull fragments or AFP flakes were observed by divers.

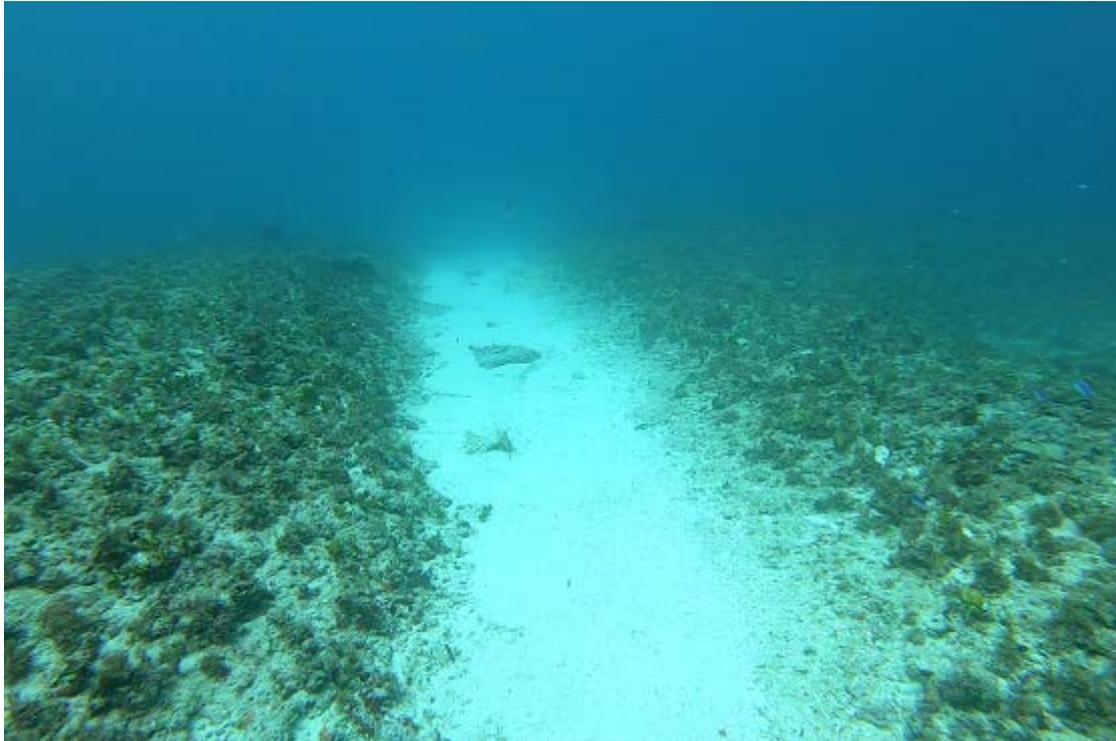
Figure 2-27 Channel of 'unnatural' appearance, Area A (Site A3-3), outside areas of physical damage per AIMS (2010)

Divers reported (and underwater panoramas confirmed) that some areas appear to have ‘unnatural’ scars or gutters e.g. at site A3-3 in priority area A (Figure 2-27) or in the Reference Area – site R1-1 (Figure 2-28). Many of these areas are outside of the physical impact zone as described in Negri *et al*, 2010 – *Grounding of the Shen Neng1 on Douglas Shoal: Multibeam Sonar Bathymetry and Towed Video Assessments*. This implies that in some unimpacted parts of the shoal areas of bare substrate and large flat featureless expanses exist. Divers noted (and videos confirmed) that macroalgae appears to grow in the middle of the sediment patches, not just on the edges as noted within some impacted areas (refer to Figure 2-28).

- Fieldwork identified that Douglas Shoal incorporates large flat areas that are relatively featureless and 'unnatural' scars or gutters occur both within and outside of the priority remediation areas. Given that there is no baseline condition assessment (prior to the grounding) for Douglas Shoal, this may implicate some challenges for the delineation of impacted areas both spatially and in terms of relative importance, noting that the visual assessment may support this consideration.

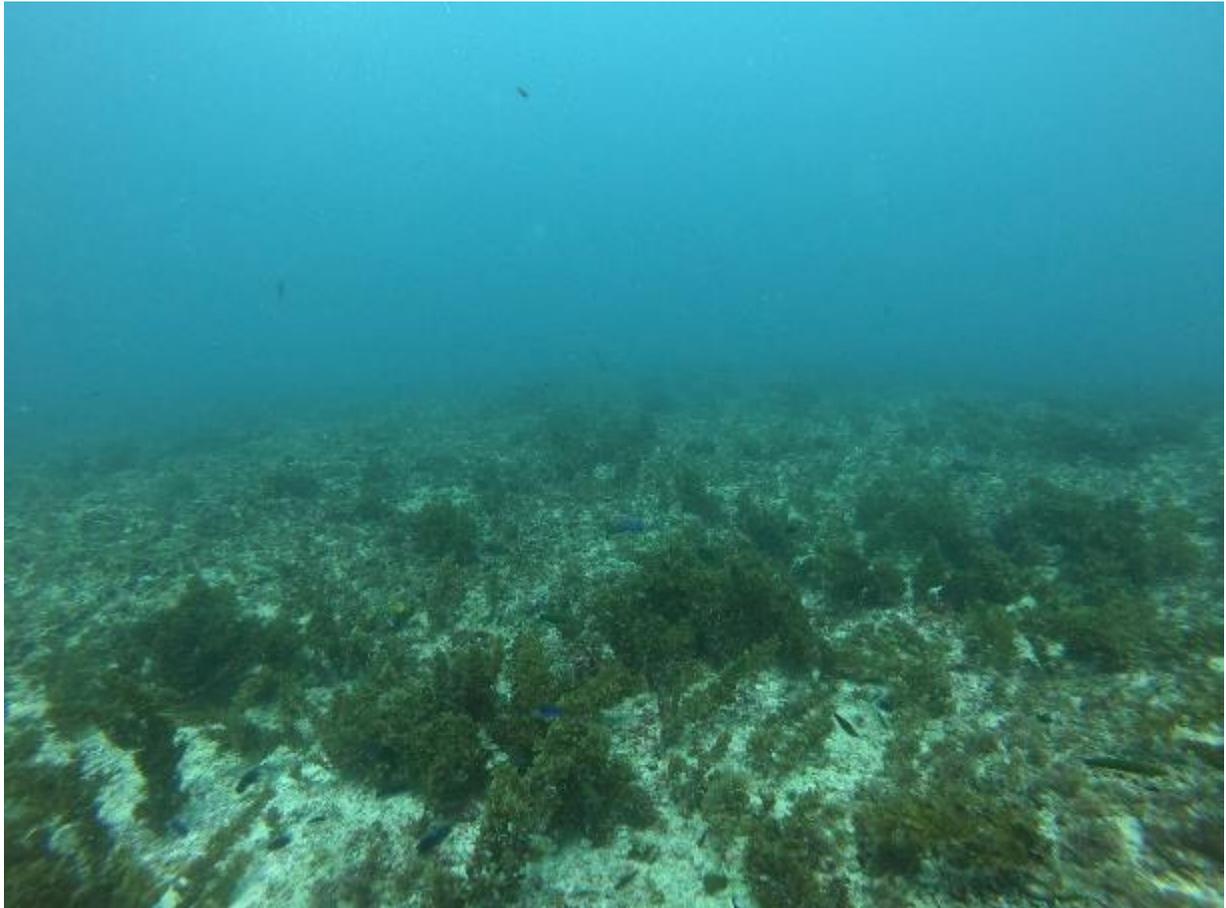
Figure 2-29 View of the typical algal community at Site F2-9 in Priority Area F

The macroalgae *Sargassum spp.* was found growing prolifically on the shoal, covering areas of consolidated sediment and rock in stands up to 1.5m high in places (Figure 2-29). The algae tended to be sparser in Priority Area A where the substrate is very uniform and more exposed to wave, and wind driven wave conditions (Figure 2-30).
