RESEARCH PUBLICATION No. 28

# Heron Island Spoil Dump

M.R. Gourlay and J.S. Jell

The Heron Island harbour was re-dredged between September and November 1987 and a swing basin for vessels and a jetty were also constructed at that time. Following concern about the potential effects of the dredging operation, a multi-disciplinary monitoring program was initiated. This report covered the investigation into the nature and distribution of sediments on the reef flat and in the spoil dump, the conditions responsible for the erosion of the spoil dump and the quantity of dredge material in the spoil dump.

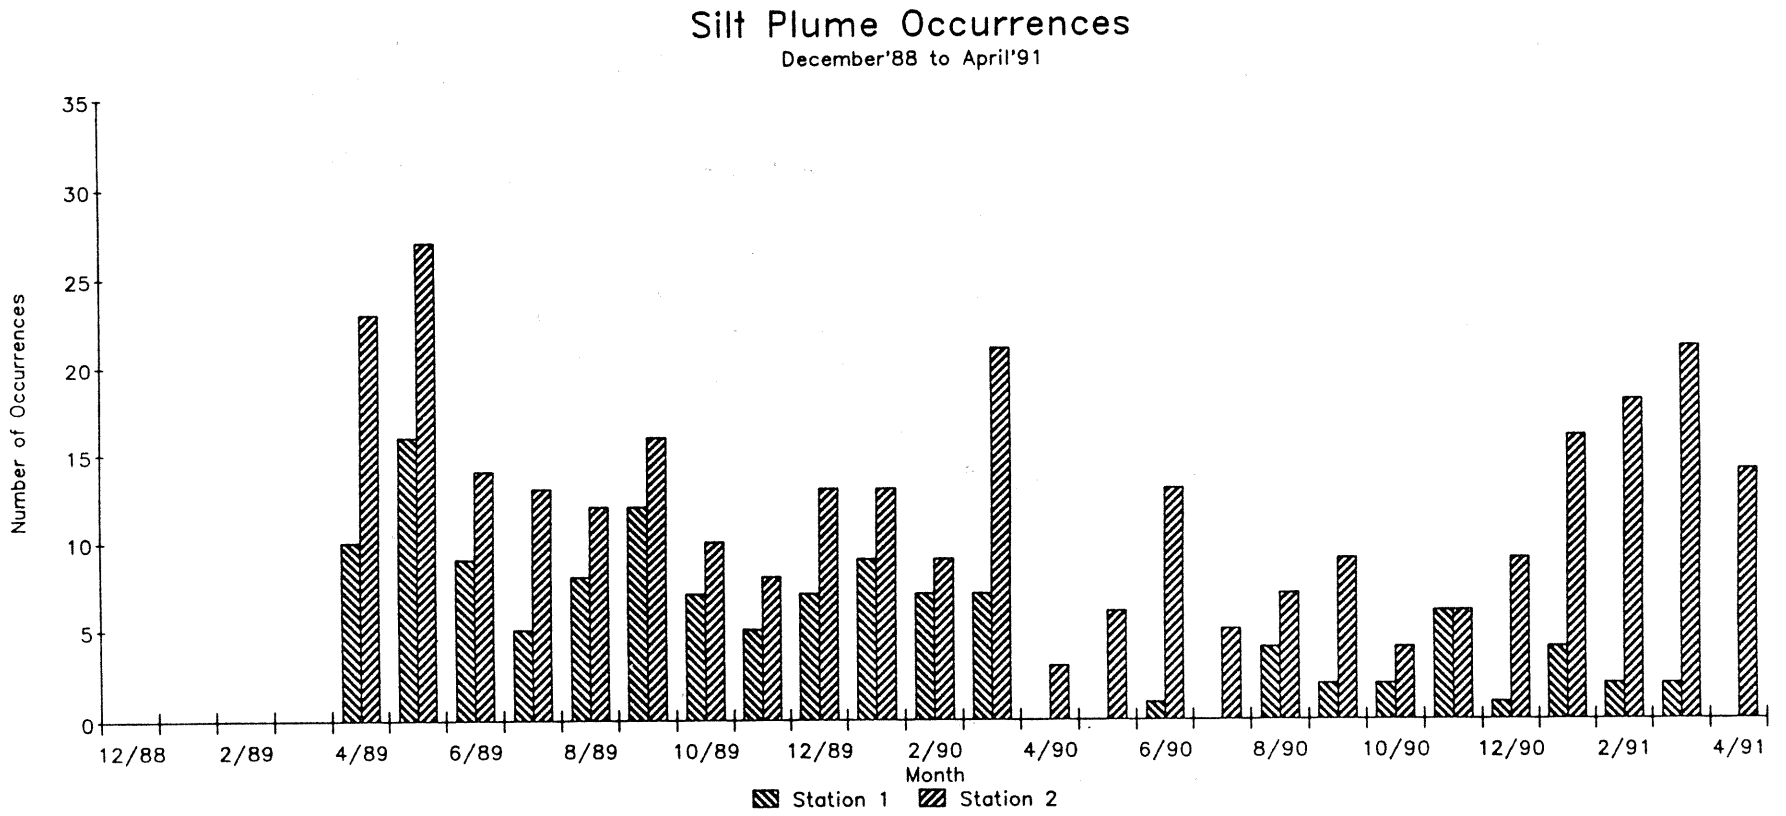
Figure 20. Monthly silt plume occurrences - December 1988 to April 1990

The variations in the conditions affecting the spoil dump and the occurrence of silt plumes during the period May 1989 to April 1991 are presented in two ways, firstly as monthly bar charts (Figures 20 to 24) and secondly in four monthly scatter plots (Figure 25).

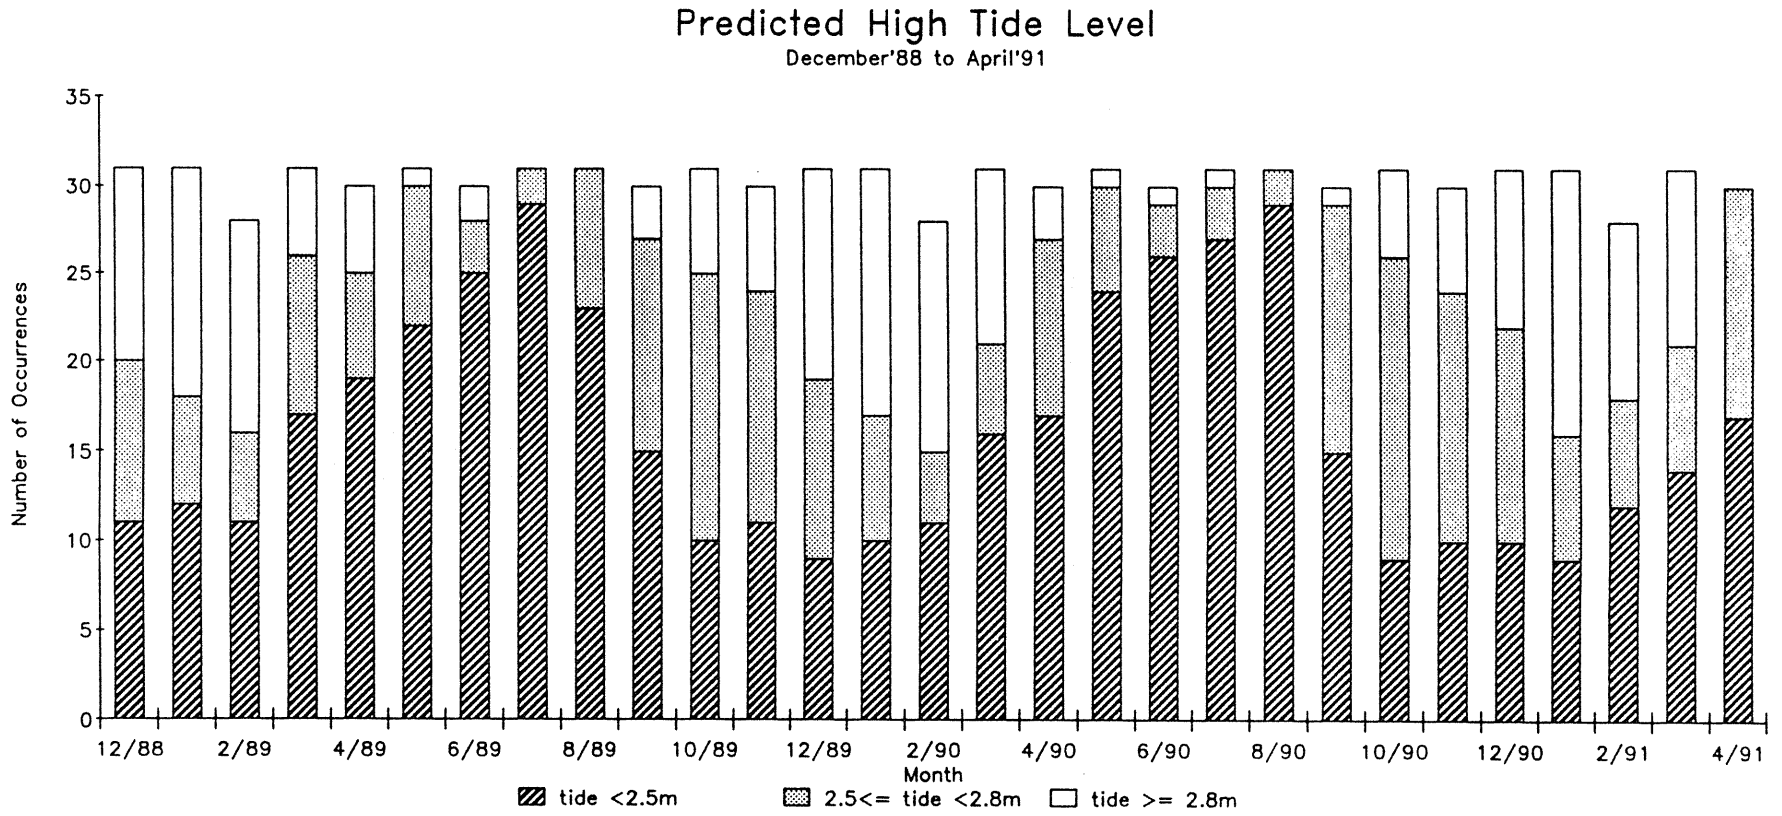
Figure 22. Monthly high tide level occurrences - December 1988 to April 1990

In contrast during the following very wet month, April 1990, winds were generally below 15kn, waves were almost always below 0.3m and the number of tides greater than 2.8m was significantly less than during the preceding month (Figures 22 to 24). It was generally the calmest month during the period of observation. This fact combined with fewer high tides is clearly consistent with a small number of silt plumes. March 1989 had a similar distribution of high tides and relatively calm conditions but with less than a third the rainfall of April 1990. Unfortunately no information about silt plume occurrences is available for comparison. However, it seems probable that the rainfall had either little effect or a negative effect upon silt plume occurrences in April 1990. Thus it is possible that all available silt had been removed by wave action at higher high tides during the previous month and that there was little silt available to form silt plumes in April. The heavy rainfall presumably percolated into the spoil dump, concentrating loose silt particles at lower levels where they are less available for removal. The effect of rainfall upon silt plume formation appears to be largely dependent upon
