Sunfish Queensland Inc

Importance of Freshwater Wetlands to Marine Fisheries Resources in the Great Barrier Reef

Report No: SQ200401

Published JANUARY 2005

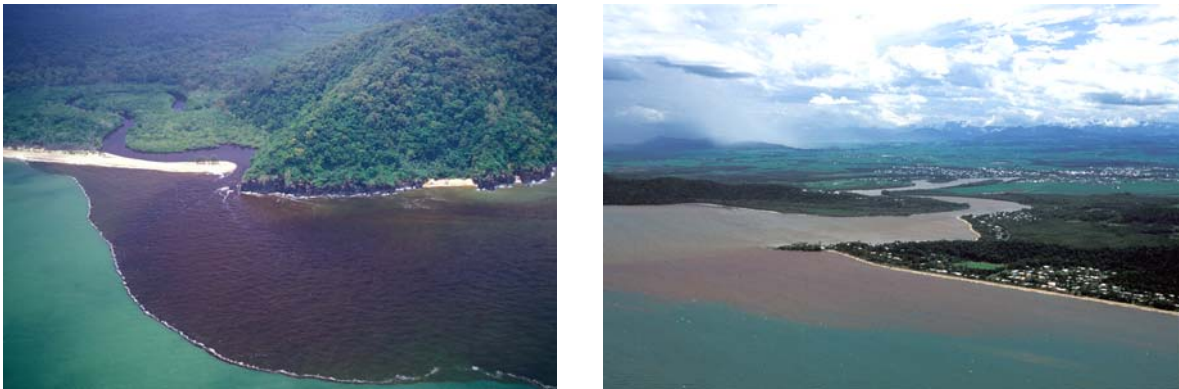
Figure 3: Comparison of flood plumes from a pristine catchment (left) and a developed catchment (right)
Photographs © Great Barrier Reef Marine Park Authority

Poor water quality often results from poor land management (Roth *et al*, 2003). A comparison of flood plumes from a small undeveloped catchment (Ella Bay) and a developed catchment (Johnstone River) is shown in *figure 3*. This highlights the different water quality associated with developed and undeveloped catchments during the same rain event.

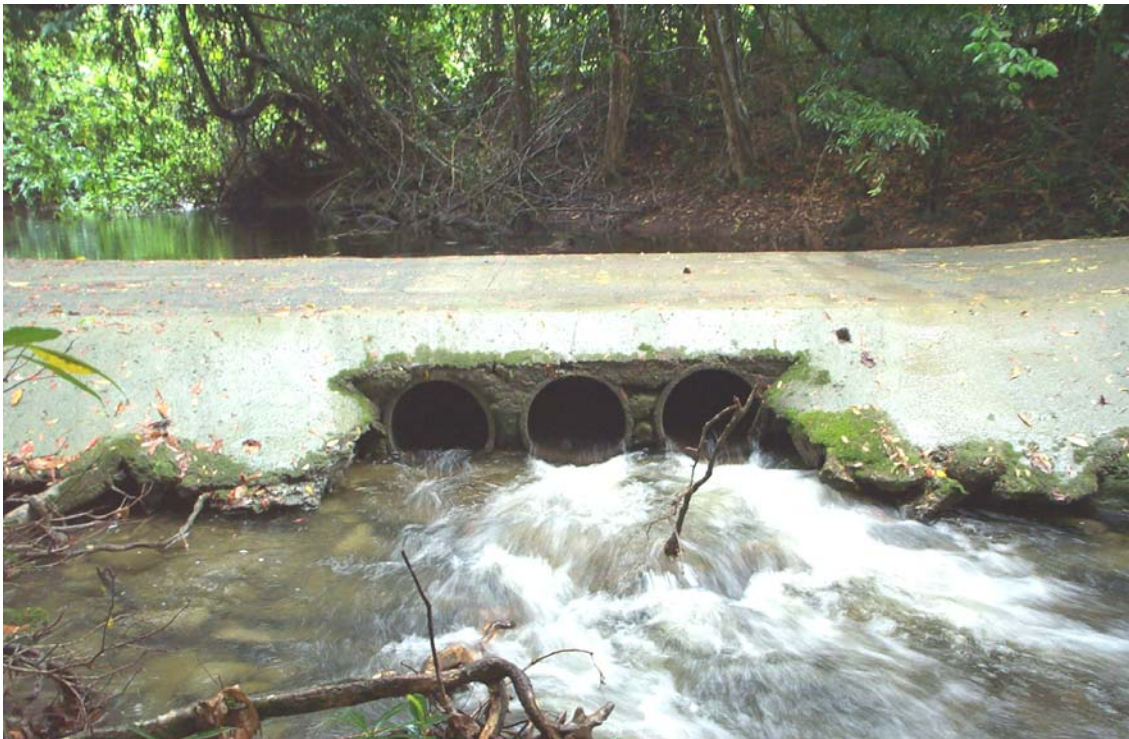
Figure 7: Culvert with high velocity water flow that reduces fish migration on a Saltwater Creek tributary

There are also less obvious causes for reduction of connectivity. Culverts under roadways may not physically stop connectivity but may effectively block fish passage if the water velocity through these culverts exceeds the swimming ability of fish (Clague, 1991). This effectively prevents or severely limits fish movement through the culvert. Native fish avoid swimming through darkened areas and this has been recognised as a barrier in long culverts (Cotterell,

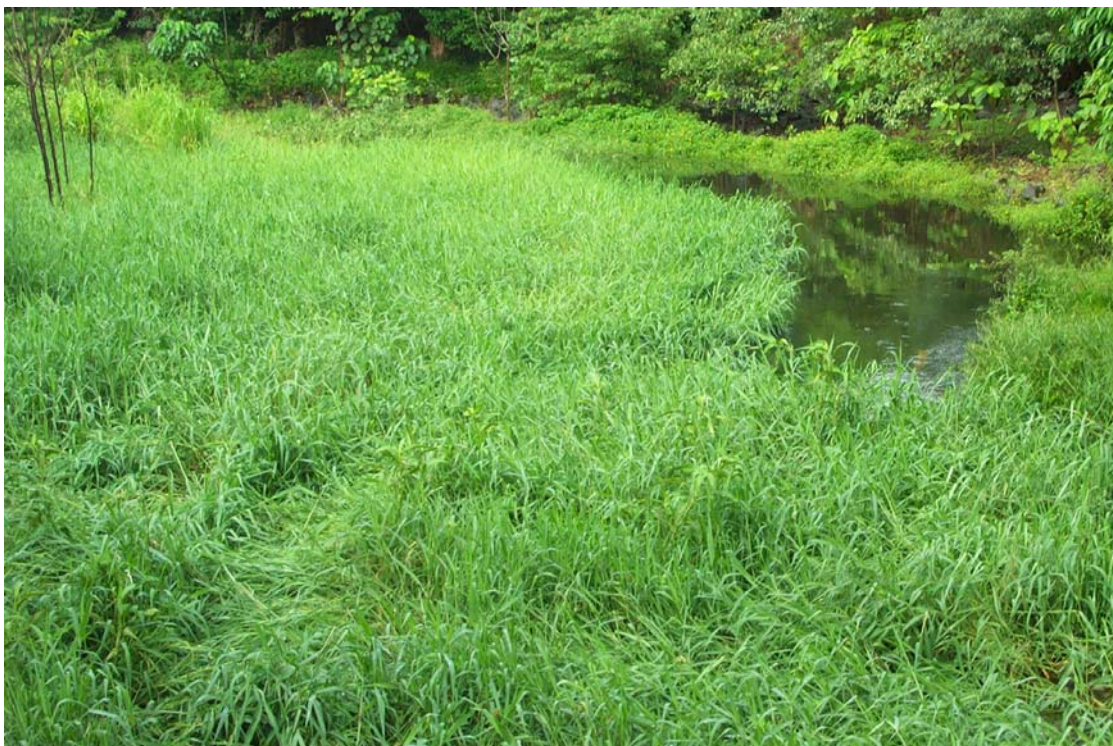
Figure 10: Middle reaches of Freshwater Creek in Cairns choked by para grass

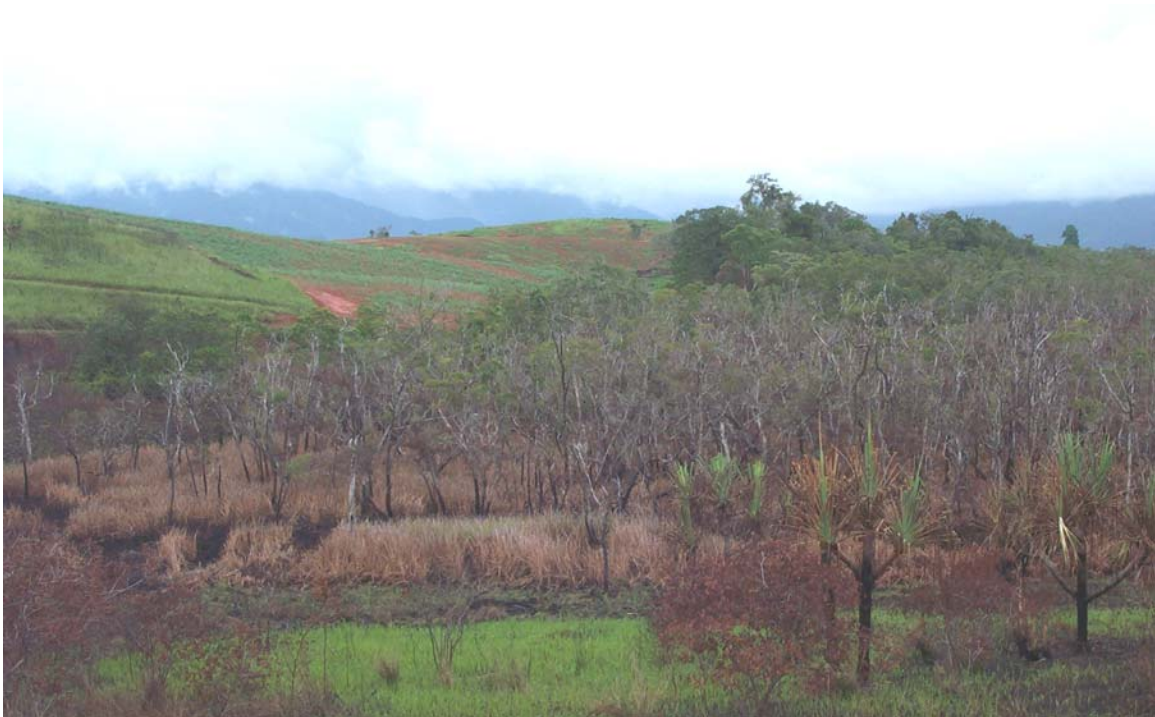
Figure 15: Southern end of Wyvuri Swamp

Despite its relative isolation, Wyvuri Swamp has been significantly degraded. At its southern end (*figure 15*), access to the swamp is along sealed roads that lead

to the Brampston Beach community. Wyvuri Swamp has been grazed extensively and suffers from invasion by para grass and other common weeds associated with grazing. It has been mined for sand in places and partly drained for horticulture. At its southern end, Wyvuri has been burned apparently igniting the underlying peat and risking stability of the surface area. Most of Wyvuri Swamp is privately owned with approximately 20% of the area in national park at the northern end. There has been no assessment of fish use of Wyvuri Swamp.

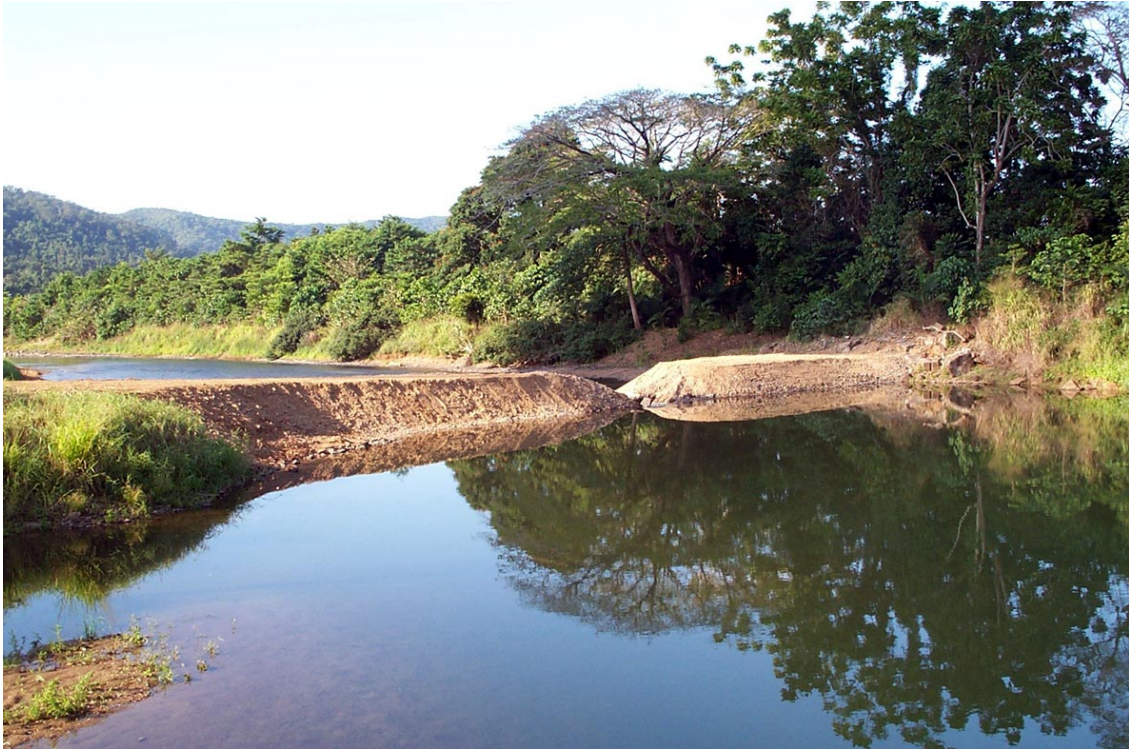
Figure 16: Sand dam on the South Johnstone River
Photograph © G Vallance

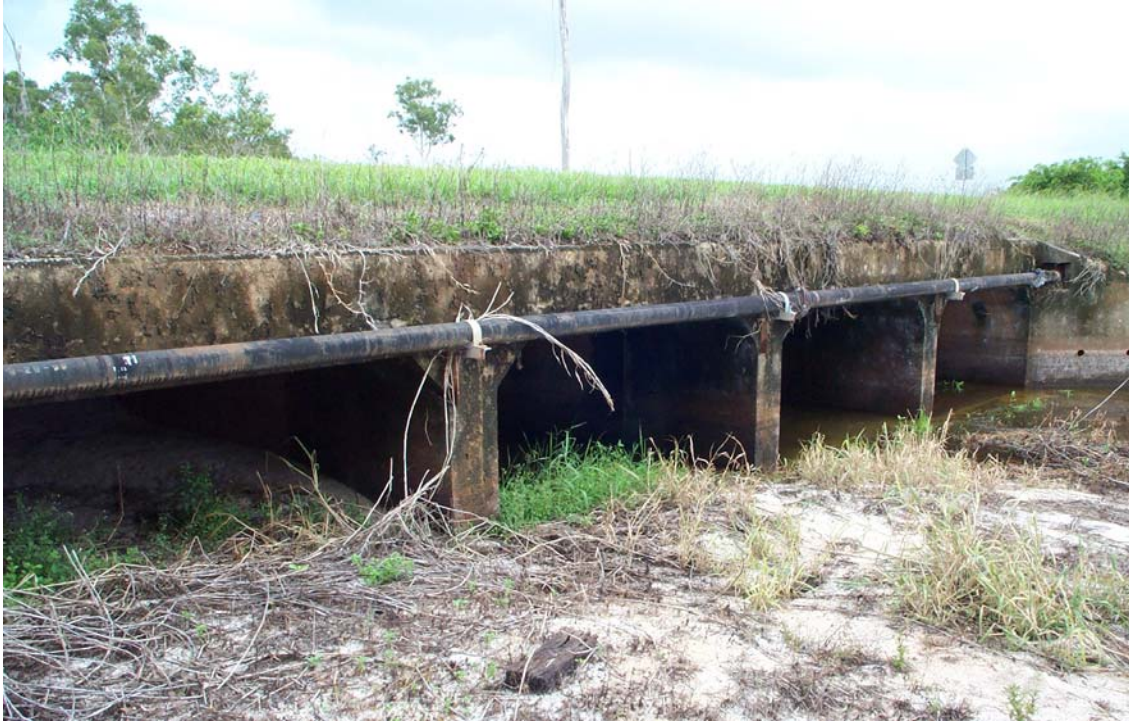
Figure 18: Crossing on Ninds Creek below Bulkuru Swamp showing iron flocculation and concrete corrosion associated with drainage of ASS

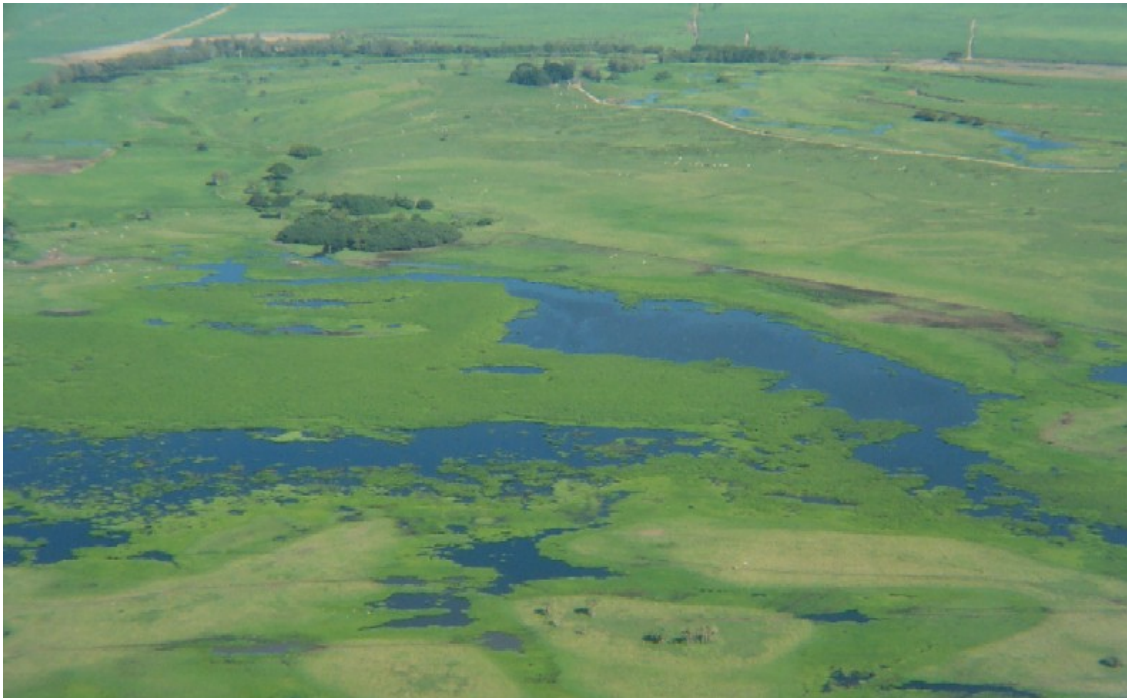
Figure 28: Part of Mungulla wetlands on the Herbert River floodplain showing lack of riparian vegetation

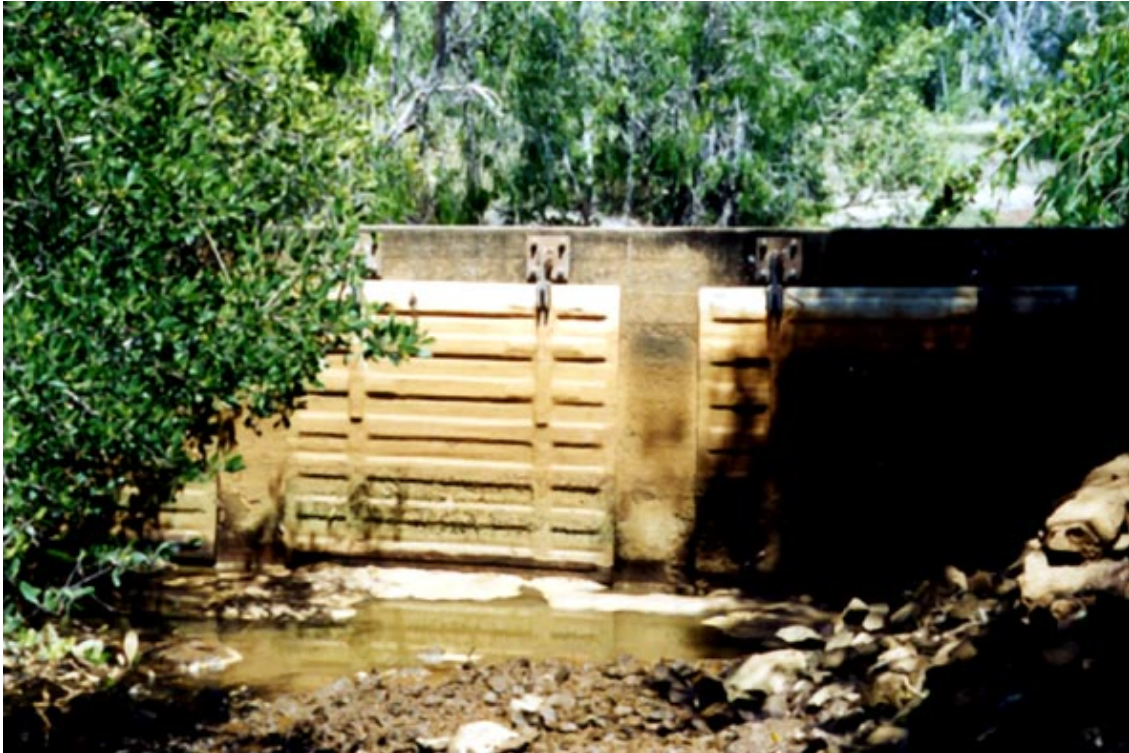
Figure 29: Floodgates preventing tidal intrusion on Mandam wetlands

The Mandam wetlands are impacted with artificial flow paths cut through the mangroves that resulted in disturbance of ASS; tide gates increase the impacts of this disturbance (Sammutt et al, 1994, 1996; White et al, 1996) (*figure 29*). While some areas close to the coast remain in good condition (Blackman et al, 1999) they are connected to tidal areas through farm drains that are potential barriers due to water quality issues.

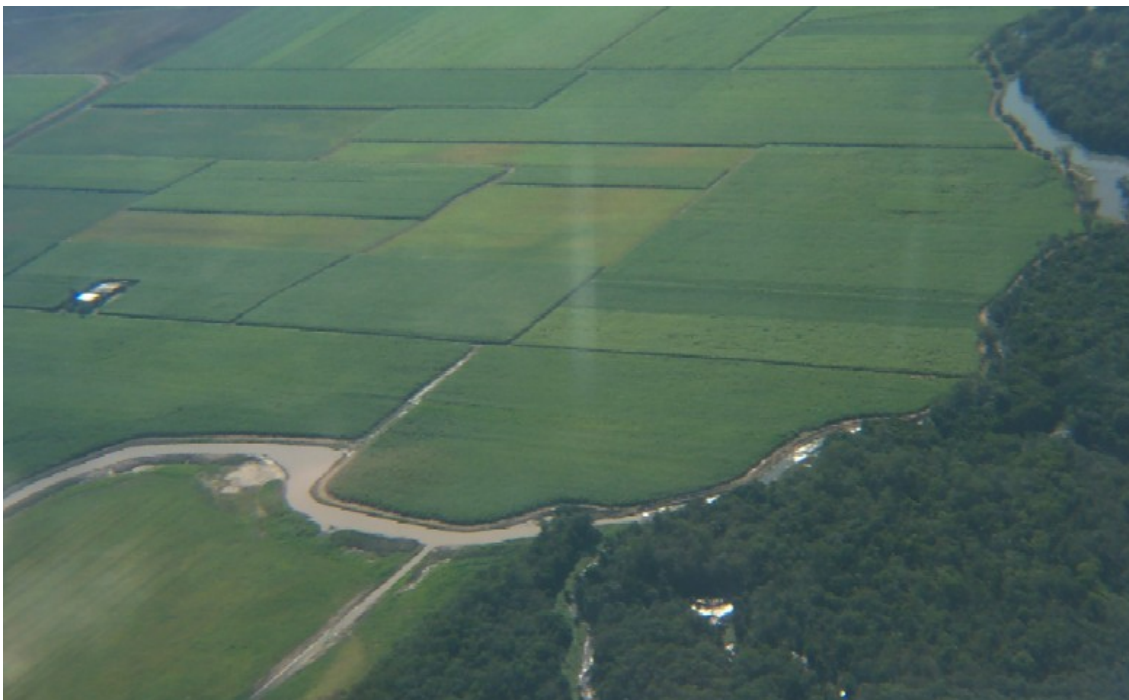
Figure 31: Ripple Creek sump at top right and farm detention area at middle left after moderate rainfall.

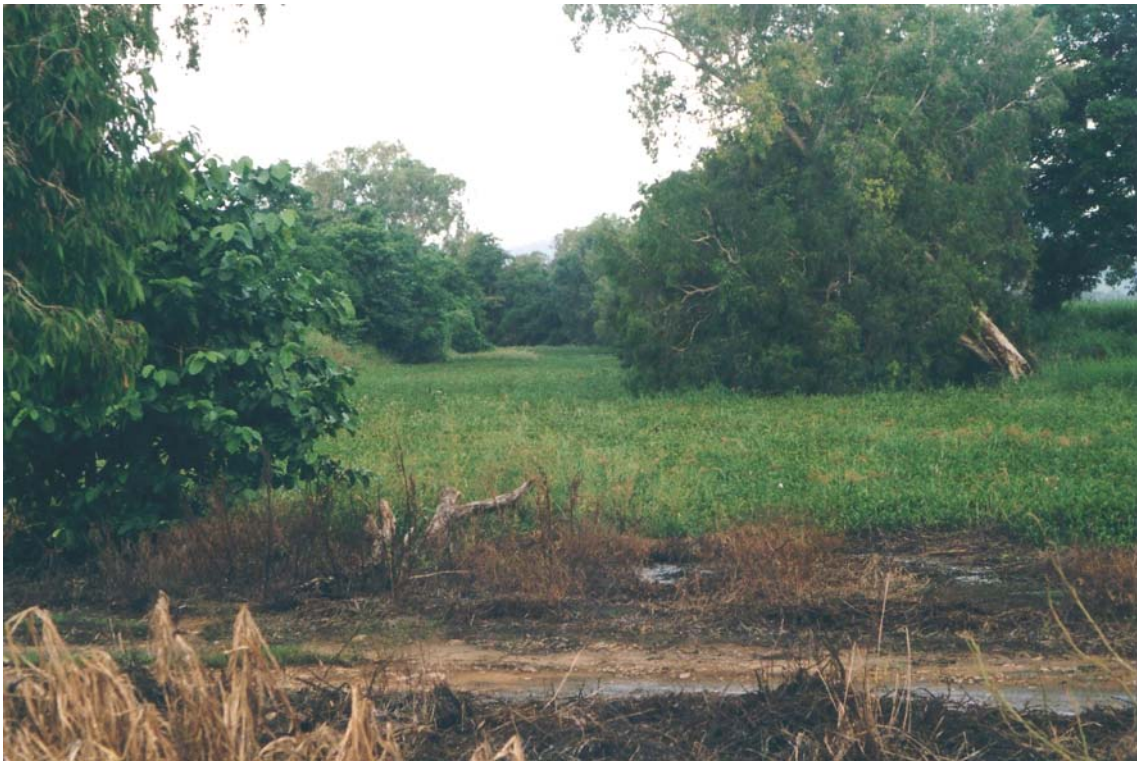
Figure 37: Healey Lagoon covered in water hyacinth, pistia and other aquatic weeds (Oct 2004)

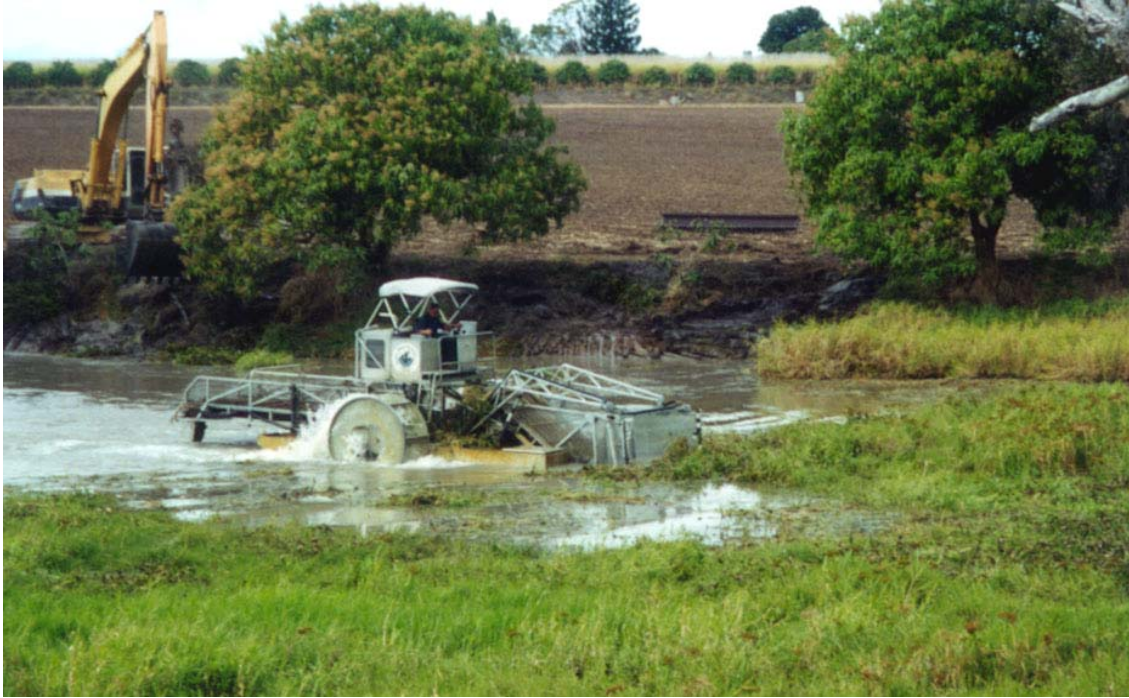
Figure 41: Aquatic weed harvester on Payard Lagoon

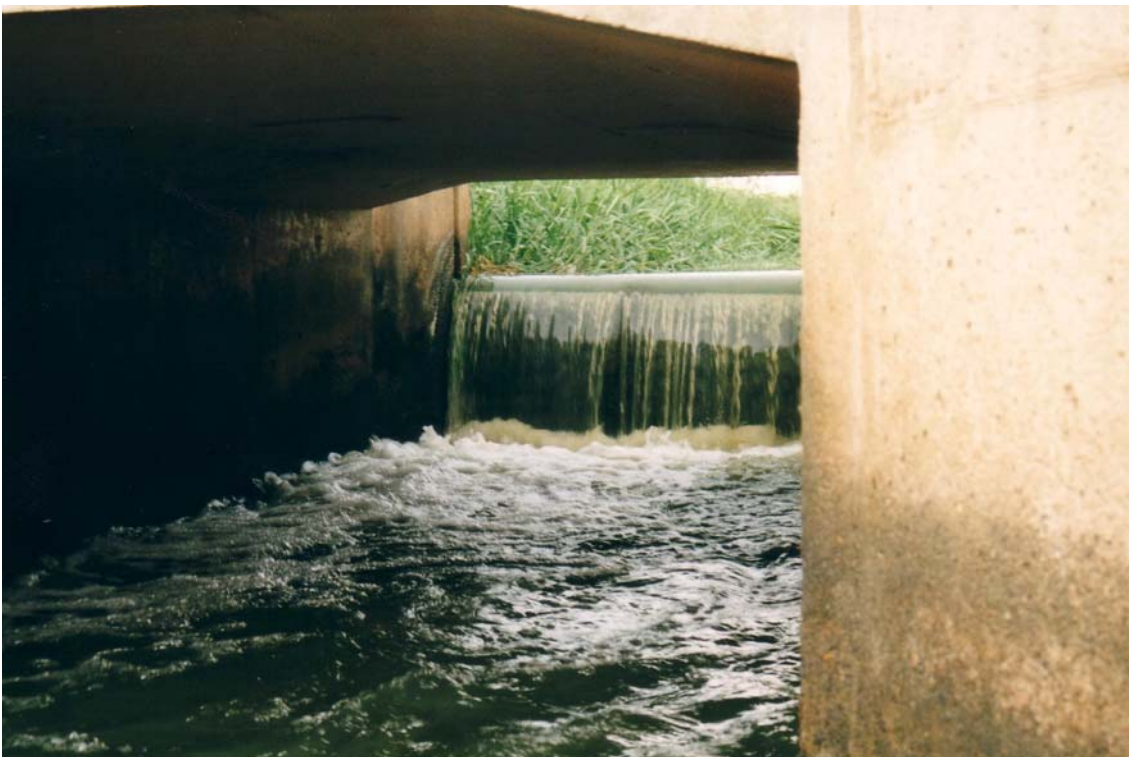
Figure 42: Drop boards on Sheepstation Creek that prevent fish migration except in flooding

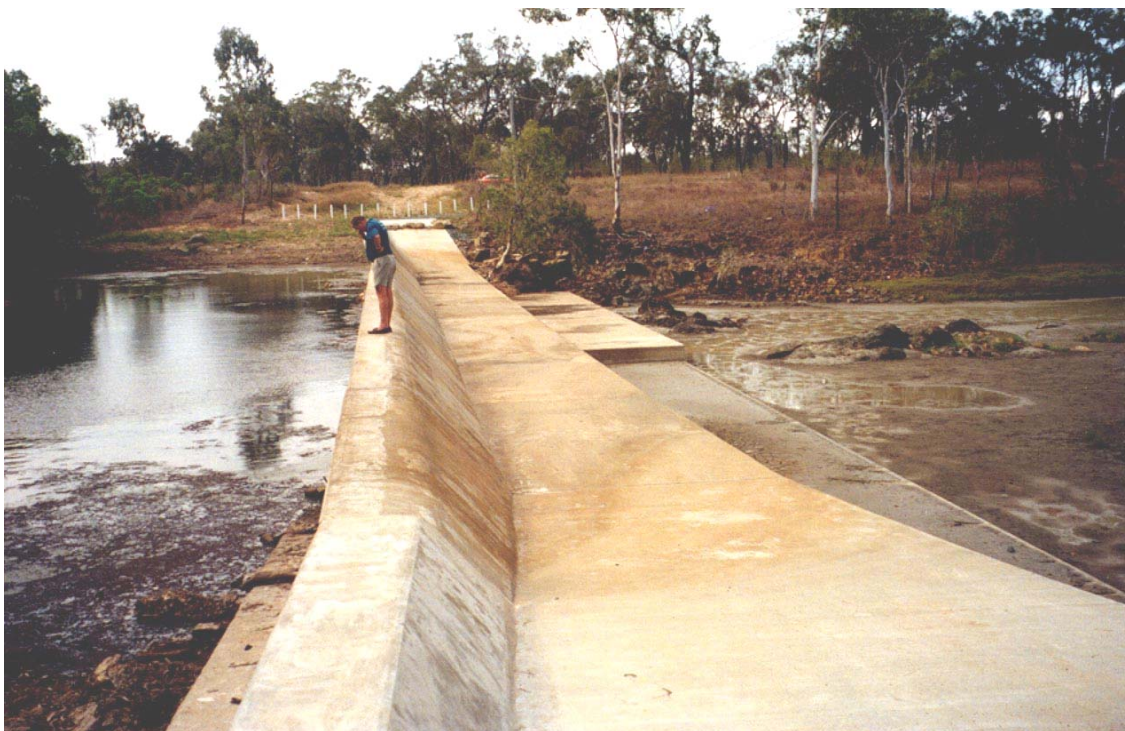
Figure 49: Tidal barrier on St Lawrence Creek

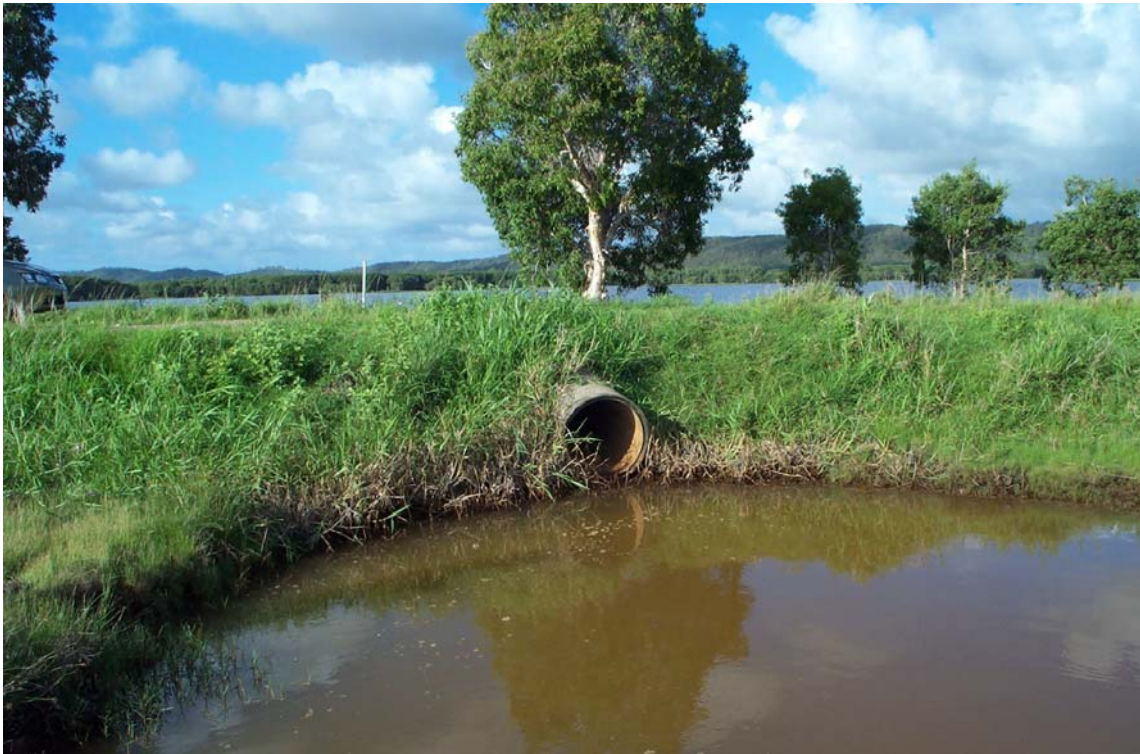
Figure 53: Pipe under the roadway and levee bank separating brackish water in foreground from freshwater wetlands in background (juvenile barramundi and other species have been recorded below the pipe)

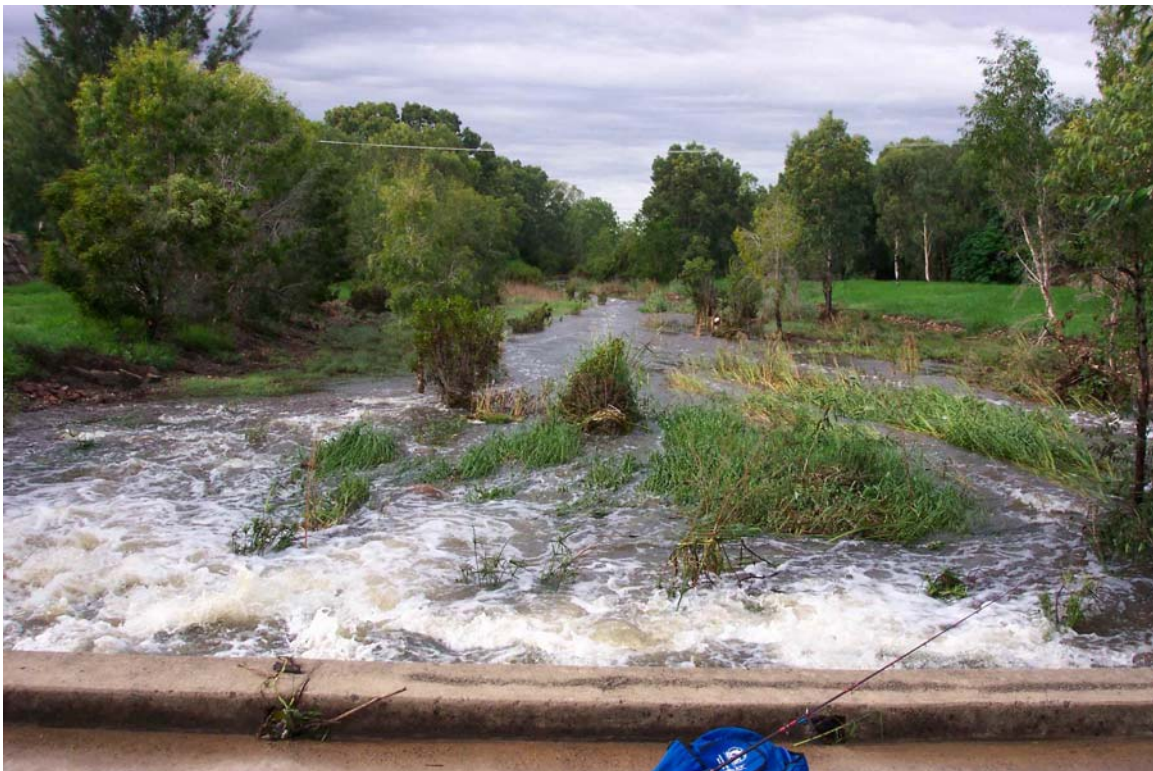
Figure 56: Moore Creek causeway at the upper tidal limit after moderate rain

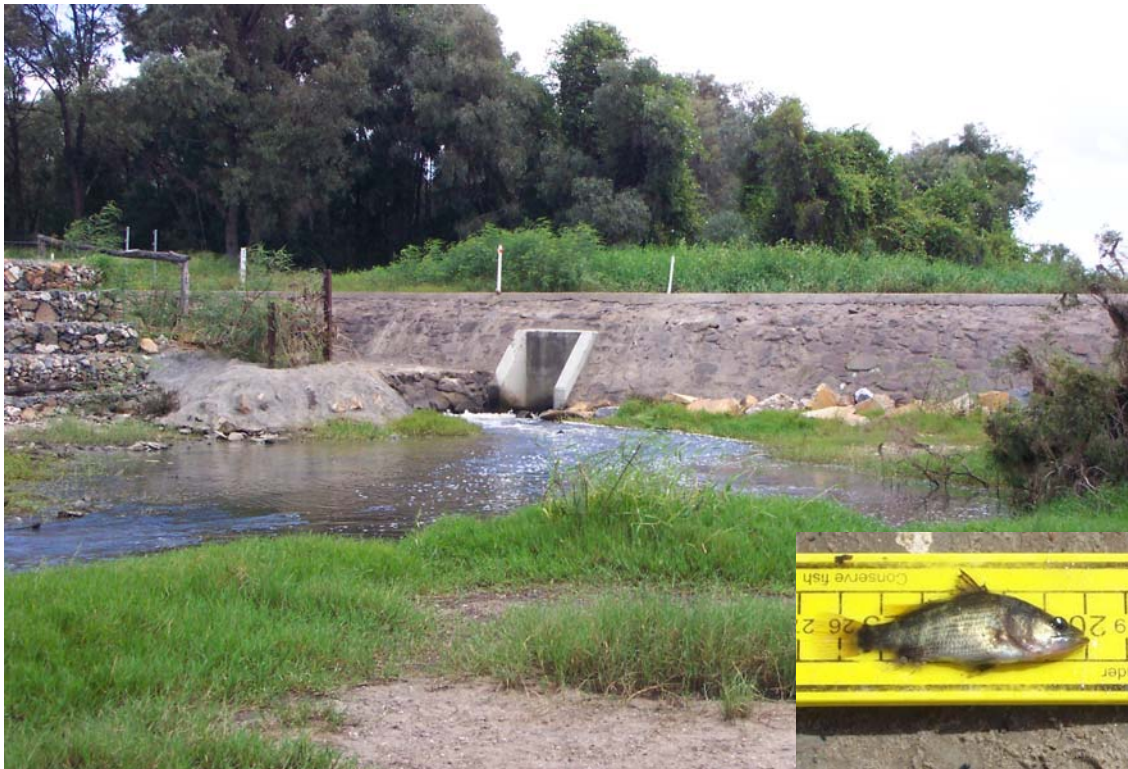
Figure 63: Bajool weir showing the overflow pipe on the downstream side
Inset: Juvenile barramundi of 67mm caught below the weir

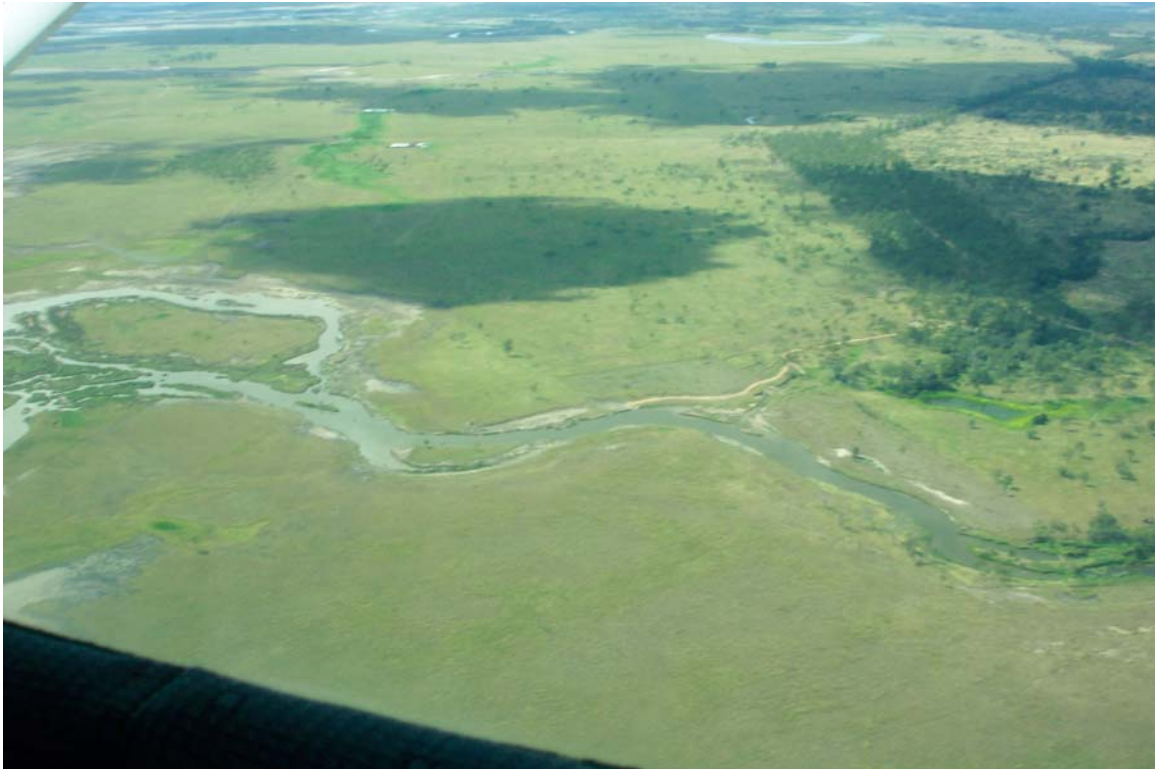
Figure 64: Aerial view of brackish lagoon on 12 Mile Creek showing lack of riparian vegetation

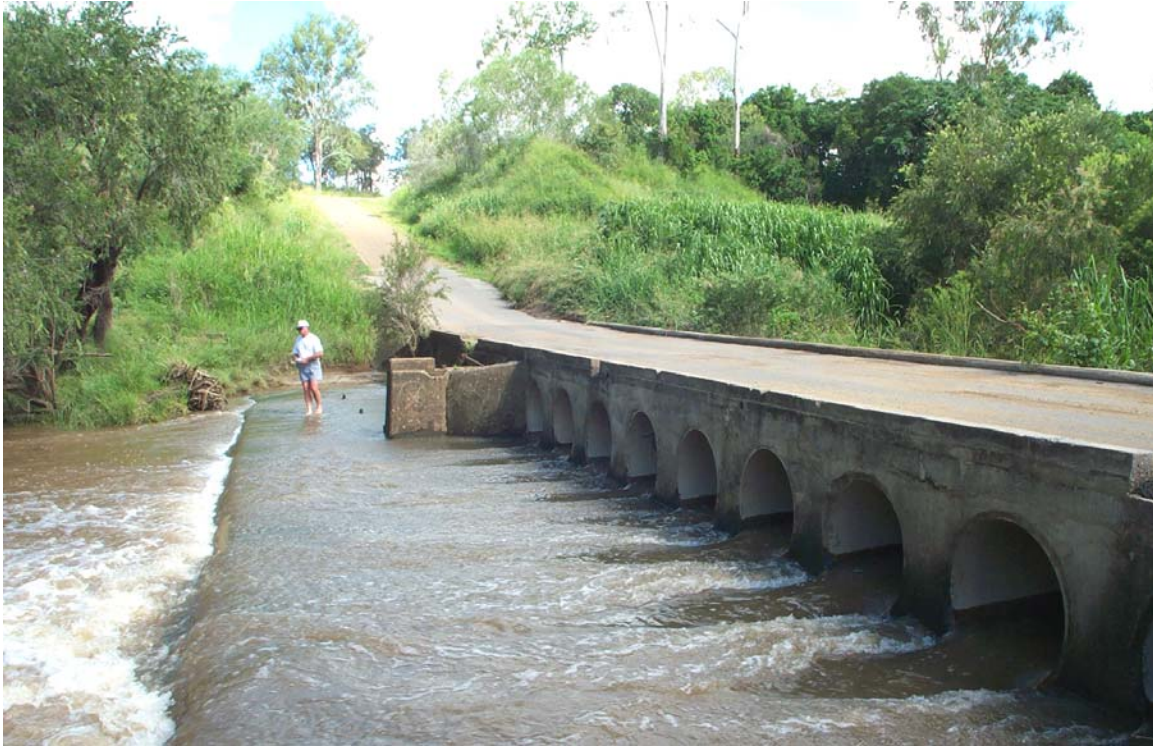
Figure 66: The causeway on Raglan Creek during a flow event indicating obstacles to fish migration

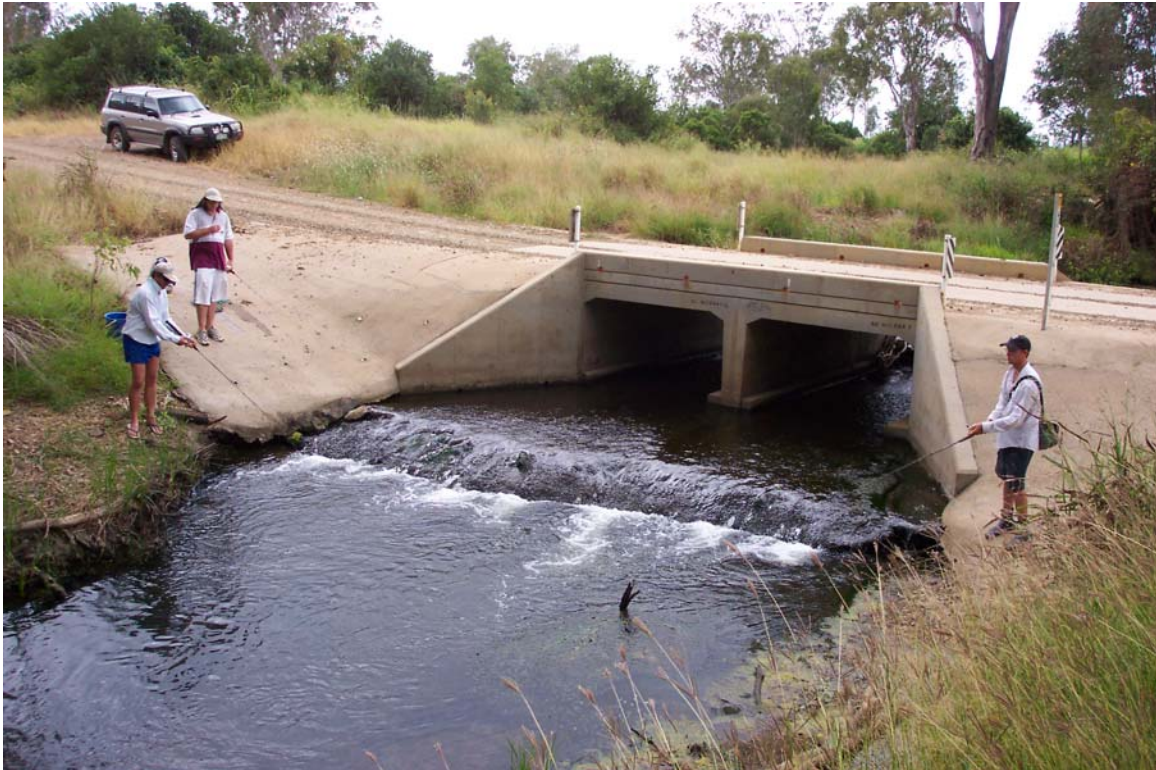
Figure 67: The culvert on Raglan Creek that now prevents upstream migration of juvenile barramundi

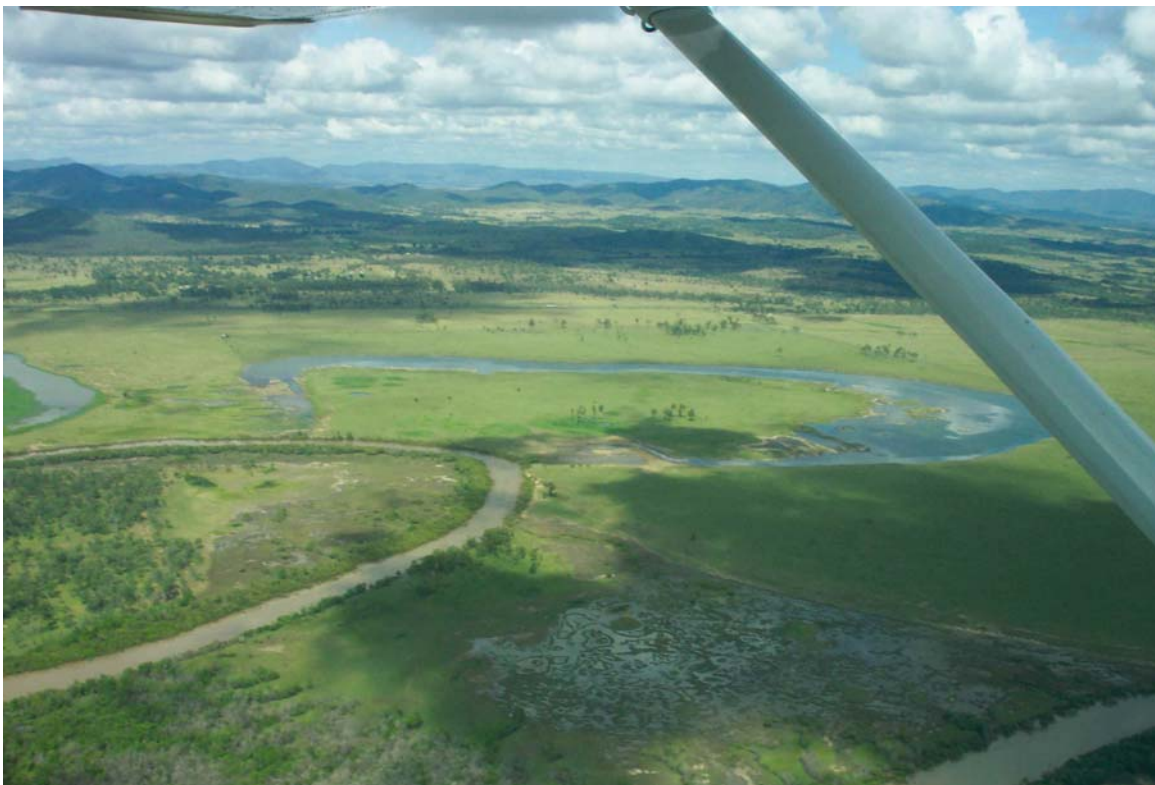
Figure 68: Pelican Lagoon adjacent to Raglan Creek showing the lack of riparian vegetation

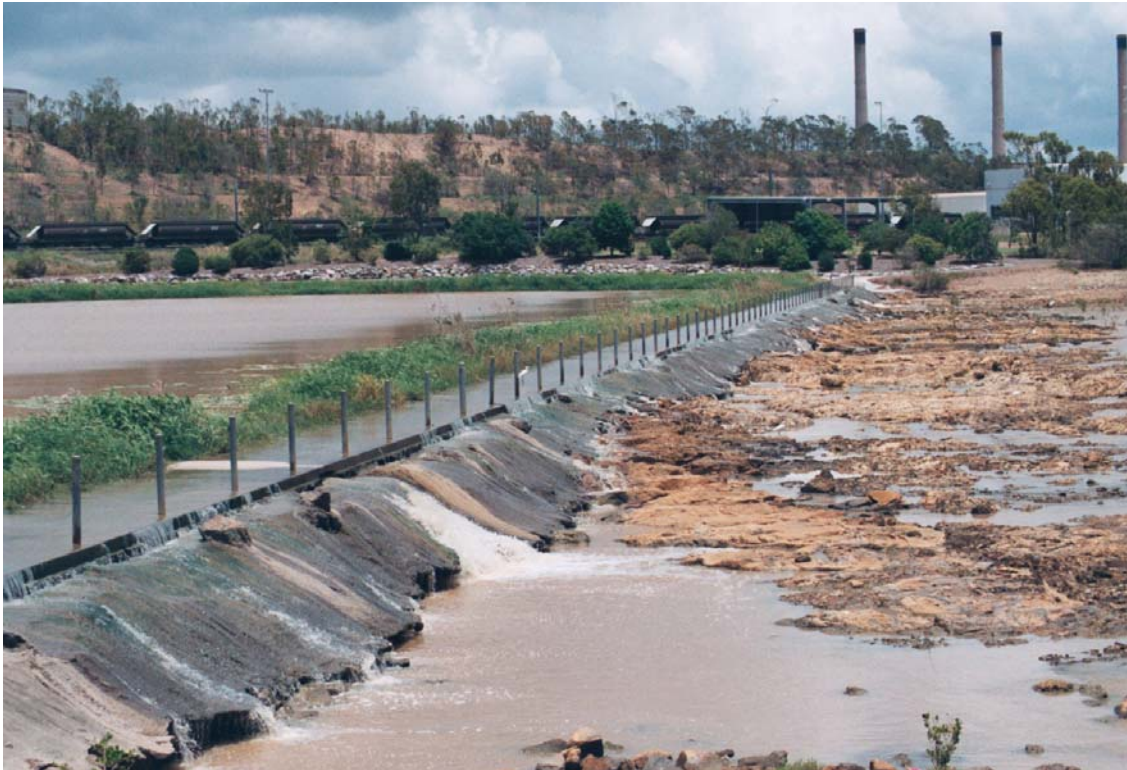
Figure 74: Water overflowing the wall on Lake Callemondah at Gladstone

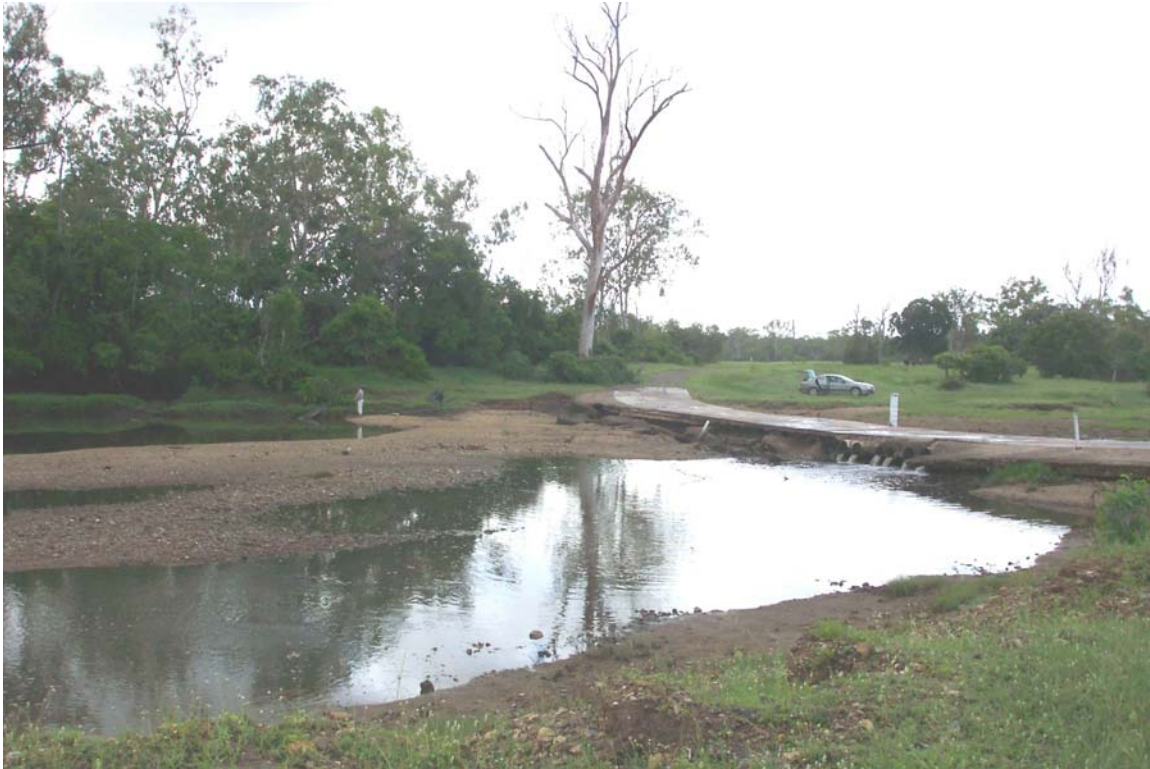
Figure 75: Old causeway over Sandy Creek about 1km downstream from tidal limit
