DOUGLAS SHOAL REMEDIATION PROJECT Visual Surveys Field Report June 2019

Visual Survey Field Report

Douglas Shoal Remediation Project

Report No: 301001-02112-EN-REP-0002 – Visual Survey Field Report

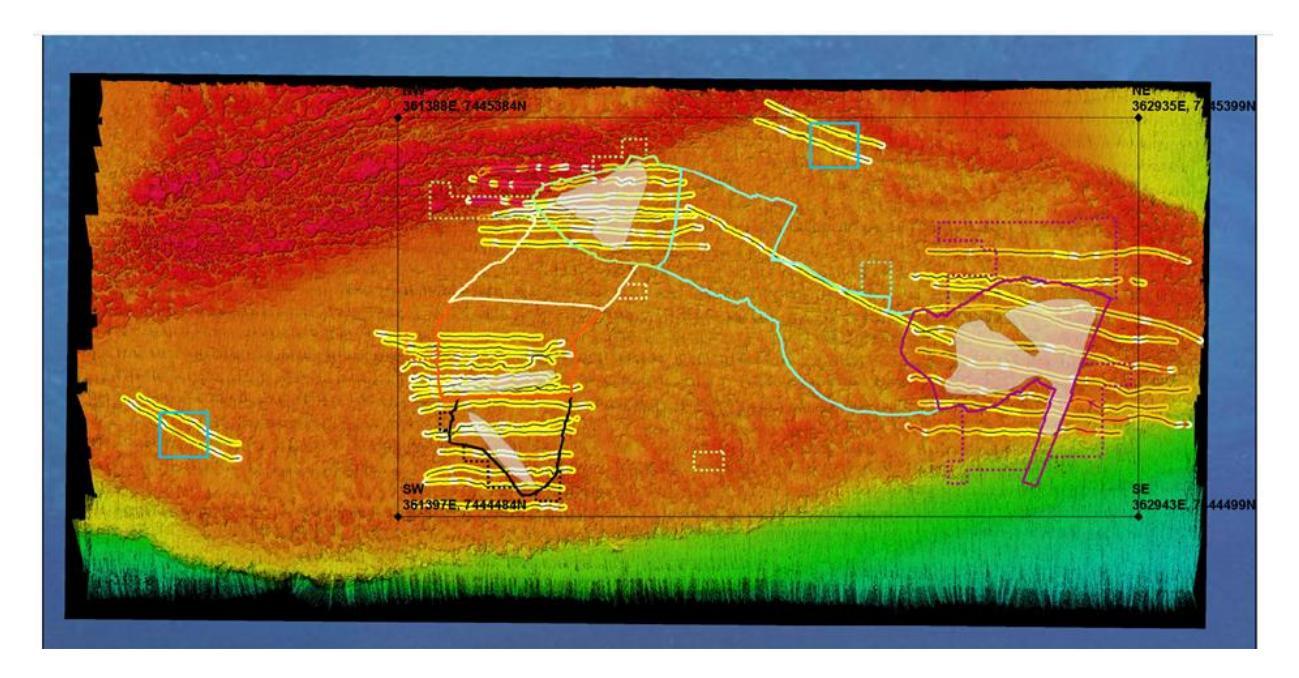
A screen shot which represents the coverage of the TUV surveys overlaid onto the bathymetry and the extent of the grounding footprint is provided in Figure 2-19. Drop camera surveys were focused in areas circled in the backscatter image (Figure 2-18)

Figure 2-19 Screen shot showing the TUV transect lines (yellow and red lines)
