Site Assessment Report

**Douglas Shoal Remediation Project
Great Barrier Reef Marine Park Authority**

8 November 2019

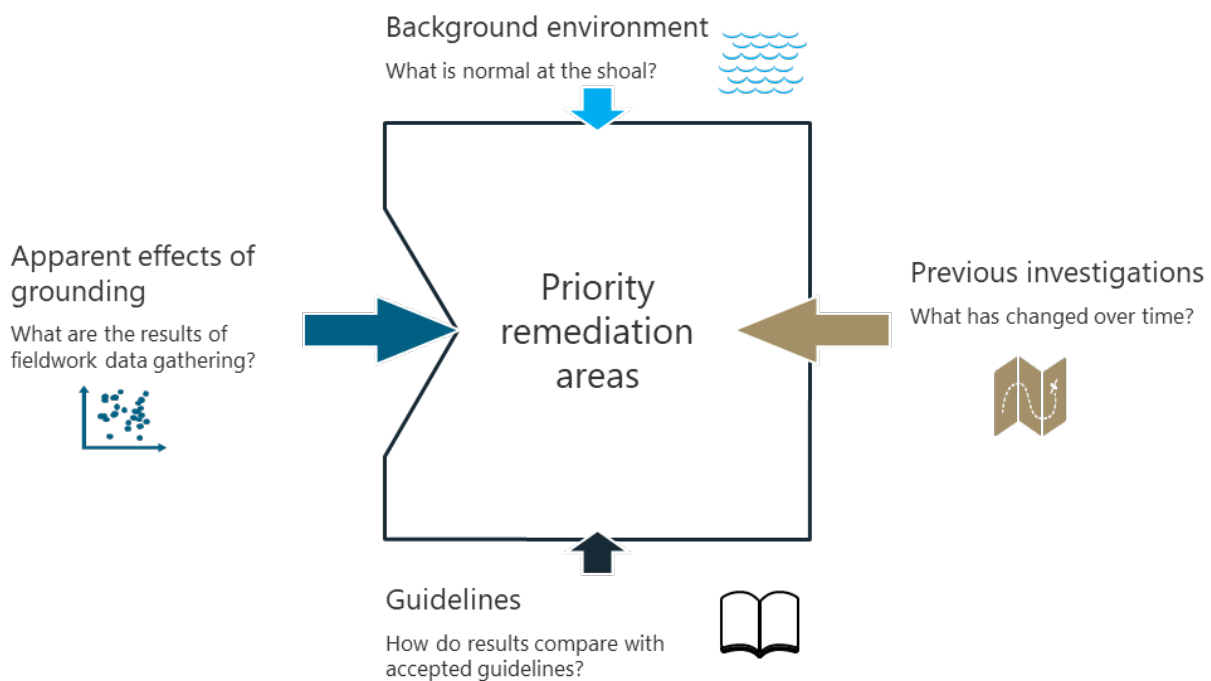
Figure 1-2 Priority remediation area delineation

Fieldwork data was considered in the context of sediment and water quality guidelines, along with information relating to the background environment and previous investigations (Figure 1-2), albeit that significant gaps with respect this information are evident:

- There are no data relating to the pre-grounding incident condition of the shoal to provide information on habitat and how this may change seasonally and in response to natural events
- There is not a consistent or comparable set of information regarding contamination or physical damage to enable detailed quantitative analysis of change over time including natural recovery.

Given these information gaps the site assessment focuses on the current state of the shoal. Evidence regarding physical damage and contamination is used to delineate areas of 'high' and 'moderate' priority for consideration as part of the options analysis.

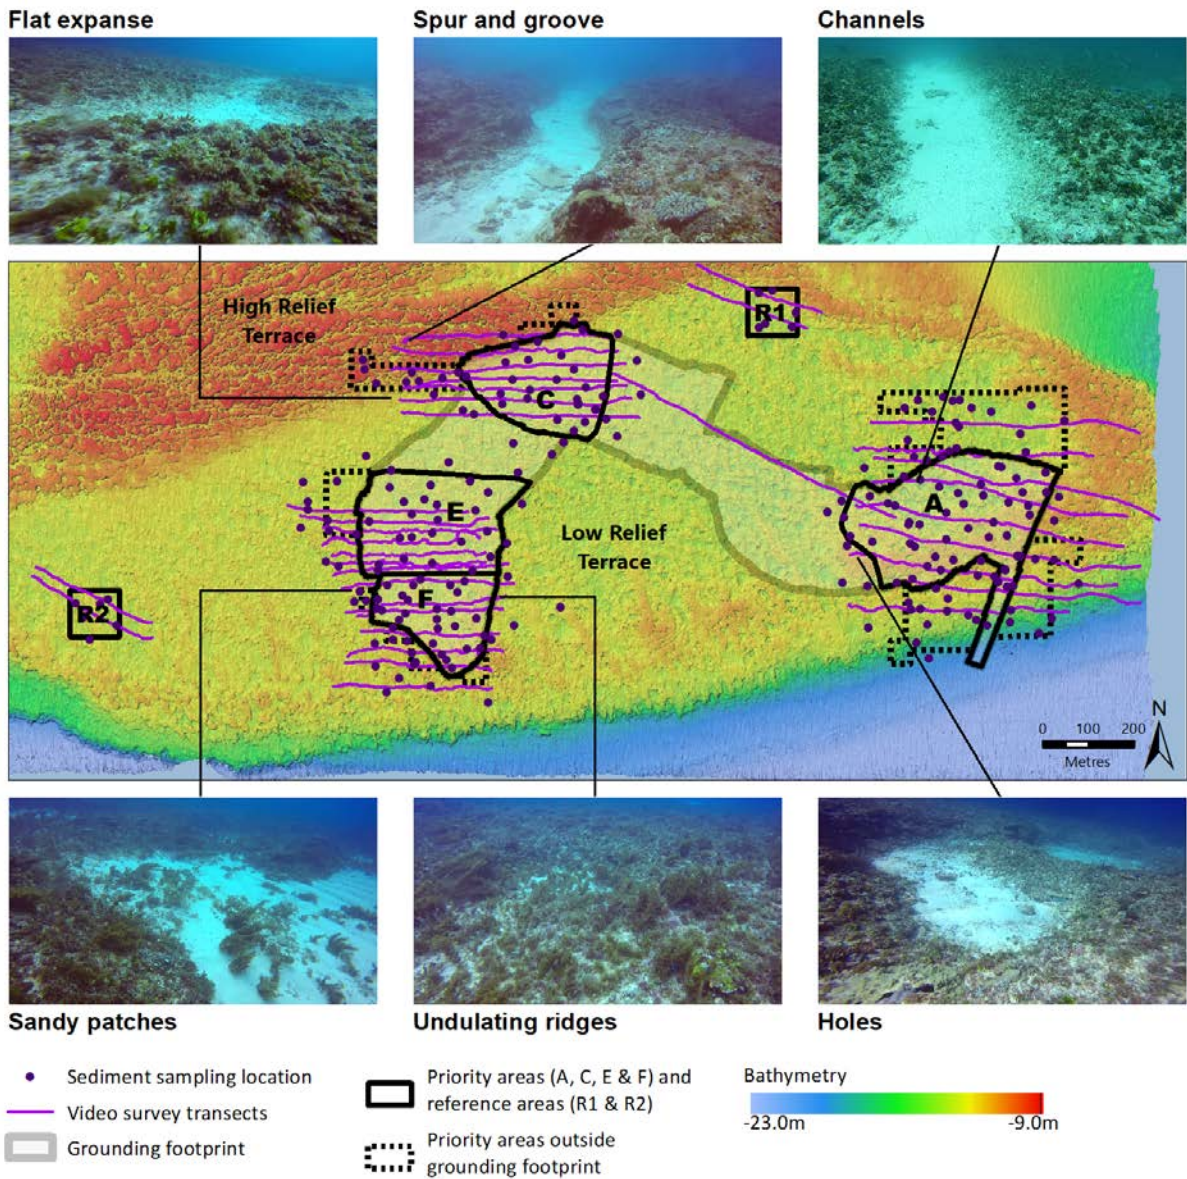
Figure 1-3 Field survey and habitat types at Douglas Shoal

While Douglas Shoal does not have a complex range of features, some habitat diversity is evident. Habitat areas of the Low Relief Terrace of the shoal include (Figure 1-3):

The High Relief Terrace to the north and north-west of the shoal contains more complex features:

- Spur and groove outcrops with moderate coral cover rising several metres from the sea floor
- Deep channels with large fragments of broken coral and coarse sand with sparse tufts of macroalgae growing within the sediment.

The surveyed area of the Low Relief Terrace consists of large expanses of turf algae on rock (32.6%), macroalgae growing predominately on rock (38.5%) and hard (3.8%) and soft coral (2.0%) growing on rock, areas of grounding related rubble (10.2%), dead coral fragments (~1%) and sand (9.3%).
