Site assessment of Douglas Shoal ship grounding in the Great Barrier Reef

Neale, S.J.¹, Boylson, B.D.¹ Graham, T.G.¹, Cameron; D.S.², Gray, L.A.², Reese, R. E.²

¹ Advisian Pty Ltd, Brisbane, Australia; bill.boylson@advisian.com

² Great Barrier Reef Marine Park Authority, Townsville, Australia; darren.cameron@gbrmpa.gov.au

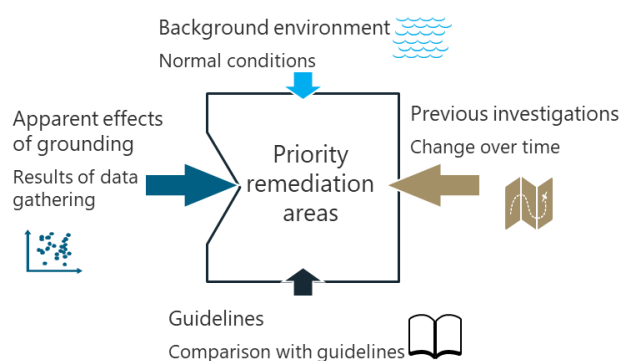
Figure 2 Priority remediation area delineation.

Field data was considered in context of sediment and water quality guidelines (National Assessment Guidelines for Dredging (NAGD [2]) and Australian and New Zealand Guidelines for Fresh and Marine Water Quality (ANZG 2018 [1])) along with information relating to the background environment and previous investigations (Figure 2).
