Great Barrier Reef  
Marine Park Authority

# Grounding of the *Shen Neng 1* on Douglas Shoal, April 2010: Impact assessment report

June 2011

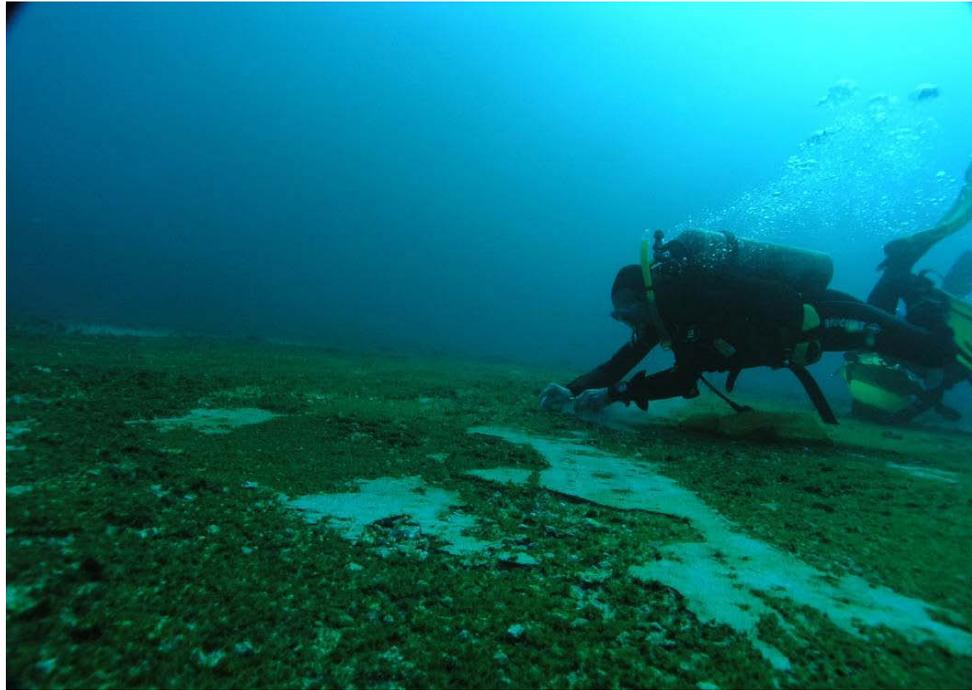
Fig. 10. A. Photograph showing divers collecting sediment from an area which has been crushed to a smooth pavement. Note the smooth area which has considerable paint smears on the surface. B. Diver holding sediment sample jar recording sample identifier. Time records on the digital photograph electronic file allowed georeferencing by cross-referencing with time records in towed GPS units. C. Paint smear on the seafloor of the shoal. Scale bar intervals are 10 cm.

Extensive areas of severe damage to the shoal benthos were observed (Figs. 10-13). The nature of this damage included areas where the seafloor had been scraped severely, resulting in either compacted bare substrate (Fig. 10A), with minimal original biota, or loose gravel or rubble material, again with minimal original living biota attached (Figs. 11D, 12B). Coral colonisation and recovery can be severely limited or delayed by unstable bottom material (e.g. Fox et al. 2003; Fox et al. 2005).

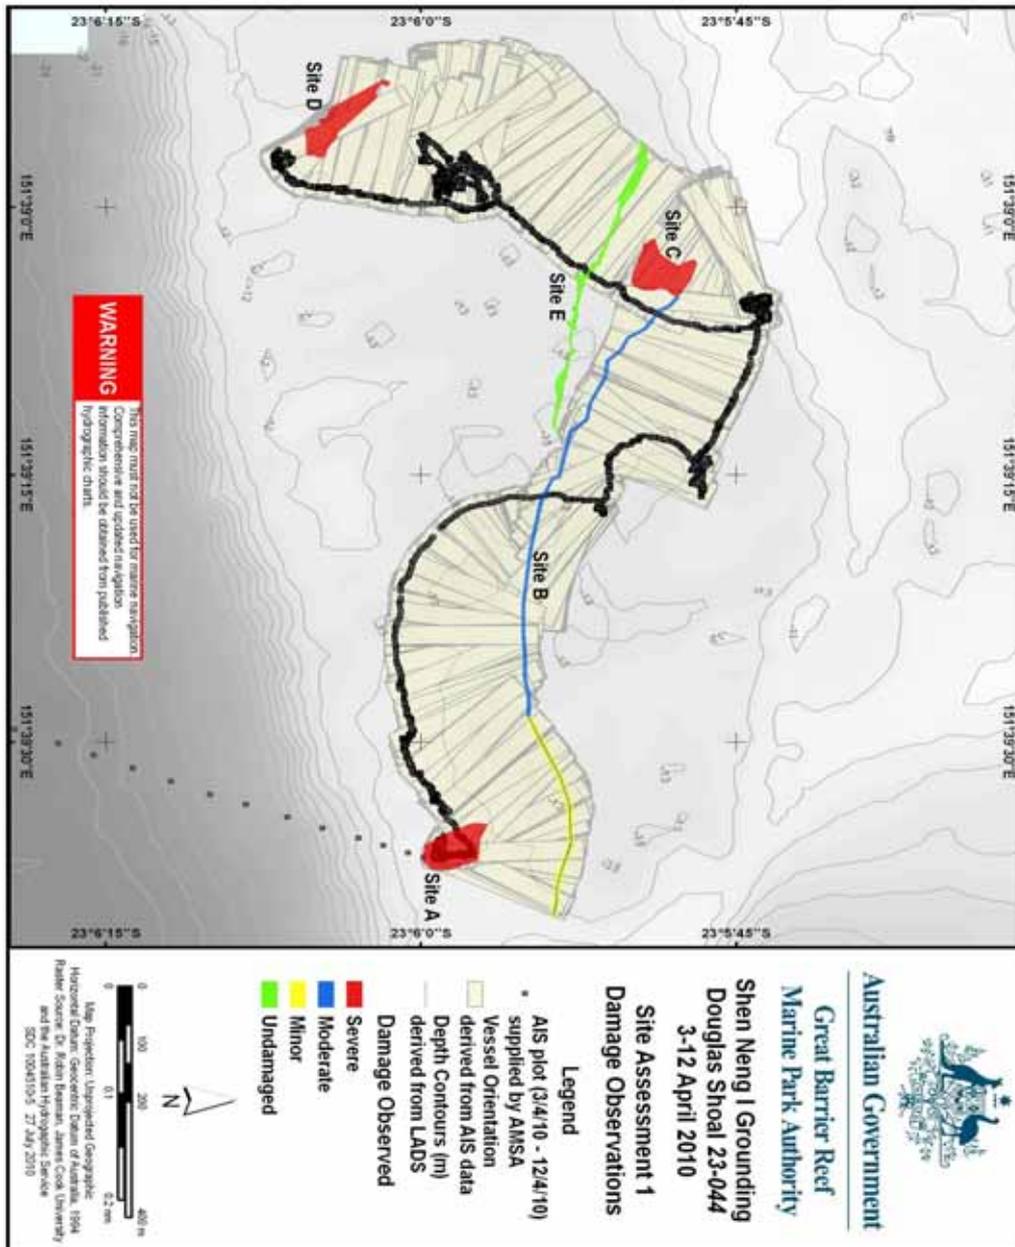
**Figure 5.** Locations of the sites inspected during the Preliminary Impact Assessment at Douglas Shoal, showing categories of damage observed against backdrop of vessel positions.

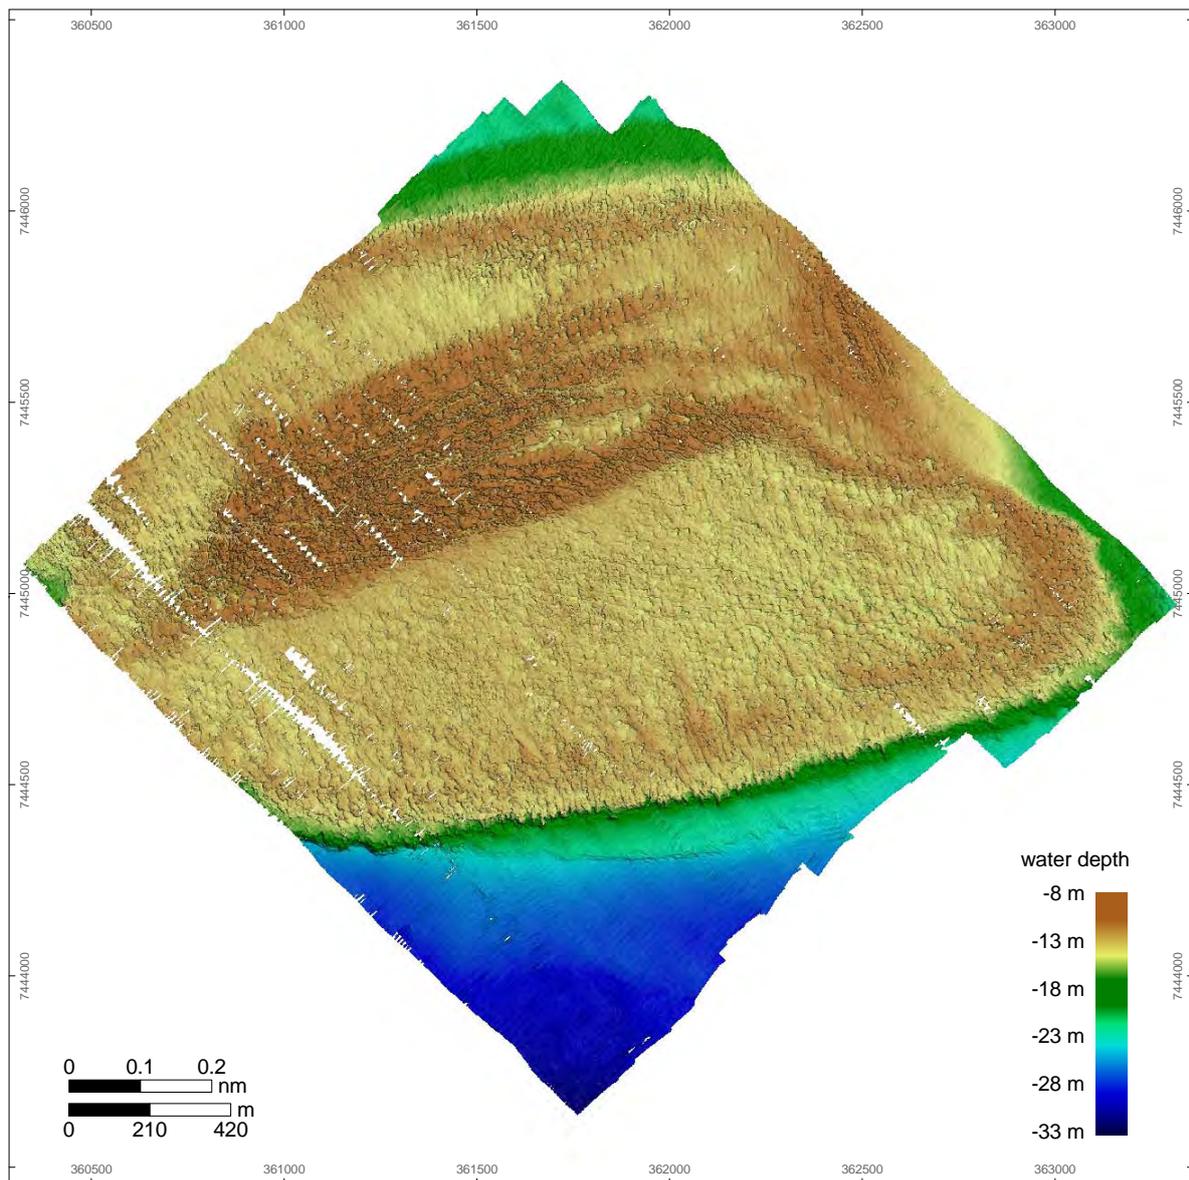
Multibeam sonar bathymetry of Douglas Shoal revealed a typical reef topography and geomorphology (Hopley et al. 2007) (Fig. 3).

Figure 3. Multibeam Bathymetry Overview. Colour-coded, sunshaded multibeam bathymetry of Douglas Shoal.

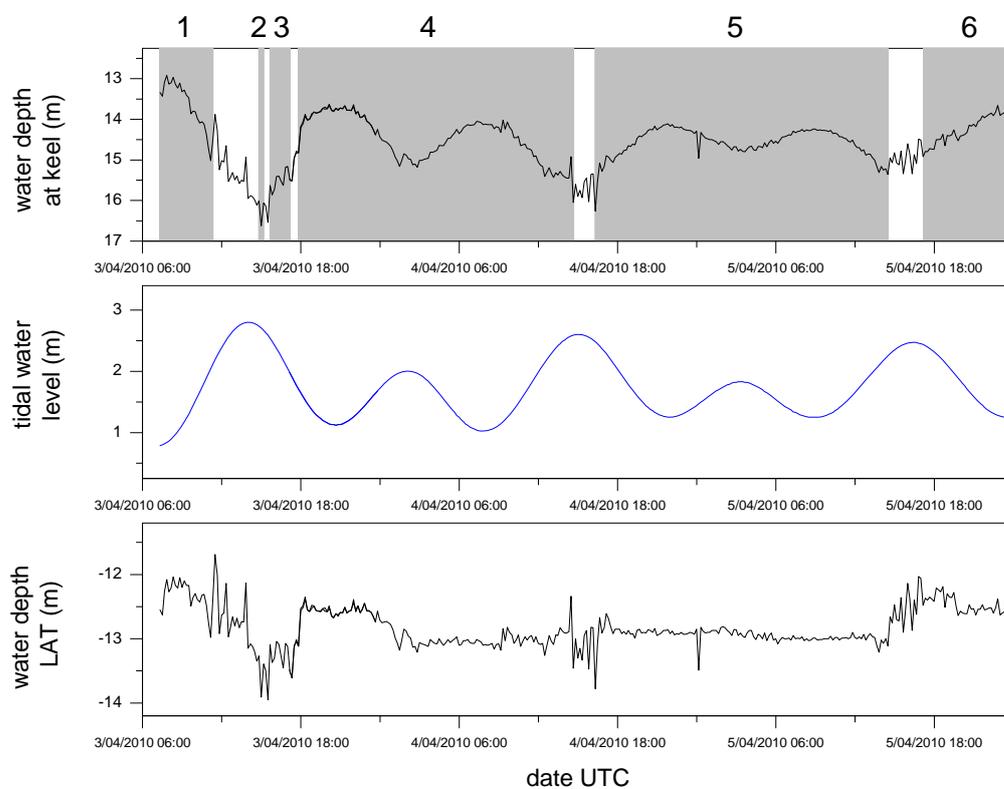
**Figure 4.** Time series of bathymetry (bottom), tidal water level (centre) and water depth at the keel (top) at the location of the Shen Neng 1's stern (GPS) in 10 minute time steps. The water depth under the keel is the sum of depth and tidal water level (note axis convention = positive down). The grey shading marks the periods when the vessel remained stationary or near stationary. Locations are marked above the figure. The figure illustrates the grounding at ca 13.5 m depth under keel (Site 1), subsequent refloating at greater depth under keel (Sites 2 and 3) and repeated grounding at Sites 4, 5 and 6. Note, only the first 6 hours of data is included at Site 6 for scale reasons.

The northward drifting *Shen Neng I* was likely stopped at Site 4 as the reef became shallower (Fig. 4). The *Shen Neng I*’s GPS and heading data shows that the stern remained in about the same location, whereas the bow was swaying in an approximately 45 degree arc, restricted to the North by the shallower reef. This caused significant wearing-down of the seafloor, clearly discernable in both bathymetry and backscatter data, which resulted in substantial destruction of the reef matrix (approximately 20,000 m<sup>2</sup>); little reef structure remains at this site.

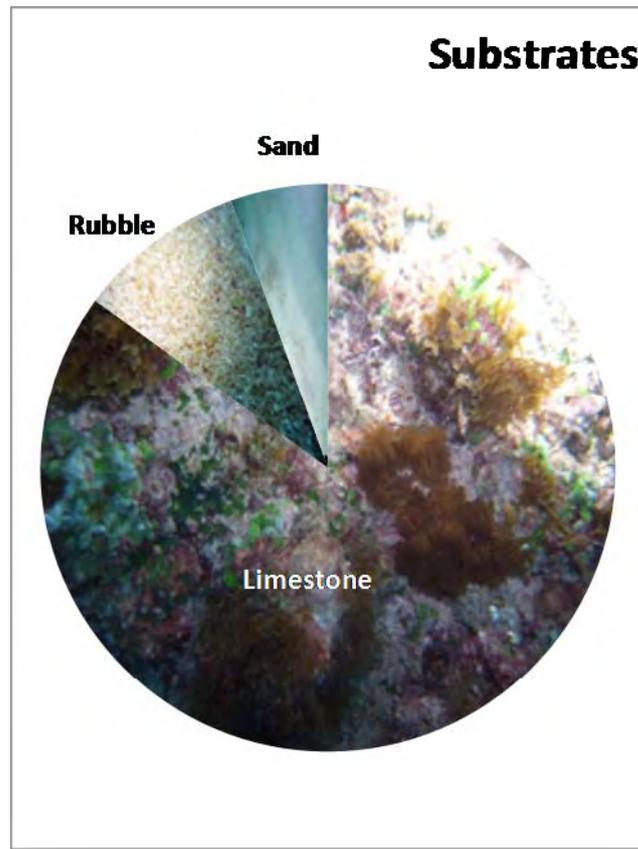
Figure 8. Relative contributions of the major substrate classes recorded from towed video footage on Douglas Shoal.

The shoal was limestone (85%) with gutters and holes where rubble (10%) and sand (5%) accumulated (Fig. 8). TUV revealed low profile benthic habitats, caused by relatively strong tidal currents. The lack of structural complexity was consistent with results obtained from the multibeam bathymetry. Macroalgae, visually dominated by *Sargassum*, was abundant over 53% of the surveyed tracks (Fig. 9A). A further 38% was classified as macro algae and filter feeder dominated communities. This included various algal species and, hard and soft corals. Approximately 8% of the surveyed shoal was dominated by small hard reef building coral colonies and the remaining 1% uncolonised.

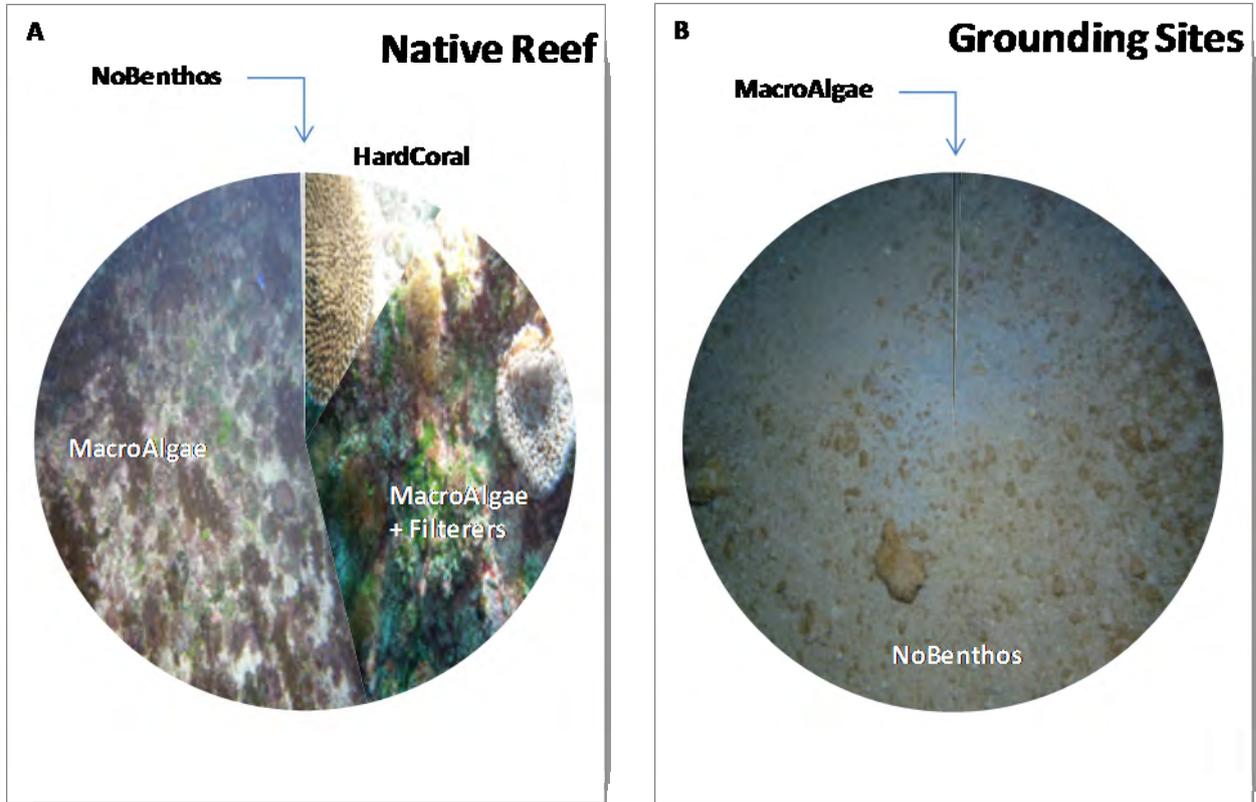
Areas affected by the ship's grounding and subsequent passage across the shoal were clearly pulverized (Fig. 9B and Fig. 10). The resultant substrate was classed as unconsolidated rubble (5 – 50

mm fragments). Damage due to the ship's anchor (distinctive drag marks) and hull (rubble areas or dislodged corals/reef) were also identified. Broad areas were levelled where the ship lifted and rotated with the tide and wind pressure.

**Figure 9.** The relative contributions of the predominant benthos classes to the undisturbed shoal (A) and areas affected by the grounding of the *Shen Neng 1* (B).

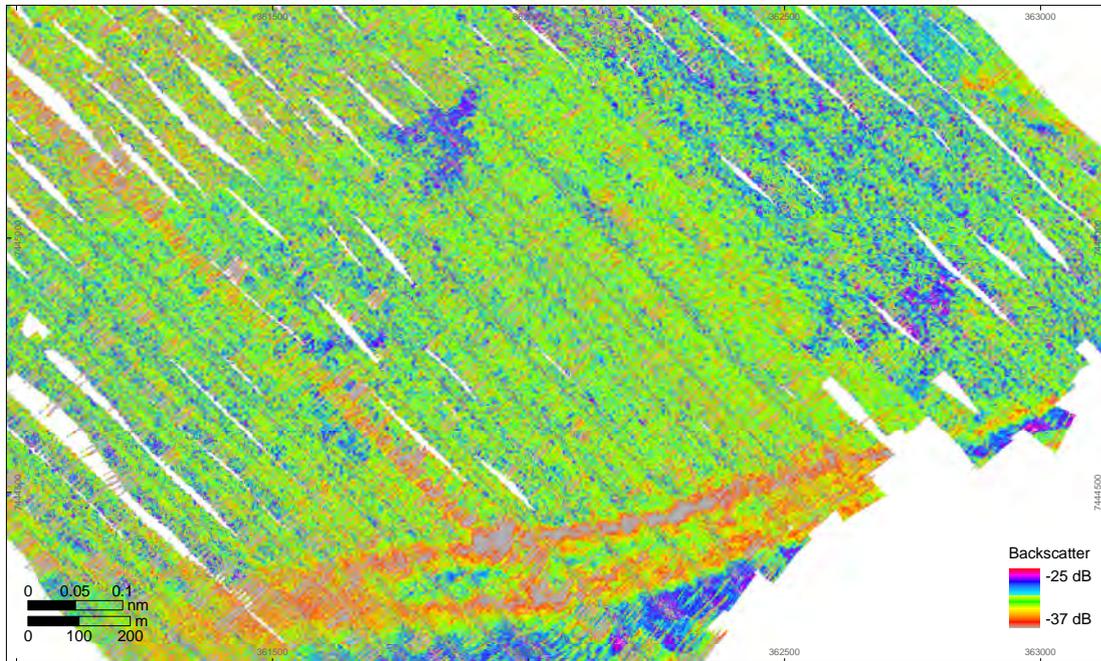
The bathymetry and slope maps of the site of initial grounding (Site 1) show little to no structural difference to the adjacent reef matrix. However, a systematic increase in backscatter strength is associated with this site (see Appendix Figs. A1 and A2). This is likely caused by an abrasion and flattening of the reef top, without destruction of the reef matrix itself and covers an area of approximately 49,500 m<sup>2</sup>. This site includes the ‘approach’ of the grounding site to the south, and a section less well defined to the west of the initial grounding site. The outlines of Site 1 were estimated based on backscatter data only, and should be regarded as a ‘guideline’ only. Note that the backscatter signature observed at Site 1 is similar to the signature of the flat seafloor immediately adjacent to the southern reef edge, an area that has not been impacted by the vessel due to its greater depth.

Figure A1. Multibeam backscatter strength of impact region.

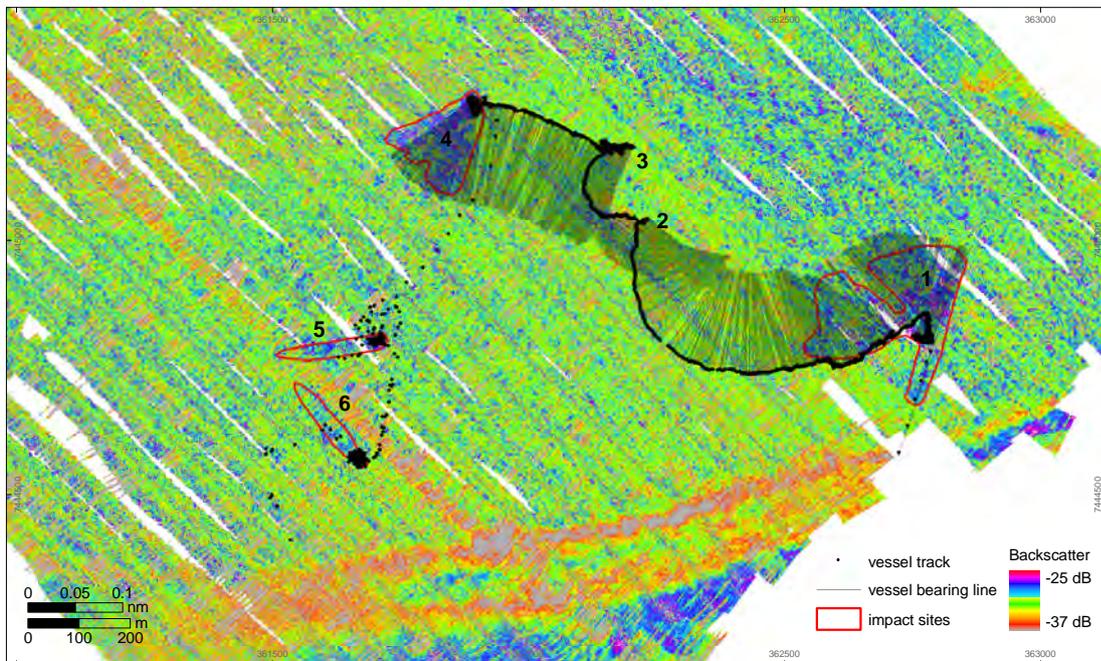
Figure A2. Multibeam backscatter strength of impact region with vessel track, bearing line and impact sites.

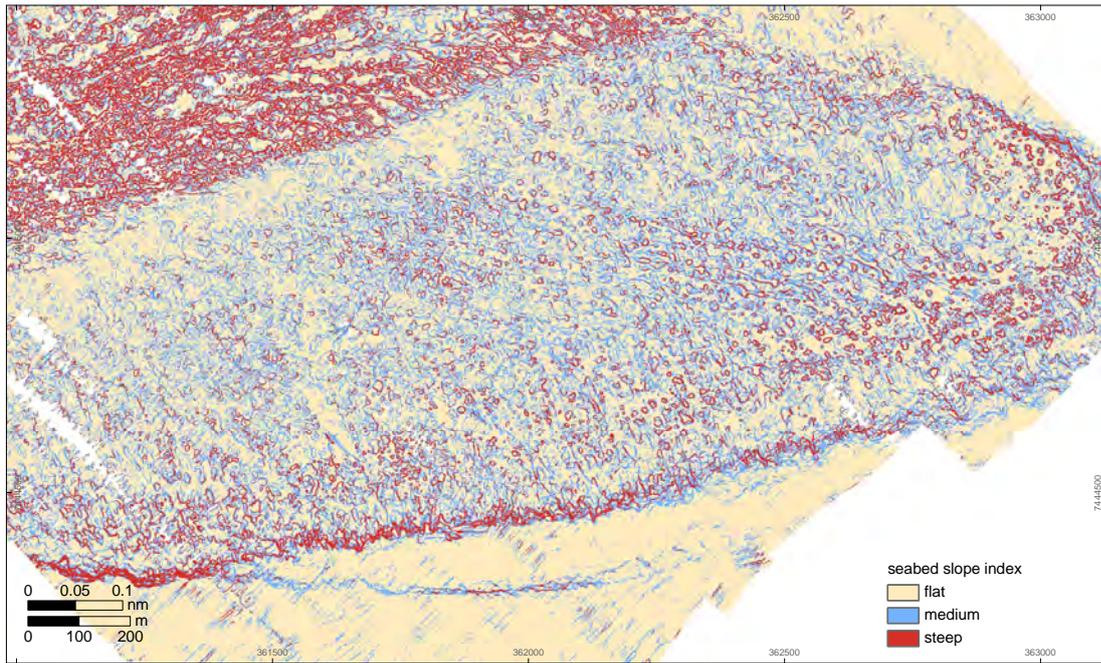
Figure A3. Seabed slope of impact region.

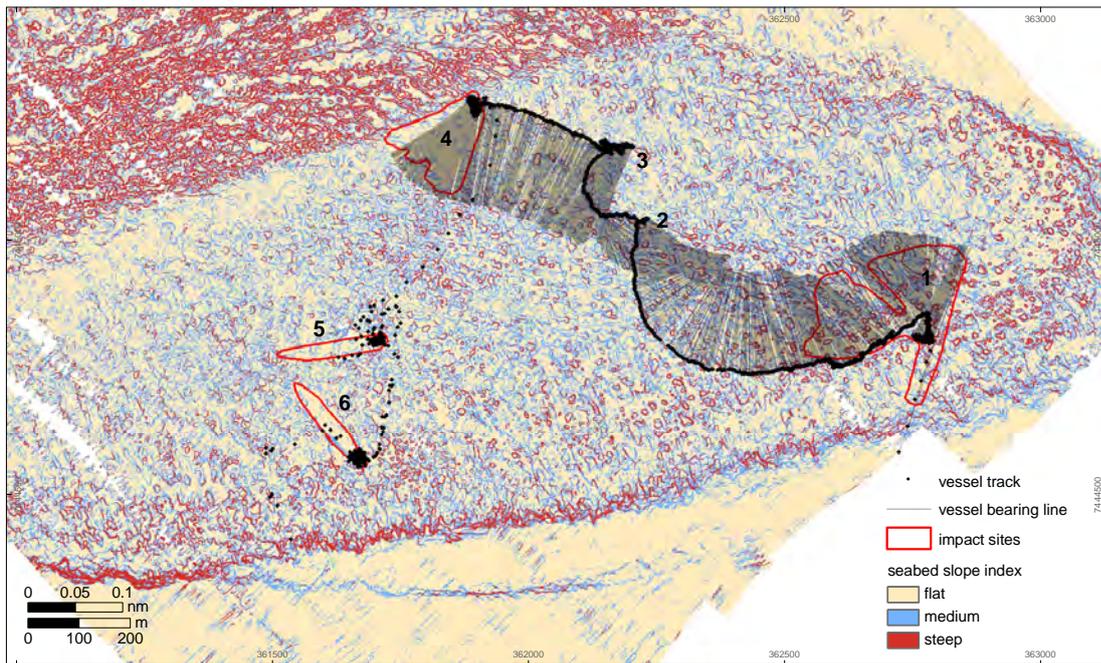
Figure A4. Seabed slope of impact region with vessel track, bearing line and impact sites (site names see text).

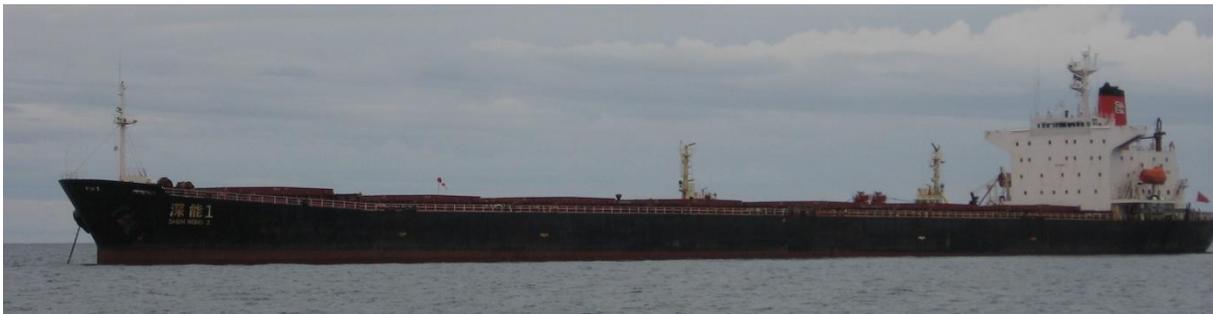
The team arrived alongside *Shen Neng 1* at approximately 0900 hours on 21 May 2010. The *Shen Neng 1* appeared stable and was at anchor on starboard anchor with no immediate signs of damage (refer **Figure 5**).

Figure 5. Shen Neng 1 on site in Platypus Bay 21 May 2010

From the water the draft of the *Shen Neng 1* was observed as: 12.6 m at bow, 12.6 m at mid ships and 14.4 m at stern using the hull draft marks in each case.

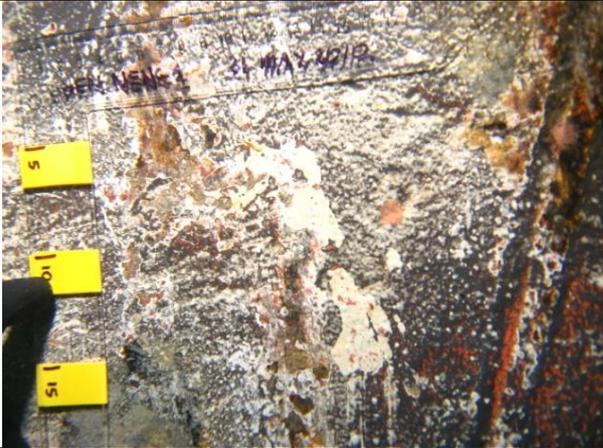
SN1-PT-03	hold 3 under	M0011363.J PG

Based on the in-water observations and photographs it was clear that the hull of the *Shen Neng 1* had recently experienced significant damage to the majority of the flat bottom and abrasion and some damage to the sides. Areas observed with no appreciable damage were restricted to the elevated areas of the bow bulb, stern and rudder.
