RESEARCH PUBLICATION No. 113

Historic Shipwreck Foam (1893)

Survey Report 2015

Peter Illidge

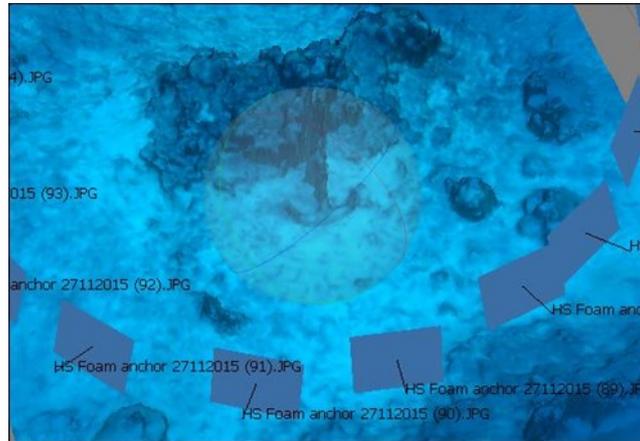
A weighted buoy was deployed at the recorded coordinates of the *Foam* anchor (18° 16'080" S x 147° 22'811" E WGS 84) and two DPV assisted divers located the anchor within six metres of the buoy weight. The buoy weight was relocated closer to the anchor and a series of photos taken without a scale. Several photos were taken around the anchor and used to trial a 3D modelling program called Agisoft (Figure 1).

Figure 1: Agisoft 3D rendering of the *Foam* anchor.

Comparison of the present position and condition of the anchor with archival data presents evidence that may be consistent with two attempts to steal this artefact. The author first dived the *Foam* anchor in 1982 when it was on top of the large coral bommie near its present position. It is now lying off this bommie. Also, on comparison of the archival photograph of the anchor taken 2009 (Figure 2) to recent pictures in its present situation (Figure 3) it looks to have been moved for a second time. It is unlikely that these movements would have been caused by cyclonic wave action because, on closer inspection of the anchor, it was noted that a piece of rope about 12 millimetres in diameter was attached to the shackle, further supporting the theory that it has been deliberately interfered with. The anchor's size and design may make it attractive to theft and this risk should be taken into account in the future management of the site.

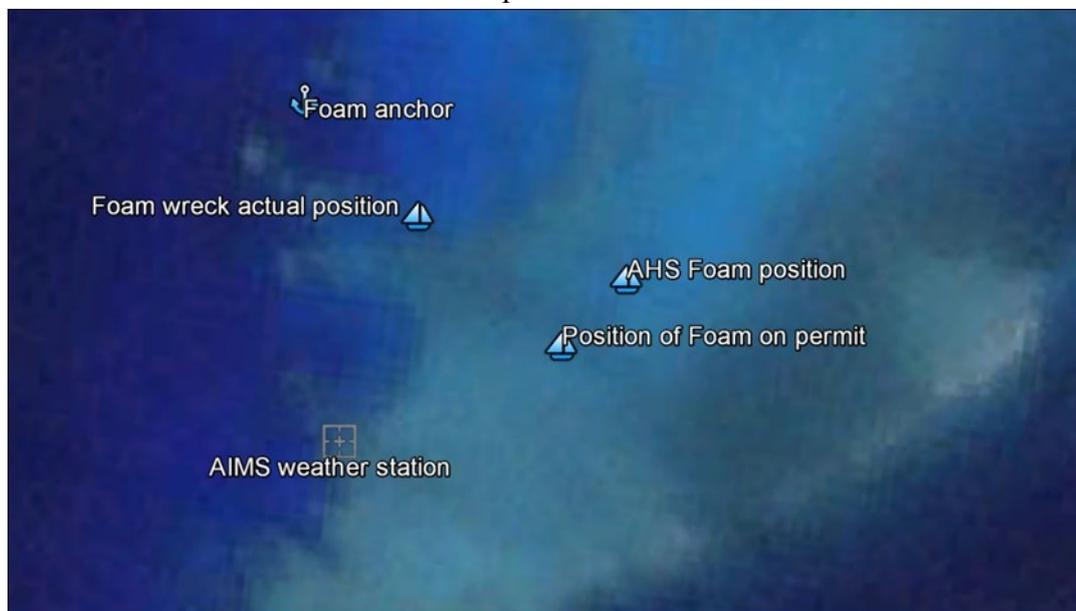
The main wreck site was located by snorkelers using the coordinates 18° 16'201" 147°22'970" WGS 84 (Figure 4), these were the most recent coordinates and so considered the most reliable. Other coordinates considered are plotted in figure four which shows a discrepancy of between 429 m and 469 m from the *Foam* wreck actual position.

Figure 3: Relative positions plotted on Google Earth, 2015.

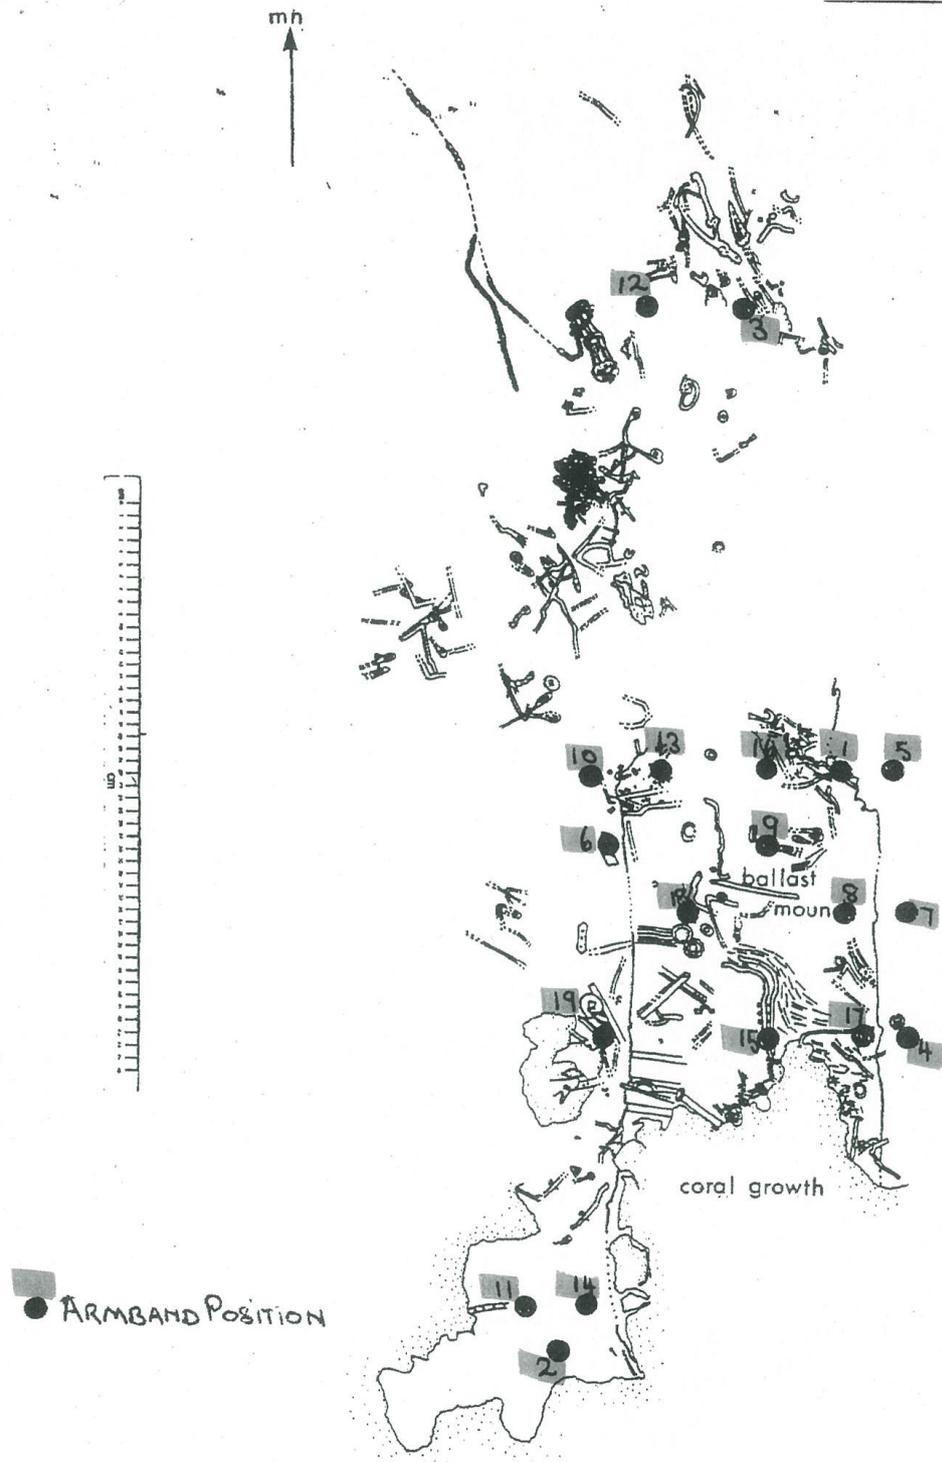
A previous expedition led by maritime archaeologist Dr Steven Beck seeded the site with ceramic replicas of clam shell arm bands to study site formation and artefact distribution. On the 4 December 2002, 19 yellow glazed ceramic replica arm bands were distributed across the site, most on the ballast pile. Each yellow glazed arm band had the letters FMAP (*Foam* Maritime Archaeology Project) and a number (1 – 19) stamped on the inside. Dr Beck produced a detailed map showing the position of each of the 19 arm bands on the site, see Figure 11.

Figure 10: Seed arm band placement by Dr Steven Beck. (Map from Beck 2009).

The survey team spent the equivalent of 16.5 person hours between sites. In this period only one arm band was located towards the southern end of the ballast pile under a coral ledge and concreted into the ballast pile. If the marine growth on the found arm band is indicative of the condition of the others they will be difficult to see amongst the coral rubble. Figure 12 shows the arm band after some light cleaning to reveal the yellow colouring. The arm bands were all numbered so it would have been advantageous to know which arm band it was so its voyage around the site may be mapped. As it was concreted into the substrate, identification would have required the breaking away of the item and possible damage to it and the artefacts it is

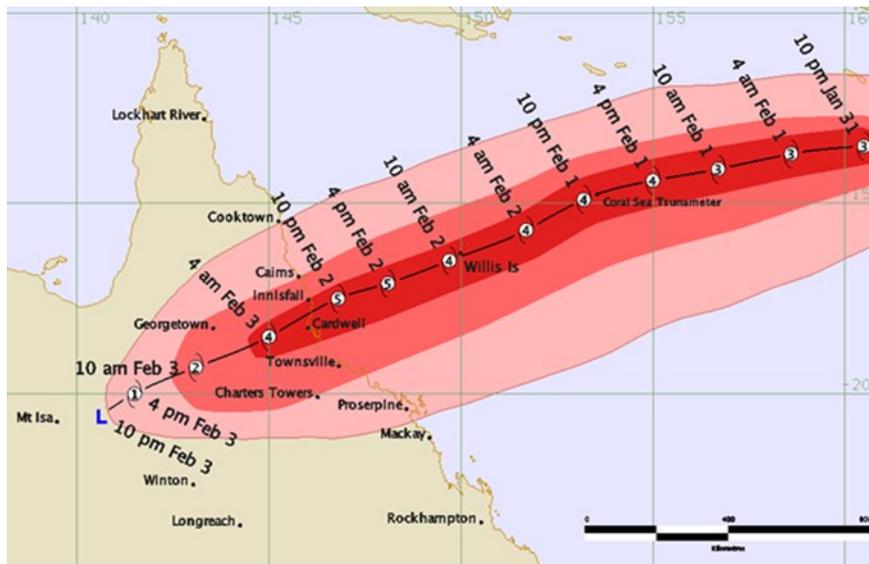
Cyclonic damage to coral communities may benefit and in some cases assist in the protection of a wreck site. When cyclonic forces render coral into rubble and then move that rubble onto the wreck site, it may protect the fabric of the site from further damage by other forces. The

accretion of protective rubble around the wreck feature, possibly during cyclone Yasi, is a good example of this. The burial in rubble has occurred since 2002.

Figure 13: Cyclone Yasi track (Bureau of Meteorology 2016).
