MANAGING FACILITIES DISCUSSION PAPER

Great Barrier Reef Marine Park Authority Issue 3 / 5 July 2016 248793-RPT-001 Advice on Managing Facilities within the Great Barrier Reef Marine Park

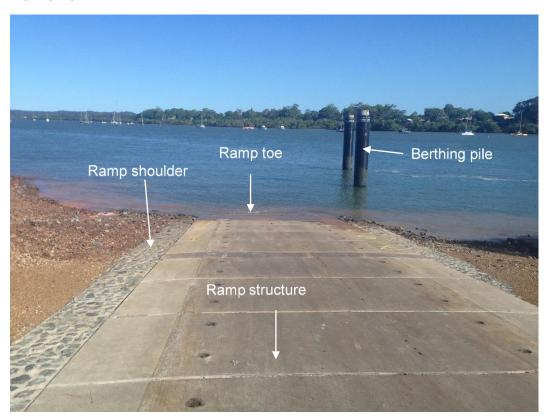
Figure 1. Barge Ramp

The ramp structure is usually a concrete slab with rock shoulder and toe. Some barge ramps have berthing piles to assist vessel berthing. Barge ramp structures are generally designed to have a 50 year design life. An example of a barge ramp is shown in figure 1. As of 27 November 2015, there were nine barge ramps permitted within the Marine Park.

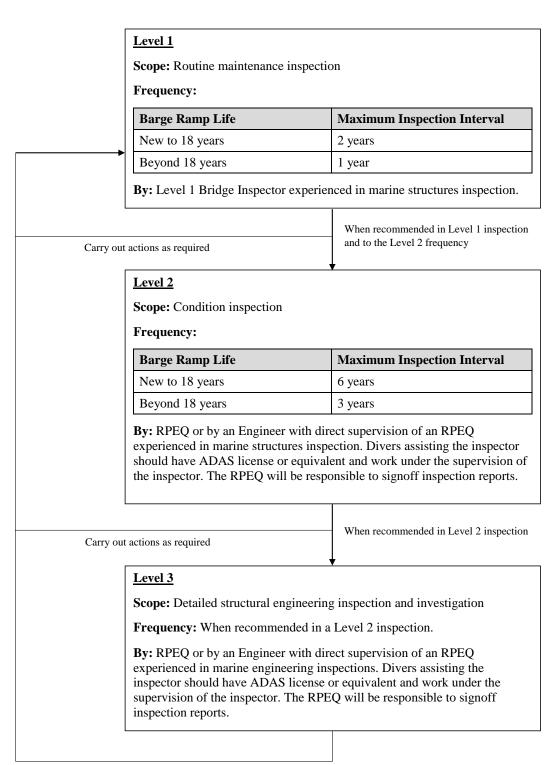
Figure 2. Inspection Regime for Barge Ramps

The inspection regime is summarised in a flow diagram shown in Figure 2.

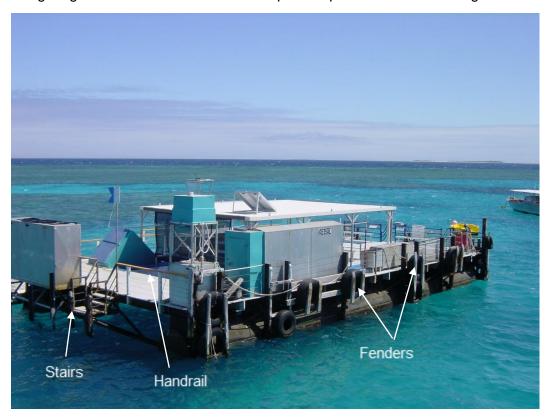
Figure 3. Pontoon (source GBRMPA)

There were 59 pontoons permitted within the Marine Park as of 27 November 2015. Most of these are smaller facilities, with nine (9) large multi-purpose tourist pontoons having lengths in excess of 20m. An example of a pontoon is shown in figure 3.

For pontoon floating components that require Certificate of Survey, the pontoon mooring systems (such as anchors, chains and piles) are suggested to require inspection for GBRMPA's purposes. For pontoon floating components that do not require a Certificate of Survey, a variety of fixings such as handrails, ladders, timber fenders and concrete deck also need to be inspected, refer to figure 3.

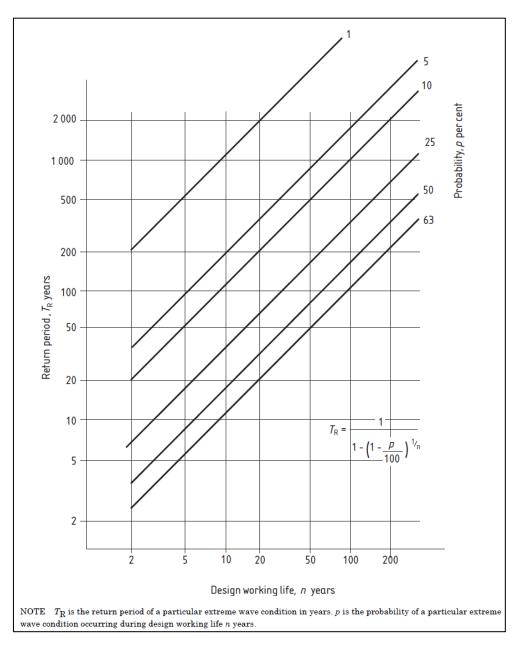
Figure 5. Relationship between Design Working Life, Return Period and Probability of Wave Heights Exceeding the Normal Average, (*source:* BS6349-1, (2000))

The information in table 16 can be represented in a graphical form as shown in figure 5.

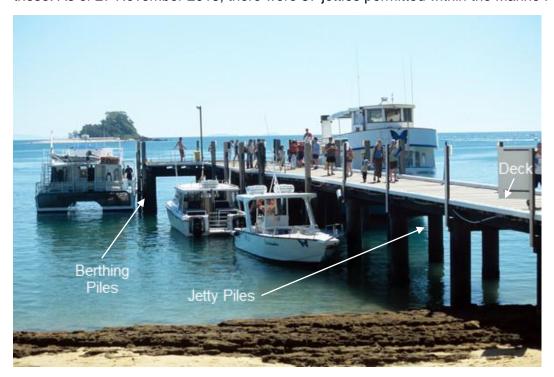
Figure 6. Jetty (source GBRMPA)

Jetty structures are constructed to provide access from land to a landing platform or a vessel berth for the transfer of personnel and/or goods. An example of a jetty is shown in figure 6. Jetty structures generally consist of timber, concrete, steel or combination of these. As of 27 November 2015, there were 37 jetties permitted within the Marine Park.

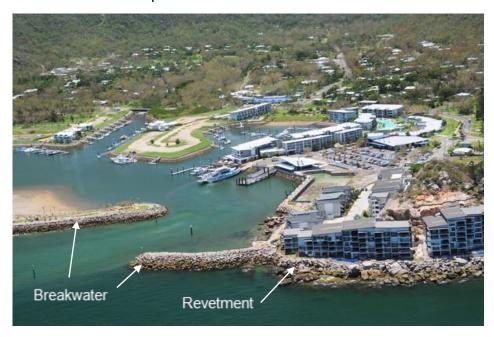
Figure 9. Breakwater and revetment (source: GBRMPA)

Walls such as rock walls, revetment, groyne, breakwaters and bund walls provide protection to the shoreline or facilities such as a marina from wave action. These can be called coastal protection structures. Walls are generally constructed of rock armour or precast concrete armour. An example of a breakwater and revetment wall is shown in figure 9. figure 10 shows a typical revetment wall cross-section profile as an example.

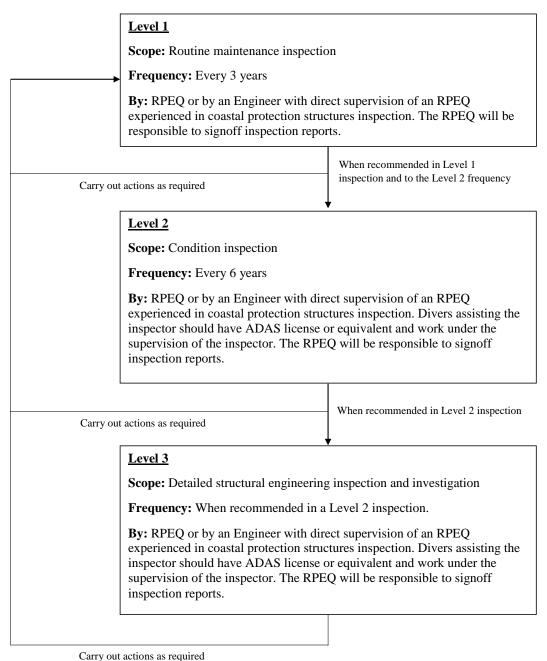
Figure 11. Proposed Inspection Regime for Walls

The inspection regime is summarised in a flow diagram shown in figure 11.

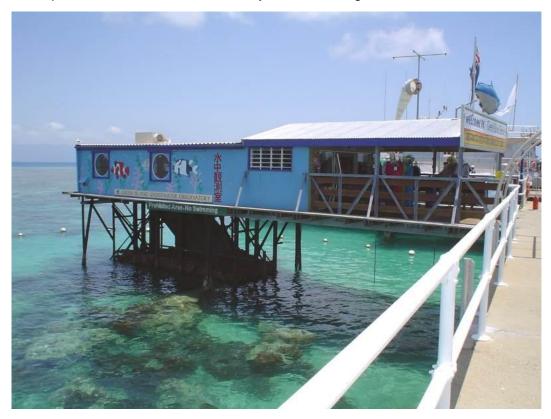
Figure 12. Green Island underwater observatory (source: GBRMPA)

An example of an underwater observatory is shown in figure 12.

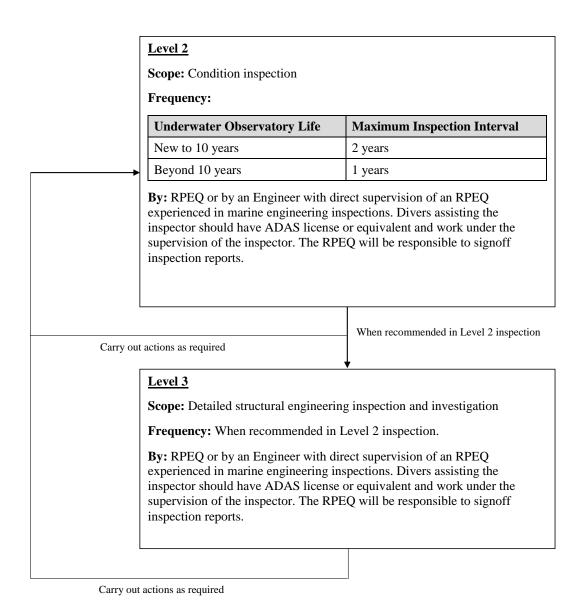
Figure 13. Proposed Inspection Regime for Underwater Observatories

The inspection regime is summarised in a flow diagram shown in figure 13

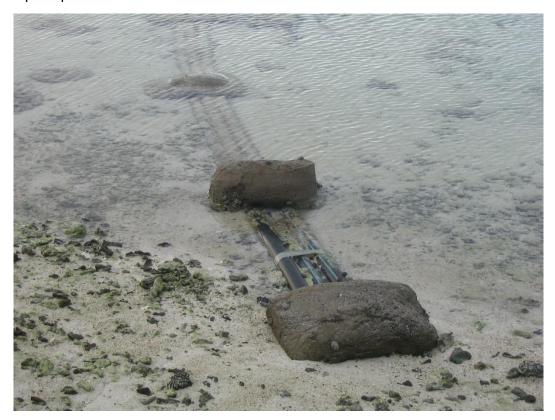
Figure 14. Water intake pipe (source: GBRMPA)

As of 27 November 2015, there were a total of 68 pipelines permitted within the Marine Park, as summarised in table 33. These include discharge outfall pipes, intake pipes and transport pipes (which traverse the Marine Park without discharge or intake). Lengths of these pipes vary from very short lengths (< 10m outfall pipes) to much longer distances (> 1km water mains, etc.). An example of a typical pipeline within the Marine Park is shown in figure 14.

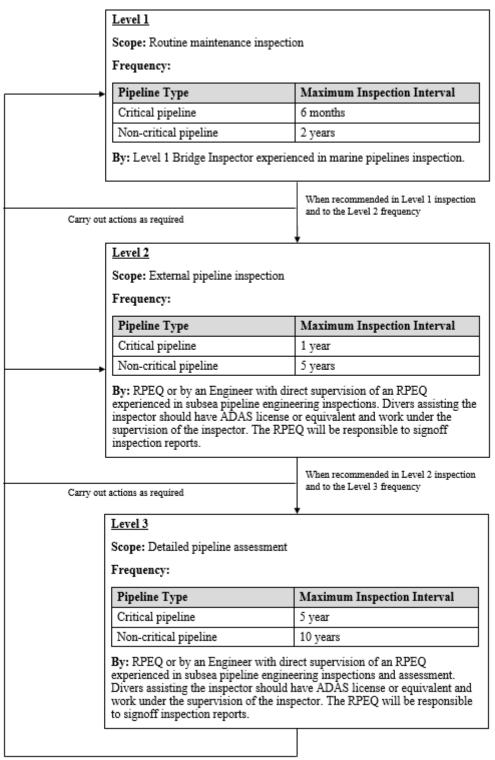
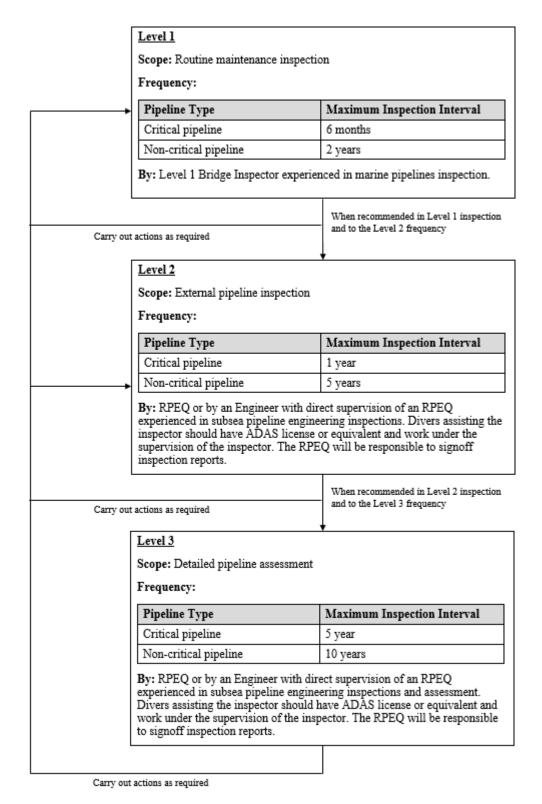
Figure 15. Proposed Inspection Regime for Pipelines

The inspection regime is summarised in a flow diagram shown in

figure 15.
