## Great Barrier Reef Marine Park Authority

## Lady Elliot Island Lightstation Heritage Register

Commonwealth Heritage List Place ID Number 105415

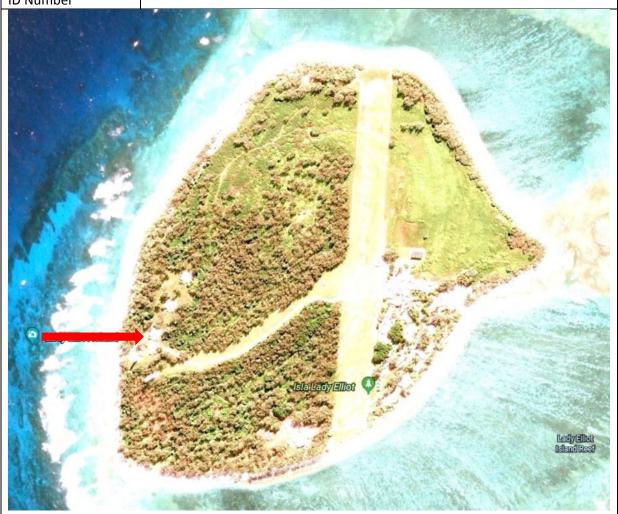
Commonwealth Heritage List Place ID Number Current Status	Listed place as at 22 June 2004
Ownership	The property is owned by the Marine Park Authority on behalf of the Commonwealth. Two lessees have lease arrangements with the Marine Park Authority. The lease agreements require the lessees to comply with the requirements set out in this Heritage Management Plan:  • The private lease relates to the use of the island for resort purposes and commenced on 1 December 2005; and  • A second lease relates to the ongoing presence of a navigation light and commenced on 27 May 2003.
Location	Lady Elliot Island is situated at the southernmost end of the Great Barrier Reef approximately 90 kilometres north-east of Bundaberg and 150 kilometres east-south-east of Gladstone (24° 07' S, 152° 43' E). The island, which occupies a surveyed area of 34.67 hectares, is Australia's most southerly coral cay and is situated at the southerly end of a drying platform reef of about 142 hectares. The Heritage Management Plan Area occupies approximately 0.8 hectares along the western side of the island and is delineated by the boundary of the lighthouse and residential precincts.  The yellow arrow on the below Google Map shows the relationship of Lady Elliot Island to Bundaberg on the mainland.  On the following image from Google Earth, the red arrow is pointing to the Lightstation precinct.
